Detailed Seismic Assessment

**Taradale Primary School Swimming Pool Enclosure, Ngarimu
Crescent, Taradale, Napier**

Ref No: 1163.1

12th April 2016

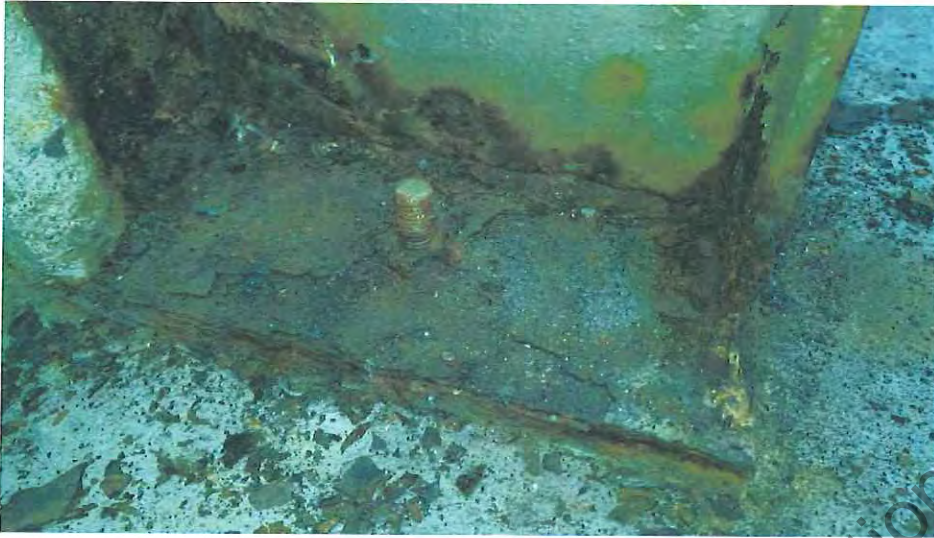
FIGURE 9: Condition of base of steel frame column and corroded nut to HD bolts

As previously reported, elements of the building structural system have degraded through corrosion of steel elements such as the frame, bolt fixing and associated connection plates, and rotting of timber elements, in particular the purlins below the Durolite.

- Significant degradation of steel portal base
- Degradation of strut to steel portal column at junction with concrete surrounds
- Degradation of steel connections
- Degradation of steel portals throughout span
- Degradation of roof timbers, particularly below the Durolite
- Degradation roof strap bracing
