**Mātauranga House**

**33 Bowen Street**

Targeted Detailed Seismic  
Assessment Report

**Ministry of Education**

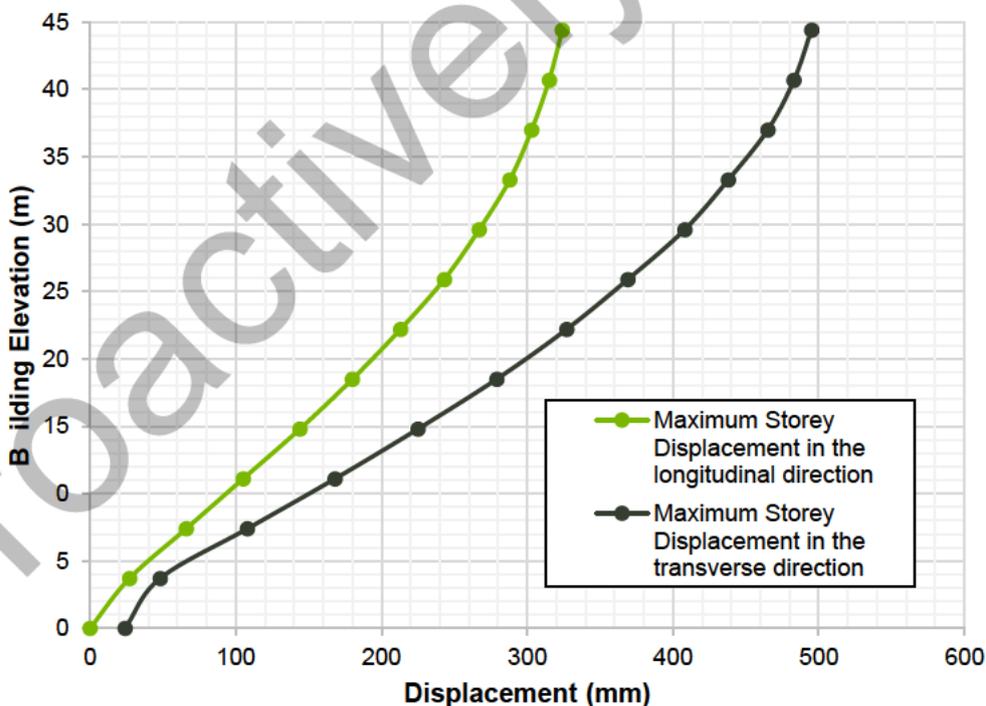
Figure 3.1 – Estimated Building Displacements for 100% ULS shaking

The building displacements up the height of the building obtained from our analyses for 100%ULS shaking are shown in Figure 3.1. The maximum inter-storey drift under 100%ULS shaking, allowing for the  $k_{dm}$  modification factor and P-delta effects, is shown in Table 3.2. In both directions, the drift is less than the design code limit of 2.5%.

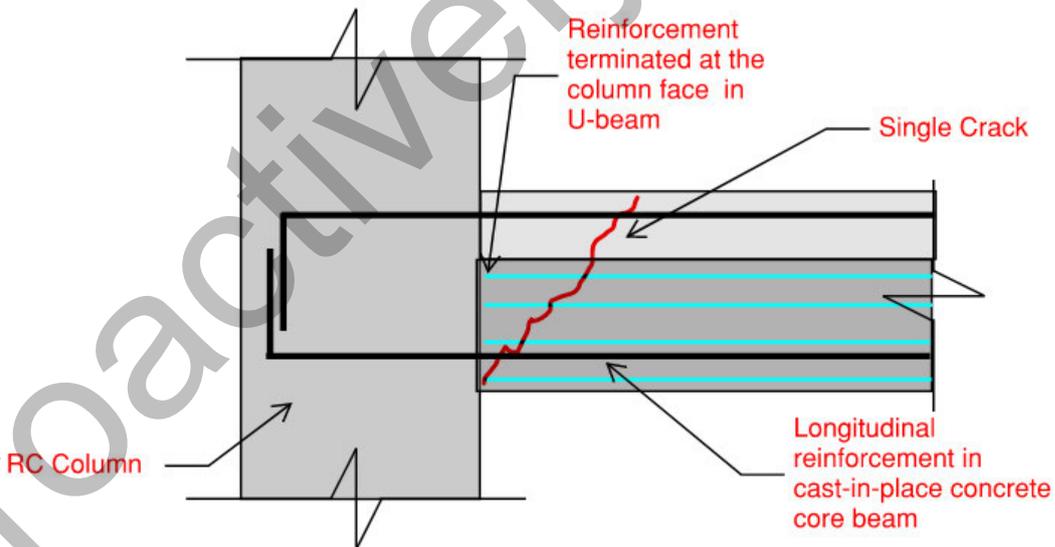
A single crack may also occur in the beam's potential plastic hinge zones due to the reinforcement detailing being such that the flexural strength adjacent to the column face is materially greater than at the critical section. This is not a preferred mechanism for ductility, compared with multiple cracks in a plastic hinge zone. The U-beams are reinforced with H10 deformed bars that are terminated at the beam end and are not anchored in the reinforced concrete column. A single crack concentrates the plastic demand to a small reinforcement length and limits the amount of plastic rotation.

Figure 4.2 – Typical RC beam section - potential single crack in the plastic hinge zone

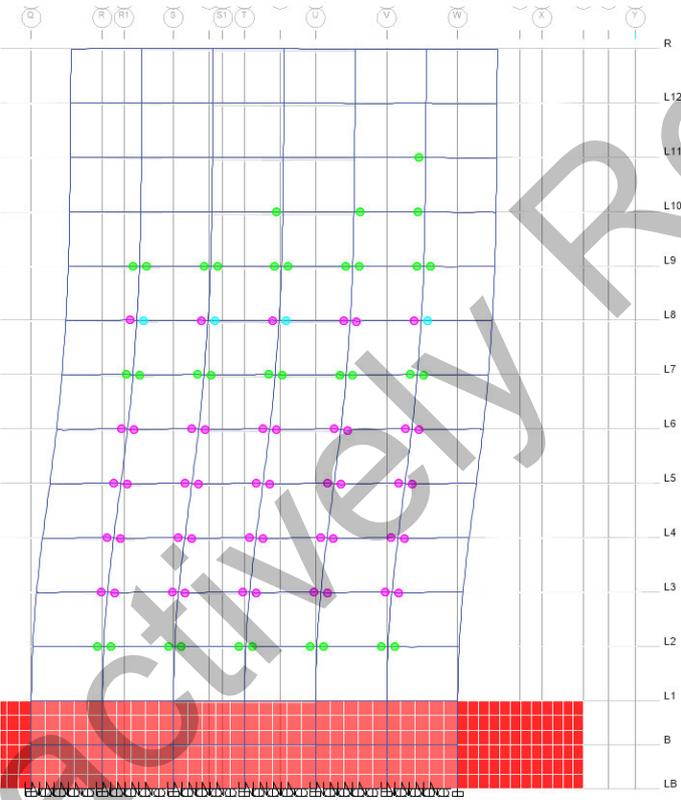
Figure 4.3 – Longitudinal Direction Plastic Hinge Status at ULS demand.

The MRFs have insufficient capacity to resist 100% ULS demand. The deformed shape from the pushover analysis in the longitudinal direction at the ULS demand is shown in Figure 4.3. The green circles show that the rotational demands on the primary columns and beams do not exceed the Life Safety limit . However, the blue and pink circles show that the rotational demands on the primary columns and beams exceed the Life Safety limits.

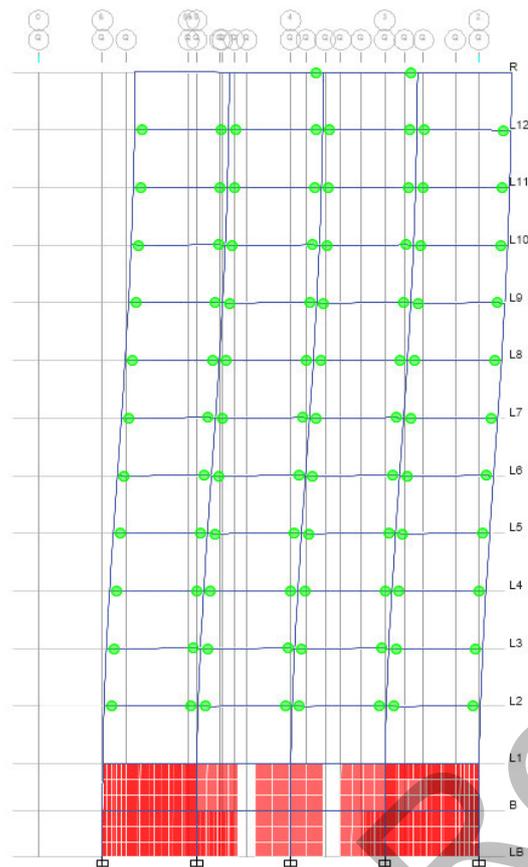
Figure 4.4 – Transverse Direction Plastic Hinge Status at ULS demand.

The MRFs have sufficient capacity to resist 100% ULS demand utilising a global ductility factor in the order of 2.5.

The deformed shape from the pushover analysis in the transverse direction at the ULS demand is shown in Figure 4.4. The green circles show that the rotational demands on the primary columns and beams do not exceed the Life Safety limits.

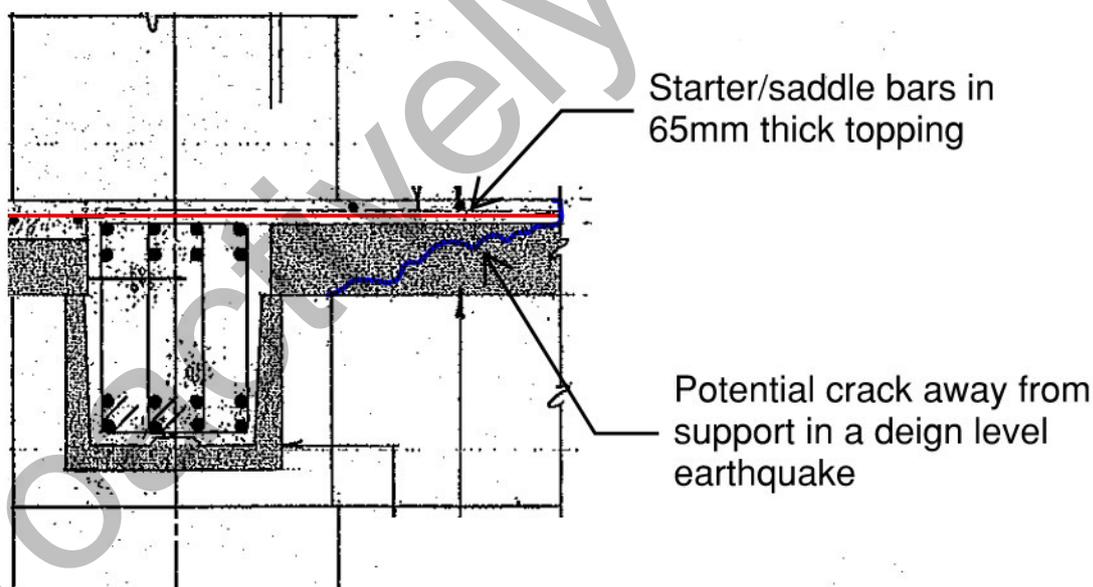
Figure 4.5 – Negative moment failure

This building has strong saddle reinforcing bars and as a result there is a potential for negative moment failure in severe shaking.

A negative moment failure could occur when a large crack forms on the top side of the unit away from the precast unit seating. This typically occurs when the building has strong and/or short reinforcing bars in the concrete topping over the RC beams. Based on the above the negative moment failure mode scores **30%NBS (IL2)**.

- Negative moment failure. Install strongbacks to the underside of all the units from level 2 – level 12. Selective weakening the starter/saddle bars in the concrete topping is also a possible retrofit solution.

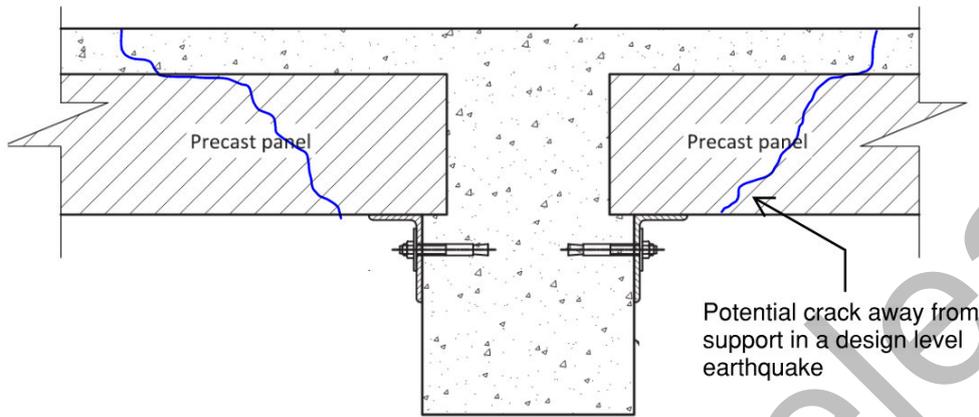
Figure 4.6 – Positive moment failure

A positive moment failure could occur when a large crack forms on the underside of the unit away from precast unit seating. Once the crack forms, beam elongation and rotation may force the crack wider. A crack

may form away from the 75mm seating from the UA in severe shaking. This is because if the prestressing strands in the hollow-core units are poorly bonded, a positive moment crack is not guaranteed to form at the edge of the seating ledge. In the absence of suitable non-destructive methods to detect poorly bonded strands, retrofits should ideally address the possibility of a positive moment crack forming away from the support.

Therefore, we note that the steel 75x125 unequal angles (UA) to the underside of the precast units is not considered reliable to mitigate a positive moment failure in a design level earthquake. Based on the above the positive moment failure mode scores **35%NBS (IL2)**.

- Positive moment failure. Undertake onsite testing to confirm if the prestressing strands in the hollow-core units are poorly bonded or sufficiently bonded. If the strands are poorly bonded, then we suggest installing strongback to the underside of the units that are within the “elongation zone” from level 2 – level 12.

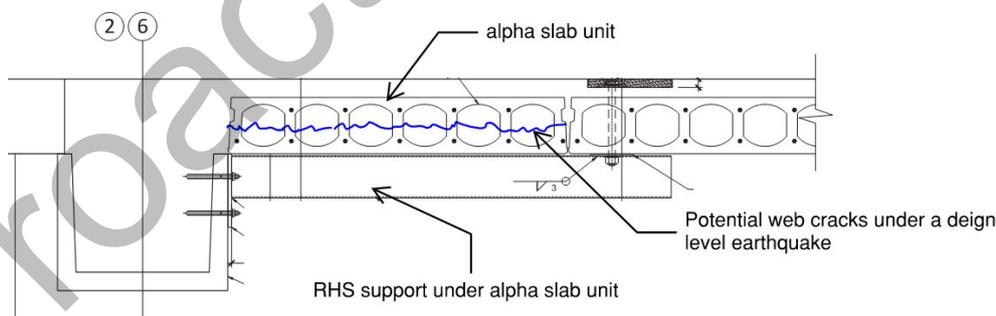
Figure 4.7 – Web cracking failure

Web cracking in the Hollowcore alpha slab units could occur in a severe earthquake. An alpha slab is the precast unit that runs directly parallel to a seismic frame. In severe shaking, horizontal web cracking of the units may be expected in the alpha slab units potentially causing the bottom portion of the precast unit to separate from the upper part of the unit.

The ISPS seismic retrofit installed steel RHS members on the underside of the alpha slabs that may support the bottom of the unit if the bottom portion of the precast unit was to separate from the upper part of the unit.

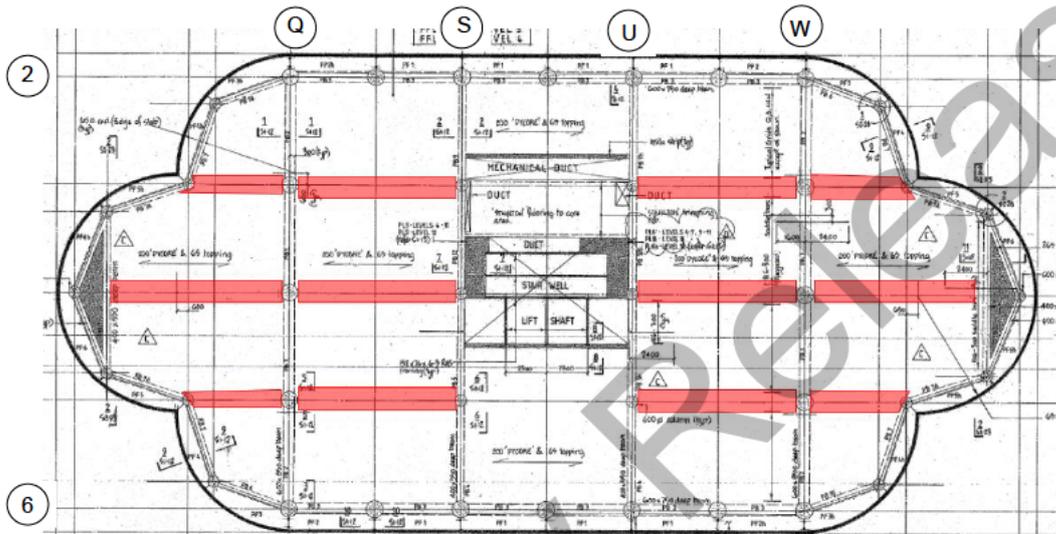
Figure 4.8 – Beta slab locations.

"Beta" units are the floor units that are supported at or adjacent to an intermediate column of the RC frame. Beta units are notably not addressed in the *Guidelines*, but their susceptibility to damage has now been well documented both in the laboratory and discussed in *Development and Validation of Retrofit Techniques for Hollow-core Floors*, dated 6 July 2021. The current guidelines suggest limiting the inter-storey drift of the building to 1.5%. The calculated drifts for the building are 1.8% longitudinally and 2.4% transversely, both greater than this recommended limit of 1.5%.

Based on the above the beta unit's score is 30%NBS (IL2). We note that the research in the difference precast failure modes is ongoing and therefore, some aspects of the *Guidelines*, may potentially change and hence affect the failure mode scores.

- Retrofit the hollowcore precast units considering the following failure modes:
  - Beta Units. Install strongbacks to the underside of the beta units in accordance with the guidance in the “*Development and Validation of Retrofit Techniques for Hollow-core Floors*”, dated 6 July 2021. The strongbacks are required at the beta units' locations from level 2 – level 12.

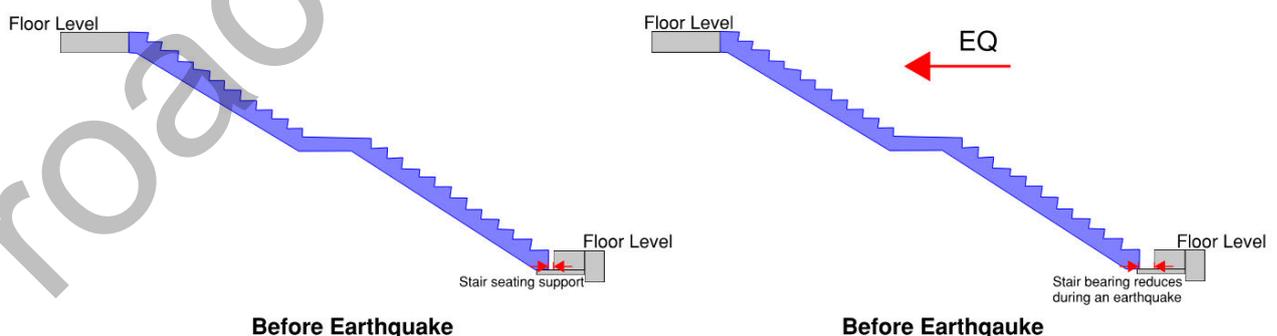
Figure 4.9 – Stair displacement before and during earthquake

- The 2014 seismic retrofit installed steel members underneath the RC stairs and increased the sliding stair seating length. The length of the sliding length is insufficient to accommodate the Guidelines’ new estimated  $2/S_p \times$  ULS inter-storey displacements, construction tolerance, stair concrete cover spalling and beam elongation. We note that the required sliding length was increased (by a  $2/S_p$  factor) due to code amendments after the original design was completed.

- If the stairs come into contact with the structure, the stair could act as an accidental brace between adjacent levels and have an undesirable effect on the behaviour of the main structure and may lose gravity carrying capacity.

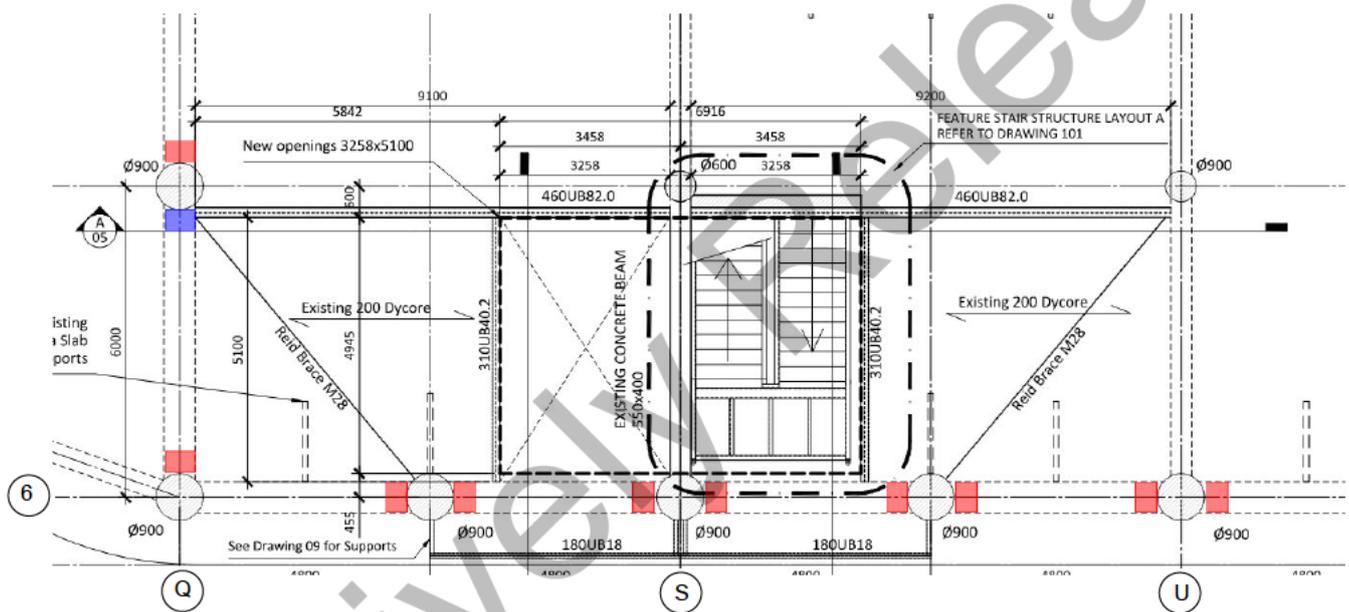
The stairs designed and constructed in 2014 are steel stairs that are tied in at the top of each flight and have movement allowances at the base support. However, the steel stairs are considered a structural weakness due to the following:

- The stairs rely on epoxy anchor connections for both gravity and lateral carrying capacity.
- In some locations, the connections are anchored into potential plastic hinges (locations where we expect localised damage in a severe earthquake). This is not desirable.
- Once the potential plastic hinges form in a design level earthquake, we expect large cracks to form. As a result, the epoxy anchors become unreliable to carry gravity loading.
- We note, epoxy anchor bolt capacities have been downgraded due to code amendments and C2 provisions after the seismic retrofit was complete. However, anchors in the beam potential plastic hinge zones are considered non-compliant.

Figure 4.10 – Expected plastic hinge locations around the 2014 stair void. Blue shows the hinge that the steel beam is anchored into. Red shows the other expected plastic hinge locations

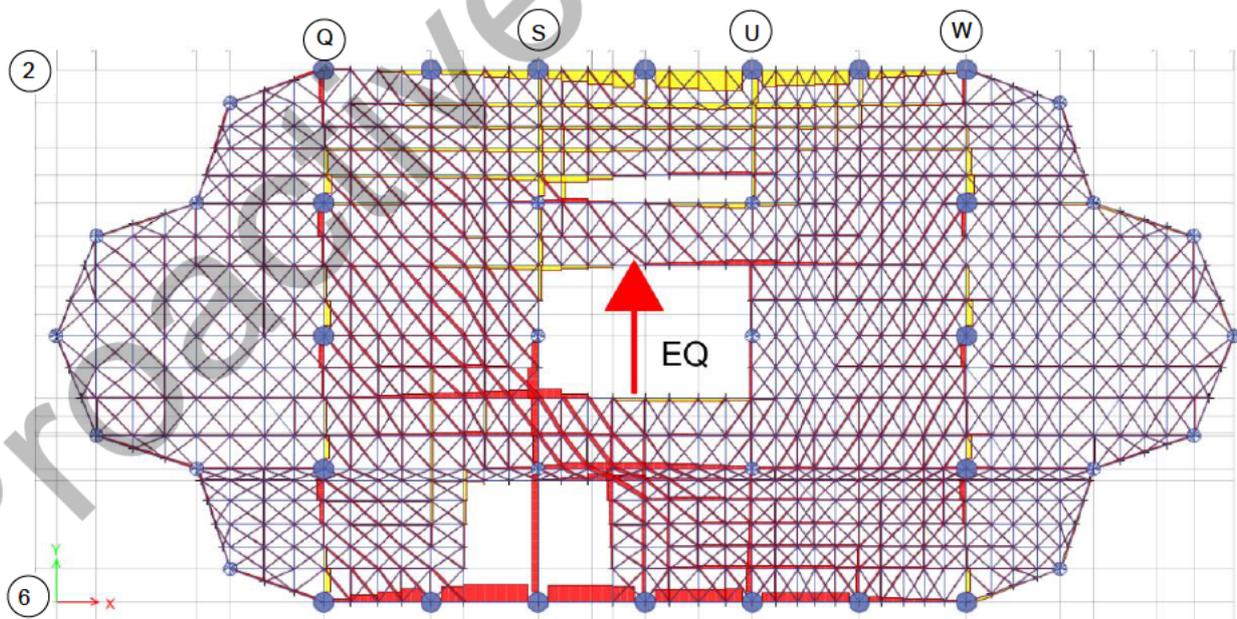
- The large voids cut out in the floor diaphragm from the 2-14 stairs also significantly reduces the shear plane to transfer diaphragm load. We note that the slab around the stair opening was reinforced with fibre as part of the 2014 strengthening, however, the fibre may rupture under beam elongation.

- The non-ductile mesh also has insufficient capacity to transfer diaphragm load to the frames. Once the tension capacity of the mesh is exceeded, the diaphragm effectively separates from the MRFs.

Figure 4.11– Grillage model of a typical floor plate. Yellow shows tension and red shows compression
