# Model School Name

## Block M1 – Classrooms

### Weathertightness Remediation Inspection Report

**March 2022**

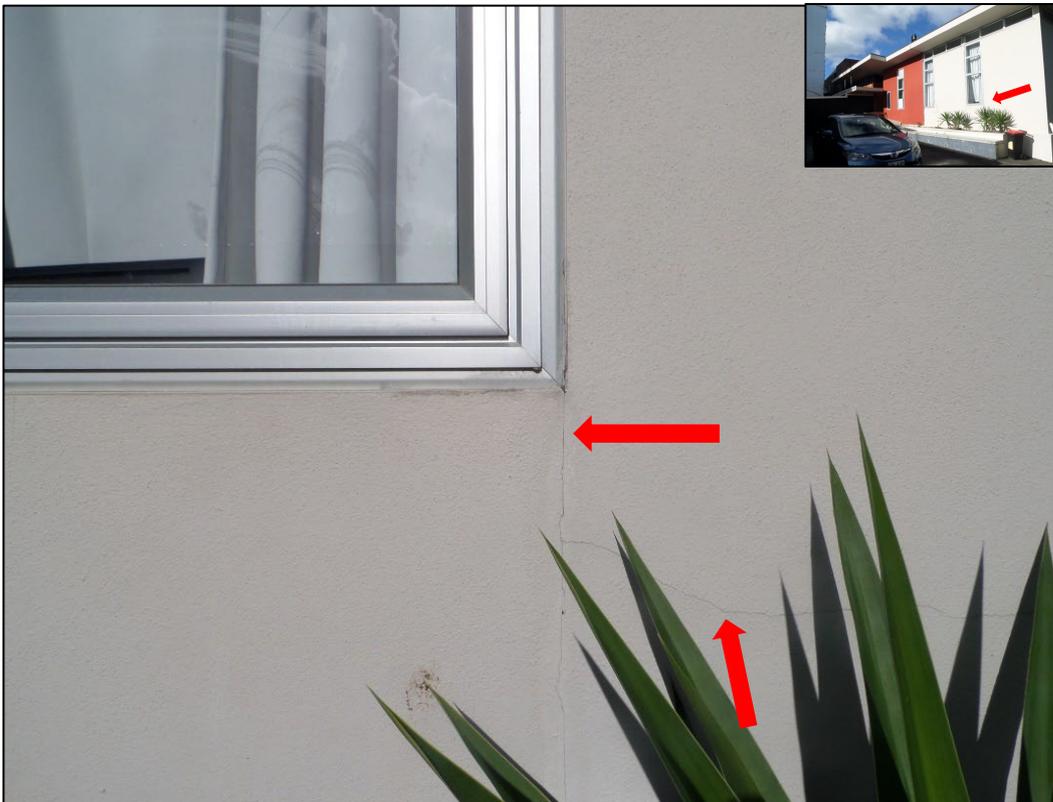
**Photograph 6:** North elevation. Cracking to stucco cladding and window junction. There are no visible control joints in the plaster. Refer next photo

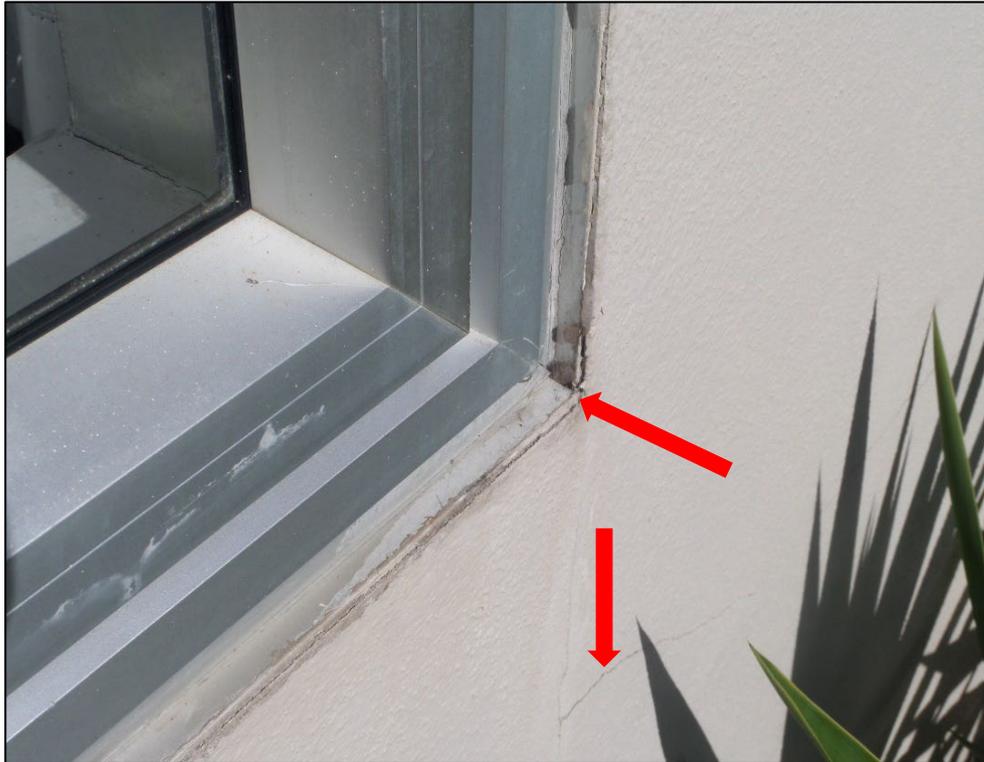
**Photograph 7:** North elevation. Close up of photo 6 showing unsealed junction between aluminium window and adjacent stucco cladding plaster work which is allowing water entry behind the cladding. The window joinery is recessed into the stucco cladding; the recess is flat, allowing water to pond on the sill adjacent to the unsealed junction. The defects will be remedied by the recladding recommended for this elevation. Cladding cracking also arrowed.

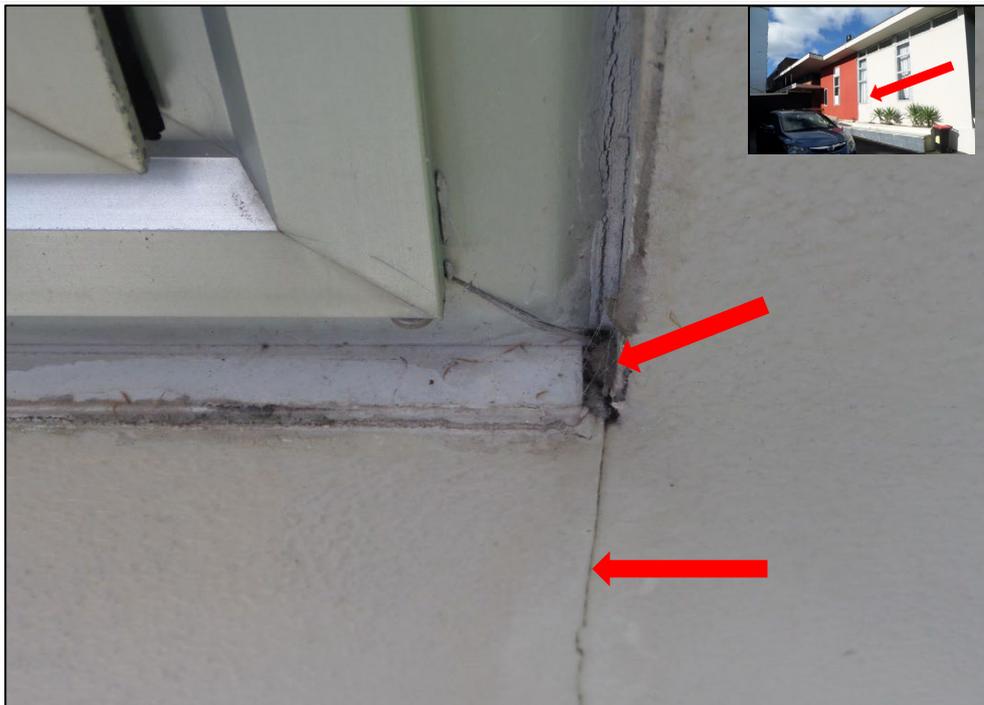
**Photograph 8:** North elevation. Cracking to stucco cladding and open junction between aluminium window and stucco cladding is allowing water entry behind cladding. The defects will be remedied by the recladding recommended for this elevation.

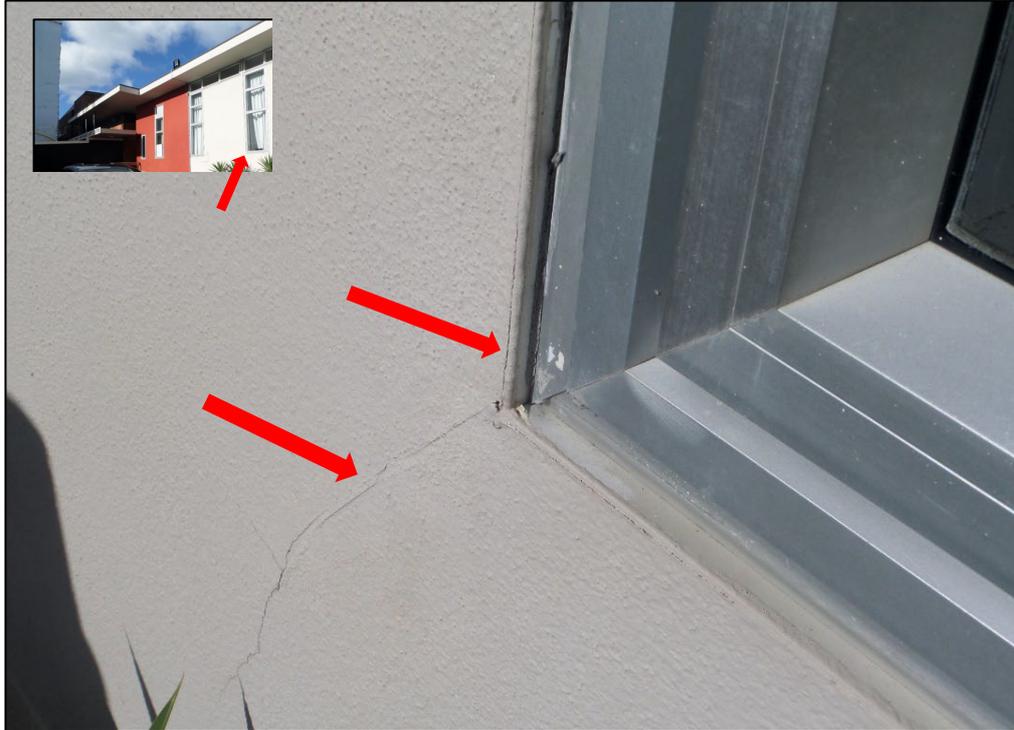
**Photograph 9:** North elevation. Unsealed junction between aluminium window and adjacent stucco cladding plaster work. Cracking in stucco cladding radiating away from window sill. The defects will be remedied by the recladding recommended for this elevation

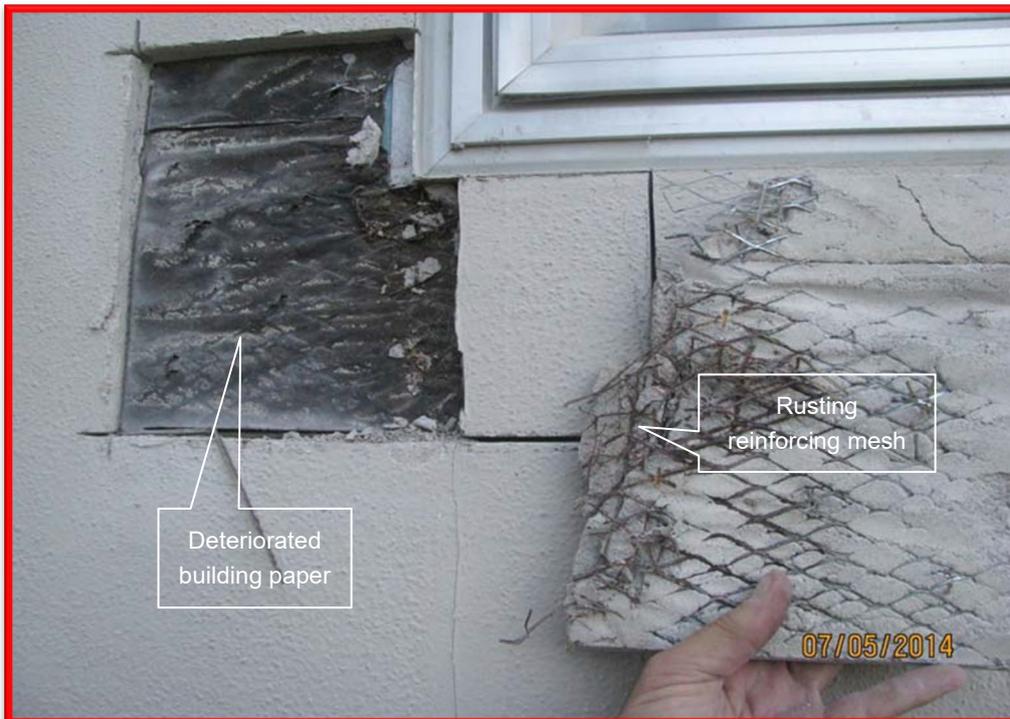
**Photograph 10:** North elevation. DT photo 1.17 showing typical failure at aluminium joinery / stucco cladding junction with deteriorated building wrap and rusting reinforcing mesh which is not sufficiently spaced off the substrate.

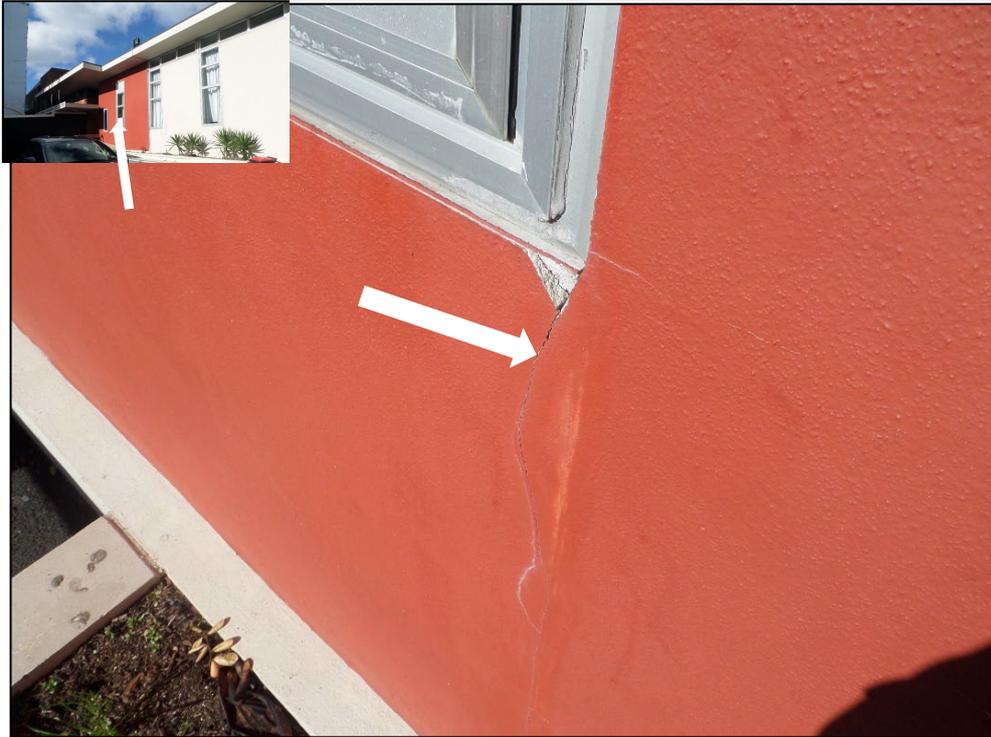
**Photograph 11:** North elevation. Cracking to stucco cladding junction between aluminium window and plaster is allowing water entry.

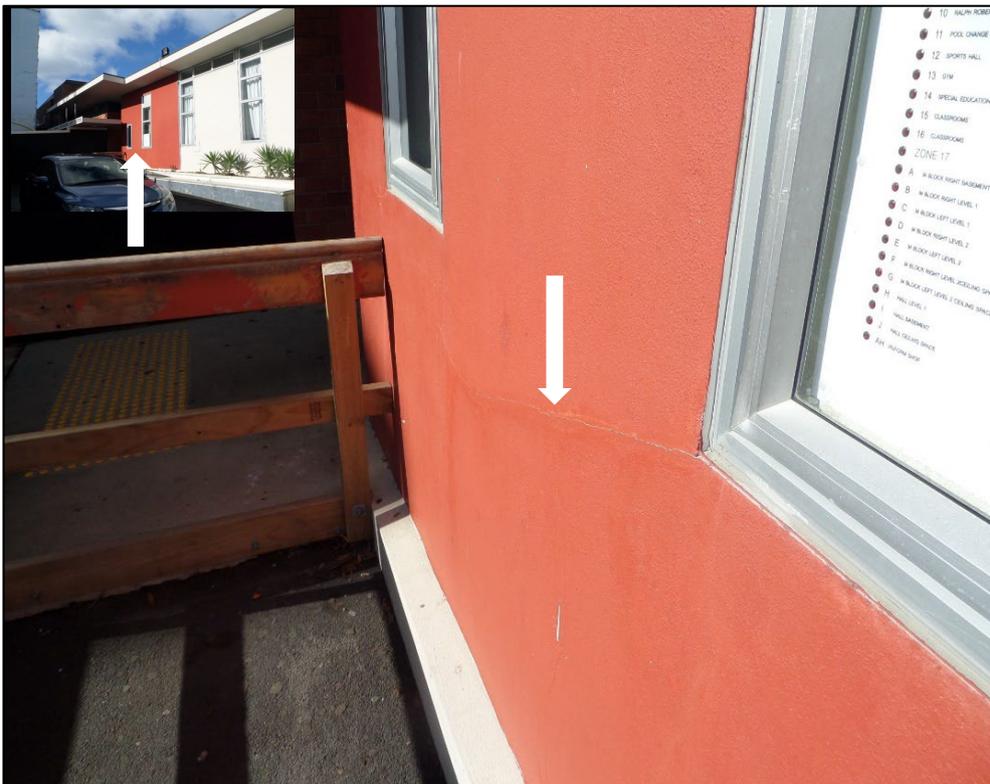
**Photograph 12:** North elevation. Further cracking to stucco cladding junction between aluminium window and adjacent plaster. The defects will be remedied by the recladding recommended for the stucco elevations.

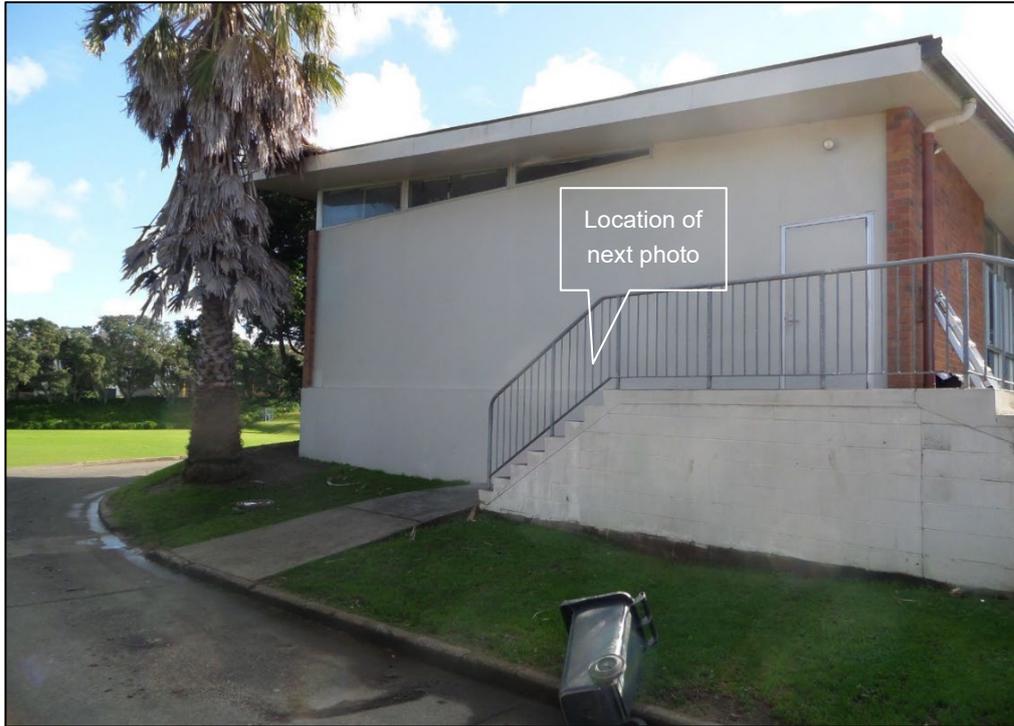
**Photograph 13:** General view of south elevation stucco cladding. There are no visible control joints in the plaster. Refer next photo at patio steps.

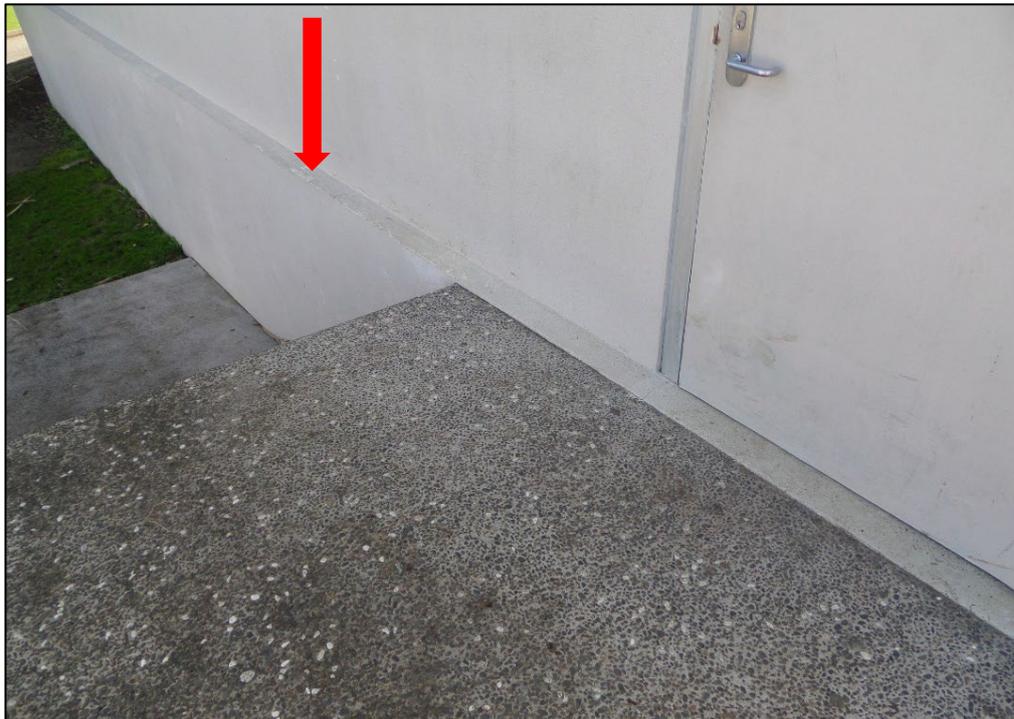
**Photograph 14:** South elevation. Junction between stucco cladding and ground floor level plinth where weather-tightness failure has occurred as evidenced from the DT report. Refer cutout at far end of this wall in photo 18.

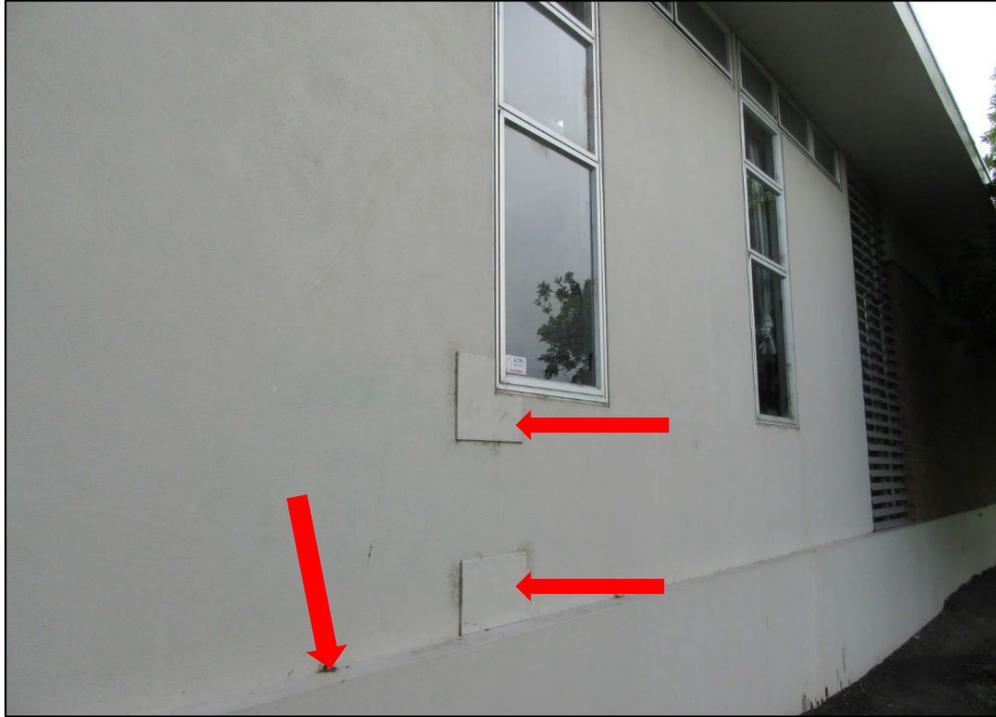
**Photograph 15:** West elevation. No clearance between stucco cladding and plinth. The DT investigation report provides evidence of moisture entering behind the cladding with resulting damage at both the window/stucco cladding junction and the base of the cladding/concrete plinth junction. The relevant DT report patches are indicated.

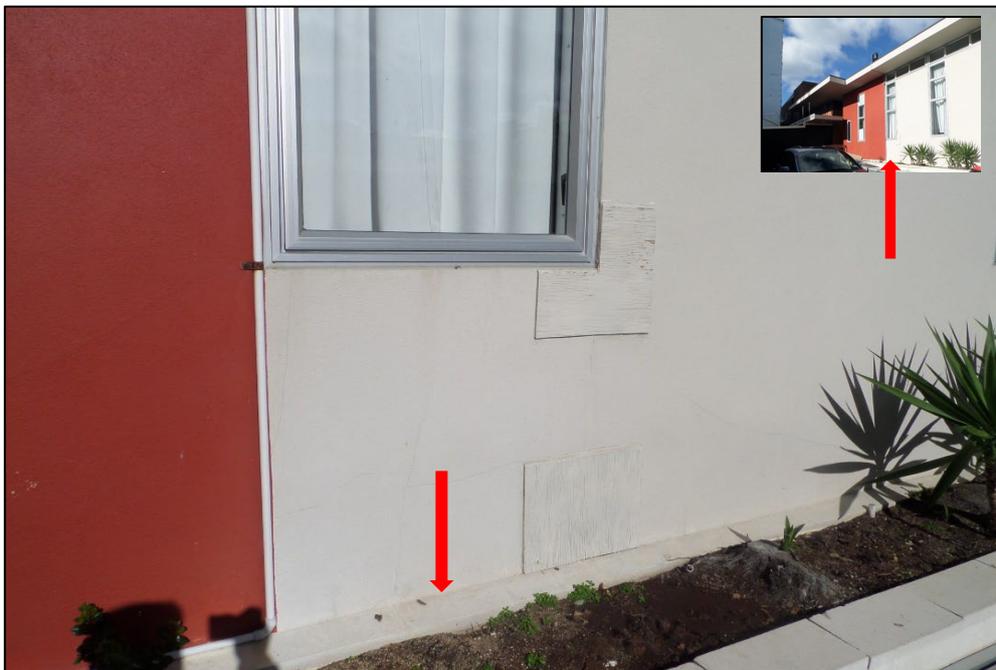
**Photograph 16:** North elevation. General view of typical junction between stucco cladding and external plinth where DT report shows weather-tightness failure has occurred (refer next photo).

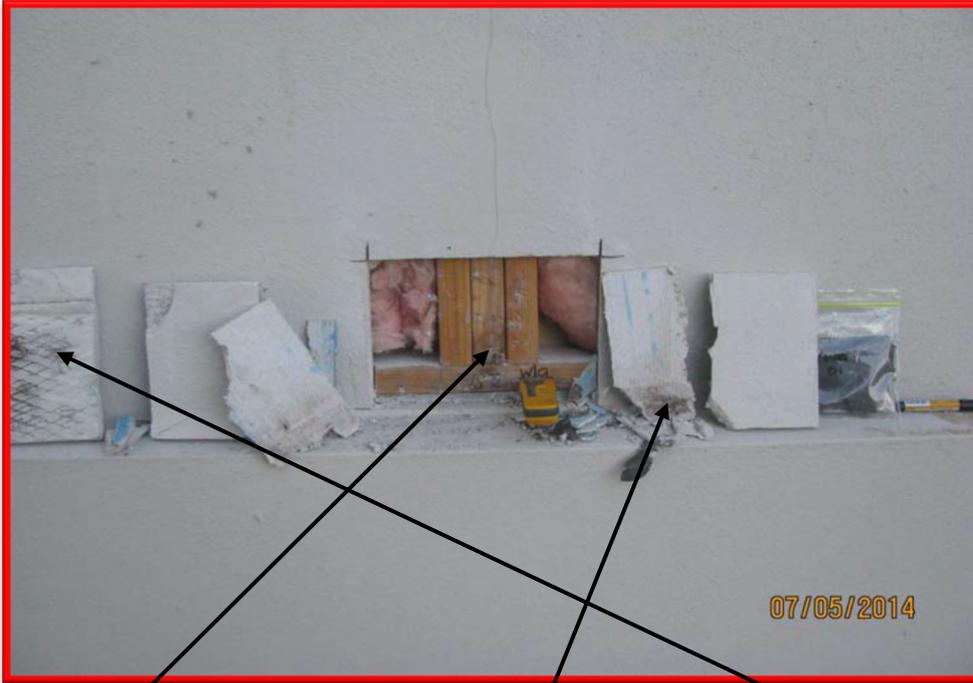
**Photograph 17:** North elevation. DT photo 1.18 showing typical failure at cladding base/plinth junction. Deteriorated building paper, mould on back of cladding, corroded mesh and timber decay have resulted from moisture being trapped and unable to drain from this junction. The defects will be remedied by the recladding recommended for this elevation.

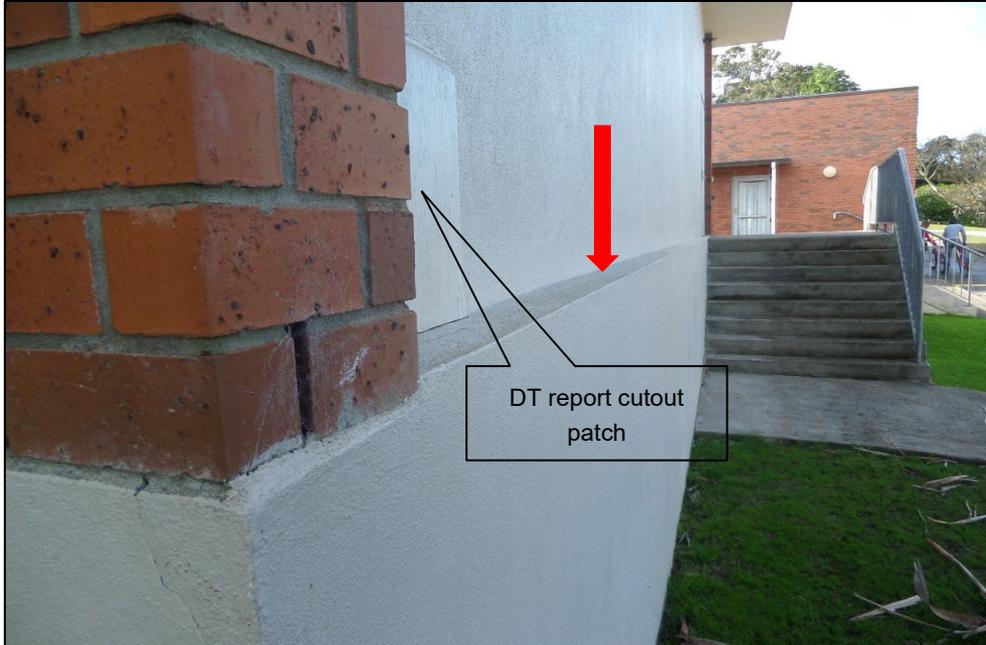
**Photograph 18:** South elevation. General view of the junction between stucco cladding and external plinth. Stucco is laid hard down onto perimeter plinth, with no clearance to allow drainage of moisture away from the base of the cladding. The DT report investigation confirmed moisture entry behind the cladding and timber framing decay at the indicated cutout. The defects will be remedied by the recladding recommended on this elevation.

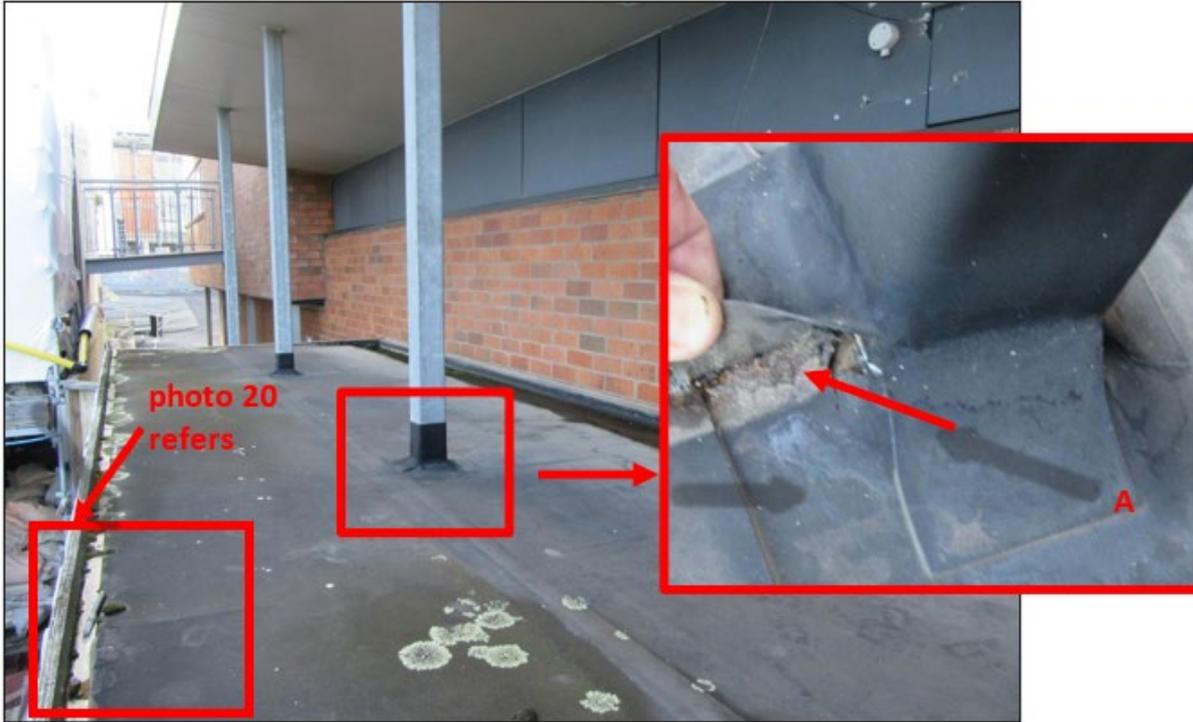
Water ingress has occurred through vertical penetrations in the canopy roof due to poor membrane detailing and inadequate falls, resulting in the membrane lifting, damaged soffit linings and likely decayed timber framing. It is recommended the membrane roof is replaced over new substrates with increased falls and associated timber framing replacement.

**Photograph 19:** General view of the canopy to the north elevation. Water is ponding due to inadequate cross-falls and there are moss and lichen growths on the membrane. Arrow A: Membrane lifting adjacent to post, exposing substrate.

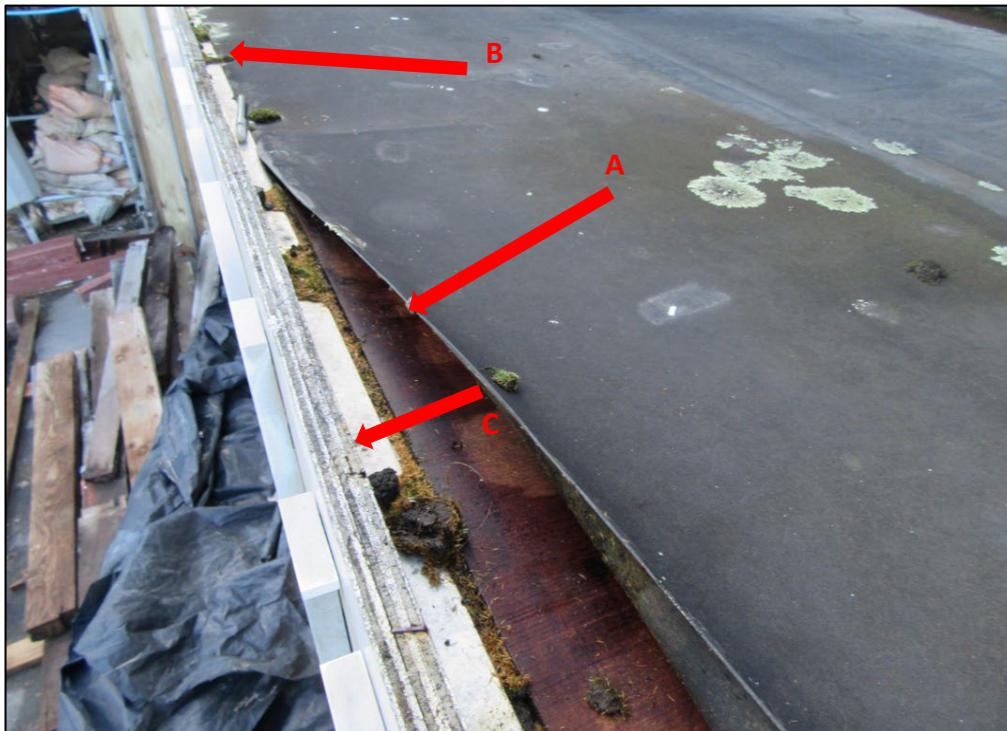
**Photograph 20:** North elevation, entry canopy. Arrow A: Membrane lifting and exposing substrate at roof perimeter. Arrow B: Fixings through top edge. Arrow C: Fascia board is face-fixed, trapping moisture. The substrate is visibly wet and there is moss growth below the membrane. Refer next photo below soffit.

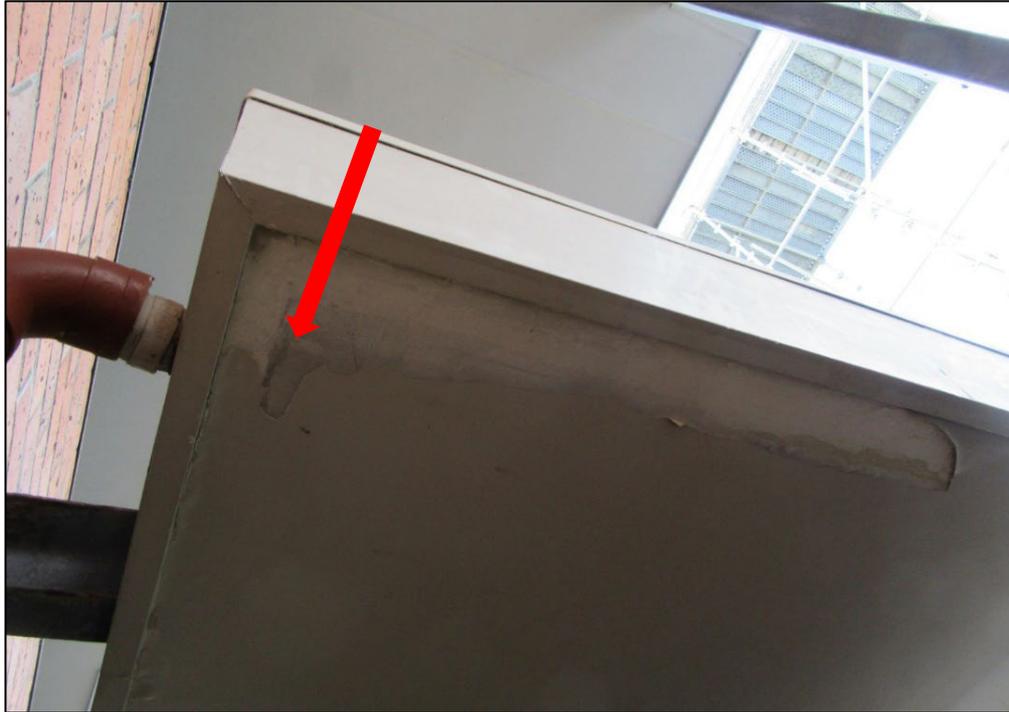
**Photograph 21:** North elevation, entry canopy. Damaged soffit lining where water has been leaking through membrane which will need replacing. The defects will be remedied with a new membrane laid over new substrate with increased falls, along with replacement of decayed framing and damaged soffit linings.

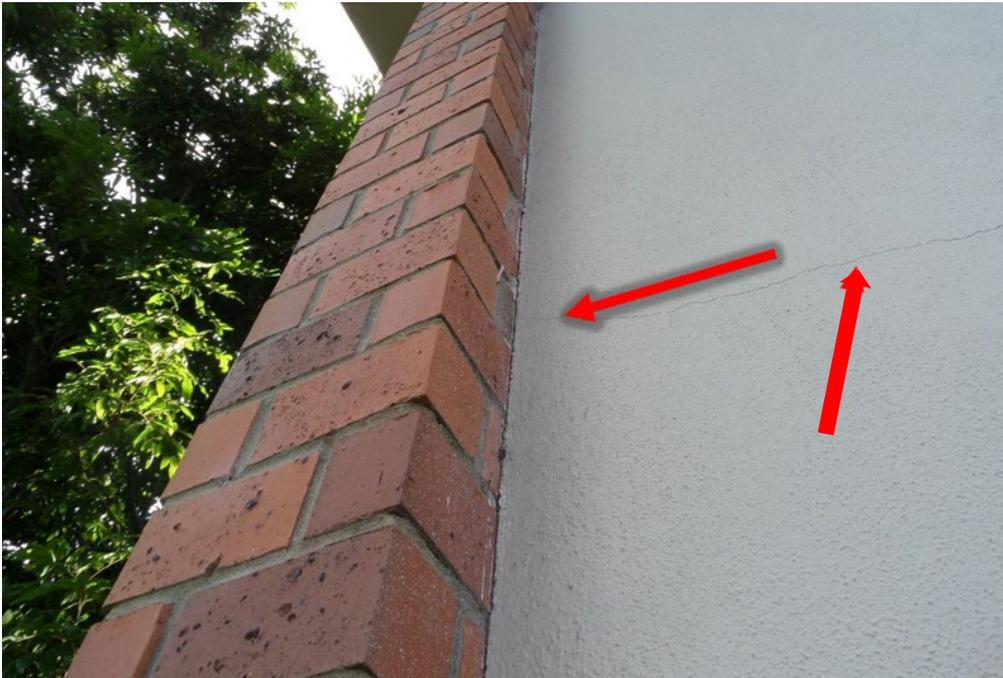
**Photograph 22:** South elevation. No flashings or seals observed at junctions between stucco cladding and brick veneer. DT investigation indicated deteriorating building wrap due to water penetration at junction. The defect will be remedied as part of the recladding required on this elevation. Note indicated horizontal crack in stucco.

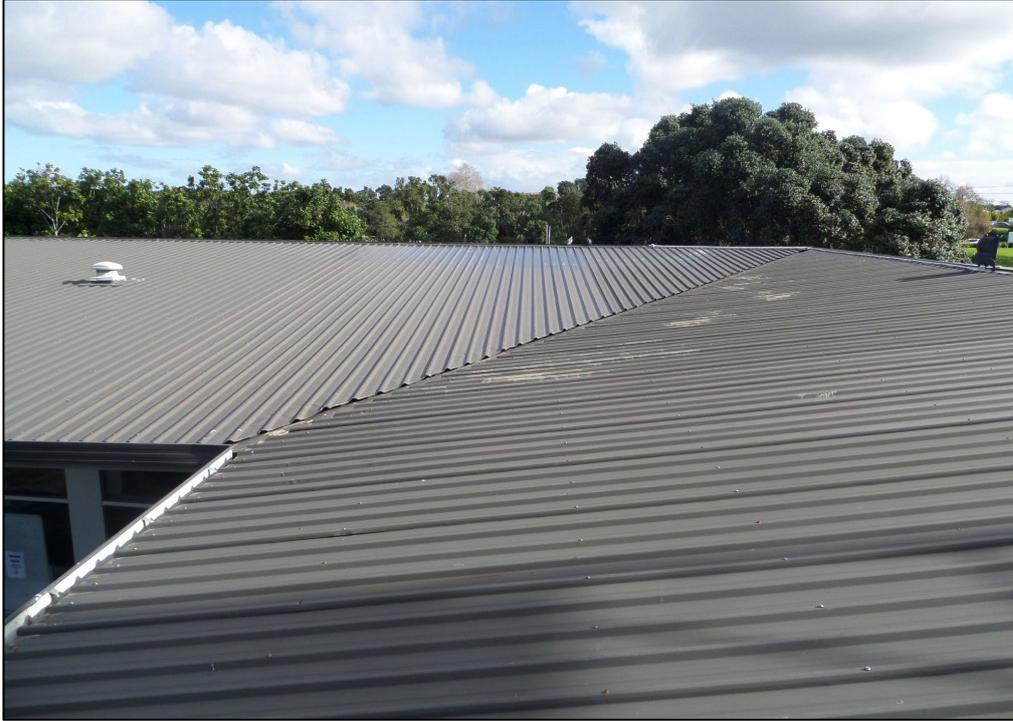
**Photograph 23:** General view of the roofing to the northern end of the building. Refer next photo of valley gutter that had been replaced between the DT report investigation and this inspection.

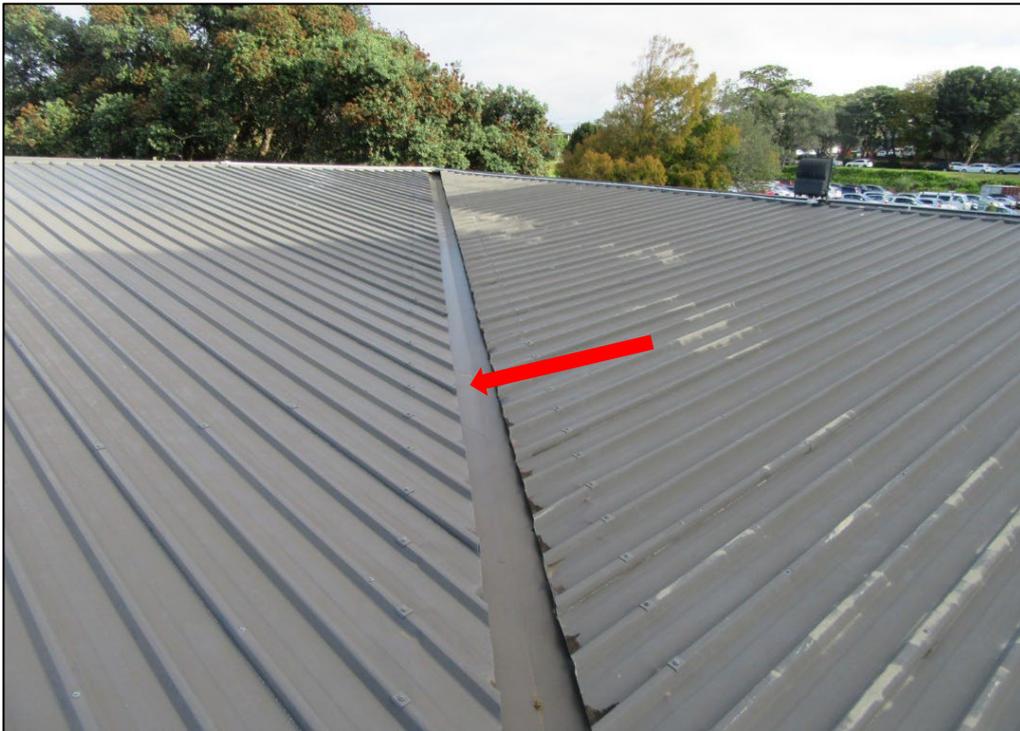
Leaks at the valley gutter have been remediated by replacement of this gutter since the DT investigation in 2015. The associated water damaged ceiling tiles need replacement. Refer Table 3.6 Maintenance work identified.

**Photograph 24:** New valley gutter. The previously damaged ceiling tiles in classroom 1 should be replaced (refer Table 3.6 Maintenance work identified).

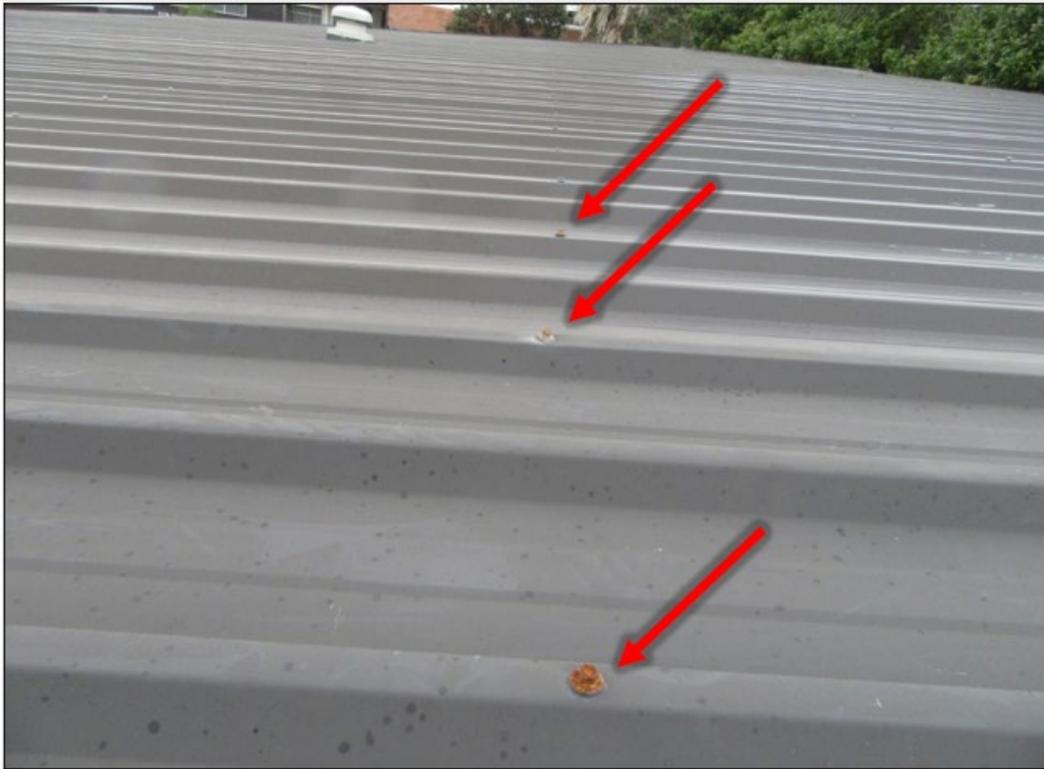
**Photograph 25:** Corroded roof fixings need replacing (refer maintenance items).

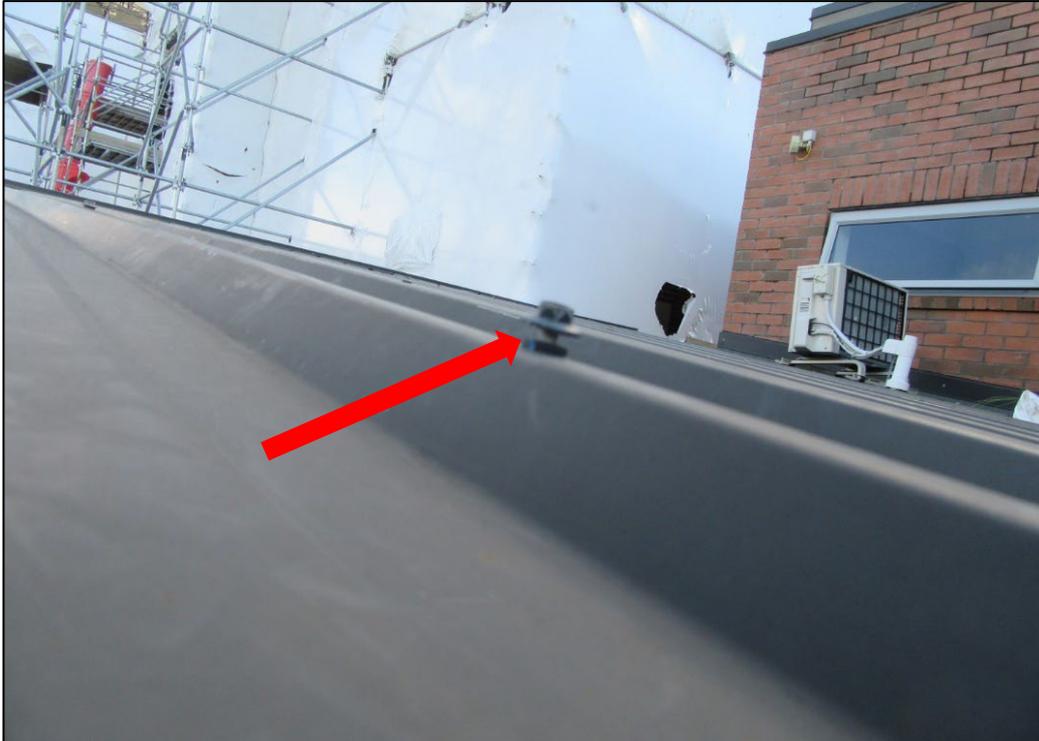
**Photograph 26:** Raised roof fixings need replacing ((refer Table 3.6 Maintenance work identified).

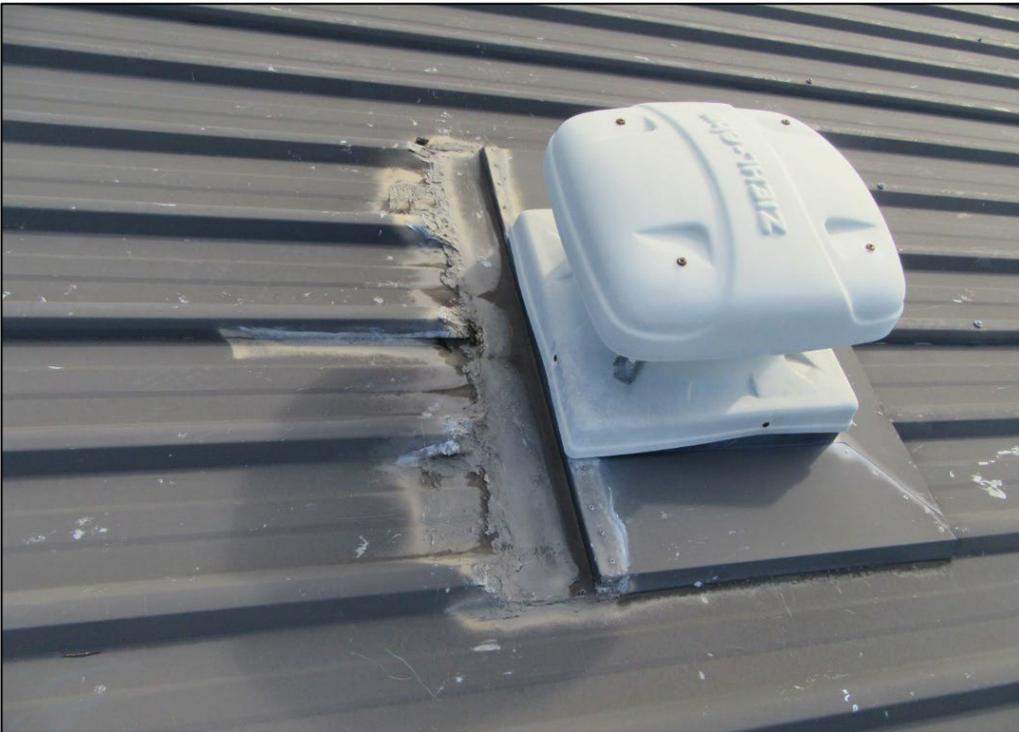
**Photograph 28:** Crude flashing and sealant installation is causing ponding at roof vent (ideally a cover flashing should have been installed up to the roof apex). No evidence of moisture entry was detected internally and it is recommended this detail be monitored annually (refer Table 3.6 Maintenance work identified).

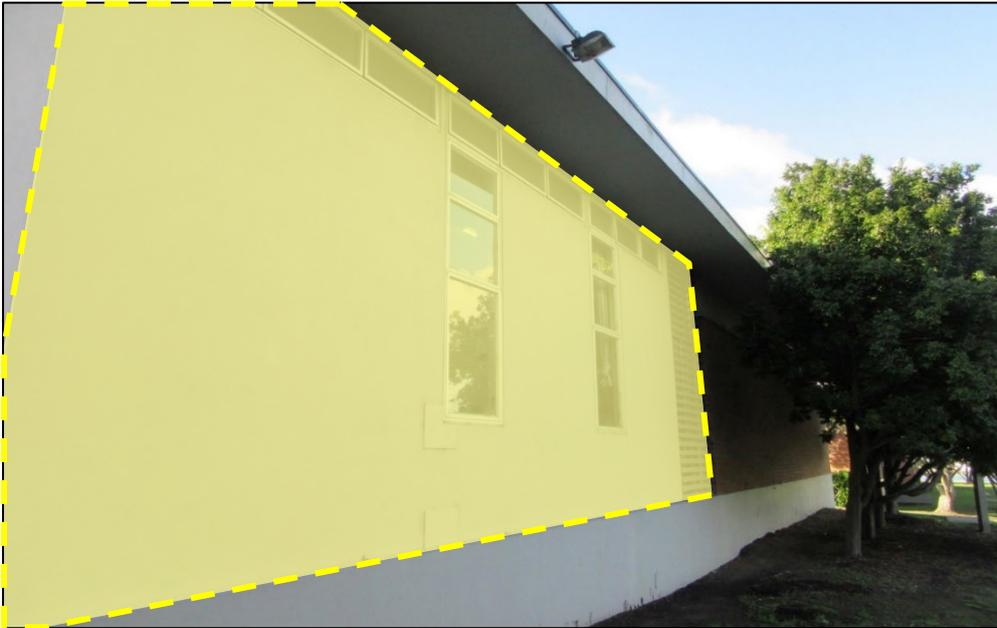
**Photograph 31:** West elevation. Brick veneer cladding at far end of elevation does not require remediation
