Appendix A

Asbestos Management Survey

14 Camrose Grove

On 27/08/2018, 10 & 11/09/2018

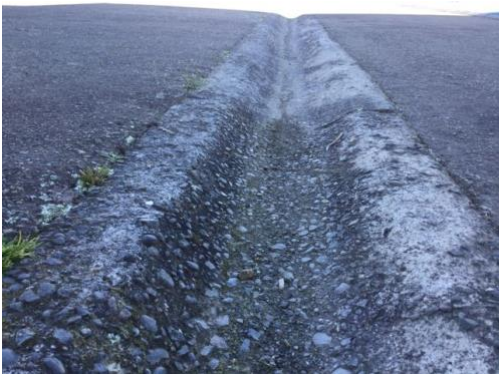
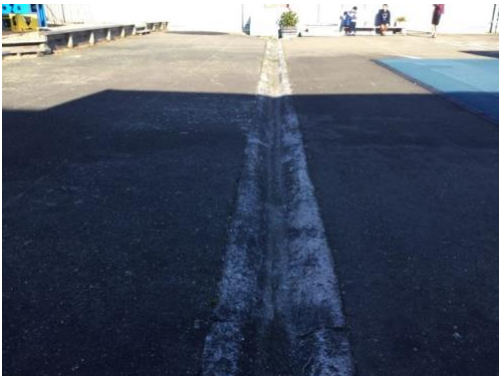
Building / Floor	Capital Montessori Preschool / External	
	Location	039	Central playground area
	Sample Number	S042/15383	
	Item / Position	Debris - Debris inside central gutter in playground	
	Material	Dust and debris	
	Extent (approx.)	20 lin m	
	Product Type	Lagging, spray coatings, loose asbestos etc.	3
	Condition	High damage / visible debris	3
	Surface Treatment	Unsealed lagging / spray / loose asbestos / textile	3
	Asbestos Type	Amosite, Chrysotile, Crocidolite	3
Material Assessment	High	12	
Recommendation	Restrict Access and Remove		
Comments	Material should be removed following asbestos procedures by an asbestos contractor holding appropriate licence in accordance with the regulations.

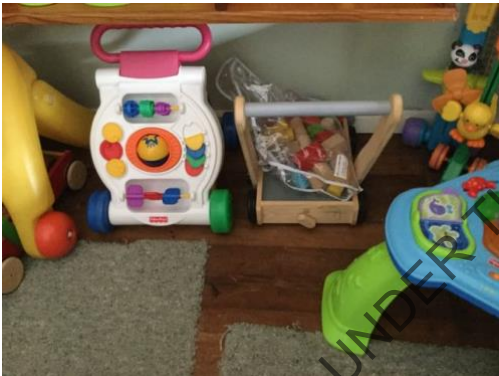
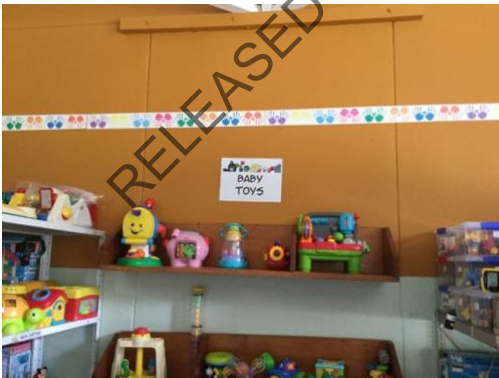
Building / Floor	Toy library / Ground Floor	
	Location	010	Class

Sample Number	S029/15370	
	Item / Position	Dust wipe - Adjacent to previous removal area	
	Material	Dust Wipe	
	Extent (approx.)	2 m ²	
	Product Type	Lagging, spray coatings, loose asbestos etc.	3
	Condition	High damage / visible debris	3
	Surface Treatment	Unsealed lagging / spray / loose asbestos / textile	3
	Asbestos Type	Amosite, Chrysotile	2
	Material Assessment	High	11
	Recommendation	Restrict Access and Remove	
Comments	Material should be removed following asbestos procedures by an asbestos contractor holding appropriate licence in accordance with the regulations.

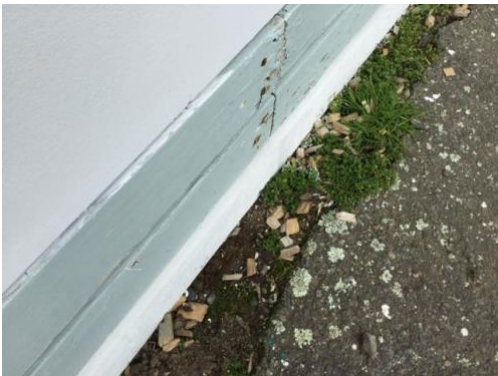
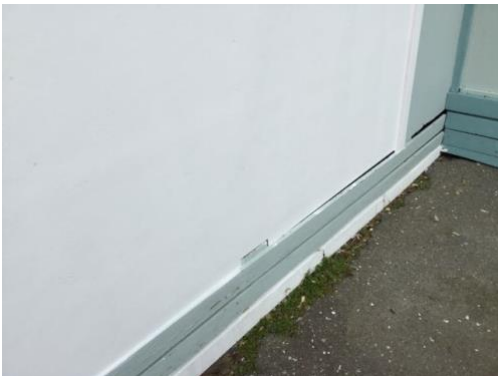
Building / Floor	Koru building / External	
	Location	016	External
	Sample Number	S030/15371	
	Item / Position	Soil to floor between concrete pad and wall below previously removed sheets	
	Material	Soil	
	Extent (approx.)	4	
	Product Type	Lagging, spray coatings, loose asbestos etc.	3
	Condition	High damage / visible debris	3
	Surface Treatment	Unsealed lagging / spray / loose asbestos / textile	3
	Asbestos Type	Amosite, Chrysotile	2
	Material Assessment	High	11
	Recommendation	Restrict Access and Remove	
Comments	Material should be removed following asbestos procedures by an asbestos contractor holding appropriate licence in accordance with the regulations.

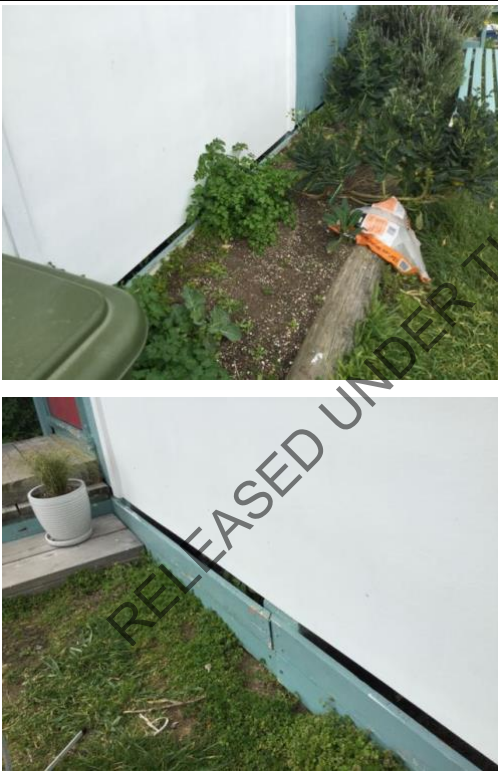
Building / Floor	Rata building / External	
Location	027	External
Sample Number	S024/15365	
Item / Position	Soil - To flower bed and front of step of Rata building	
Material	Soil	
Extent (approx.)	10 lin m	
Product Type	Lagging, spray coatings, loose asbestos etc.	3
Condition	High damage / visible debris	3
Surface Treatment	Unsealed lagging / spray / loose asbestos / textile	3
Asbestos Type	Amosite	2
Material Assessment	High	11
Recommendation	Restrict Access and Remove	
Comments	Material should be removed following asbestos procedures by an asbestos contractor holding appropriate licence in accordance with the regulations.

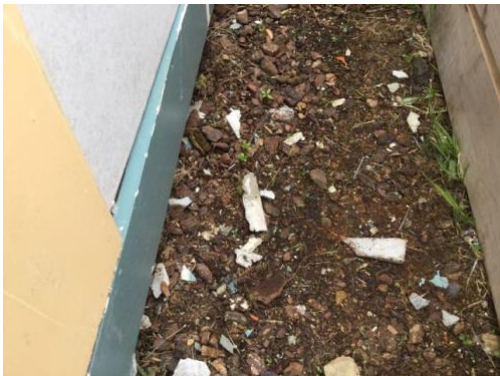
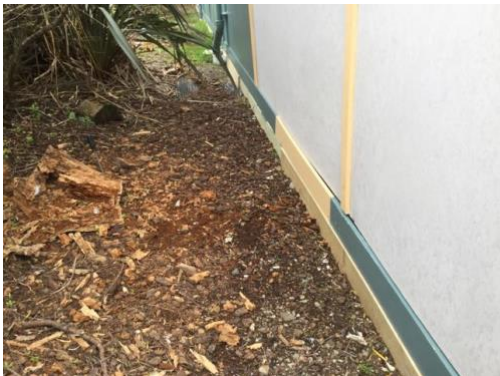
Building / Floor	Kowhai building / External	
	Location	006	External

Sample Number	S016/15305	
	Item / Position	Debris - Boarding debris around white replacement sheets	
	Material	Insulation board	
	Extent (approx.)	20 m ²	
	Product Type	AIB, textiles, gaskets, ropes, paper etc.	2
	Condition	High damage / visible debris	3
	Surface Treatment	Bare AIB or encapsulated lagging / spray / textile	2
	Asbestos Type	Amosite, Chrysotile, Crocidolite	3
	Material Assessment	High	10
	Recommendation	Restrict Access and Remove	
Comments	Material should be removed following asbestos procedures by an asbestos contractor holding appropriate licence in accordance with the regulations.

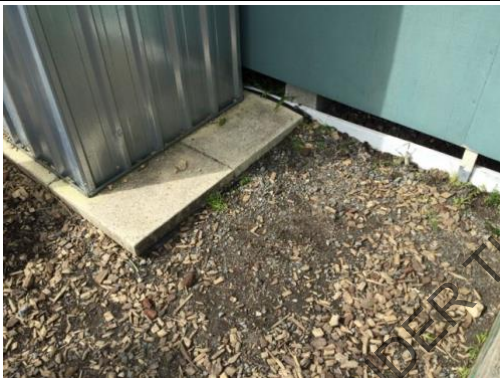
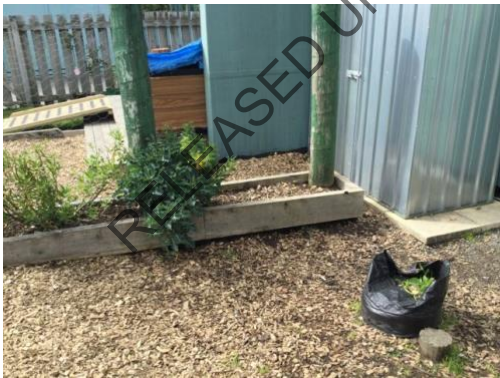
Building / Floor	Kowhai building / Ground Floor	
	Location	006	External

Sample Number	S032/15373	
	Item / Position	Soil - To garden at front of Kowhai building	
	Material	Soil	
	Extent (approx.)	6 m²	
	Product Type	Lagging, spray coatings, loose asbestos etc.	3
	Condition	Significant breakage of non-friable materials or several areas of damage to friable material	2
	Surface Treatment	Bare AIB or encapsulated lagging / spray / textile	2
	Asbestos Type	Amosite, Chrysotile, Crocidolite	3
	Material Assessment	High	10
	Recommendation	Restrict Access and Remove	
Comments	Material should be removed following asbestos procedures by an asbestos contractor holding appropriate licence in accordance with the regulations.

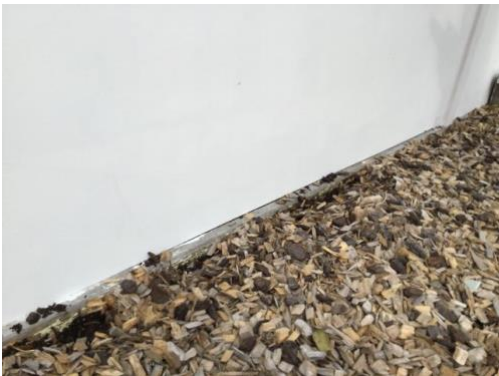
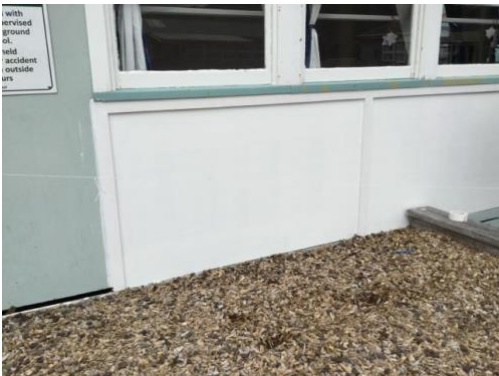
Building / Floor	Koru building / External	
	Location	016	External

Sample Number	S031/15372	
	Item / Position	Soil/woodchip to playground area below previously removed sheets	
	Material	Soil	
	Extent (approx.)	4 lin m	
	Product Type	Lagging, spray coatings, loose asbestos etc.	3
	Condition	High damage / visible debris	3
	Surface Treatment	Unsealed lagging / spray / loose asbestos / textile	3
	Asbestos Type	Chrysotile	1
	Material Assessment	High	10
	Recommendation	Restrict Access and Remove	
Comments	Material should be removed following asbestos procedures by an asbestos contractor holding appropriate licence in accordance with the regulations.

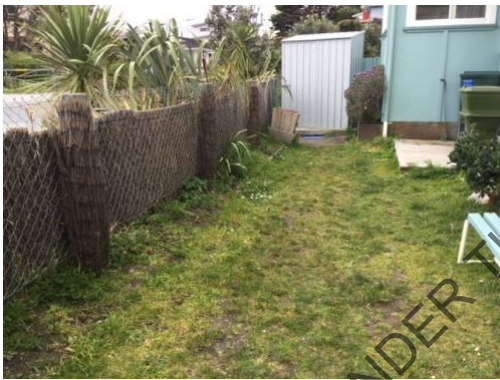
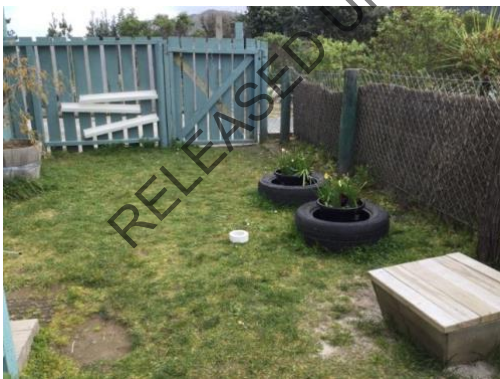
Building / Floor	Rata building / External	
	Location	027	External

Sample Number	S038/15379	
	Item / Position	Soil - To grass garden 1m back from previously removed sheets	
	Material	Soil	
	Extent (approx.)	35 m ²	
	Product Type	Lagging, spray coatings, loose asbestos etc.	3
	Condition	High damage / visible debris	3
	Surface Treatment	Unsealed lagging / spray / loose asbestos / textile	3
	Asbestos Type	Chrysotile	1
	Material Assessment	High	10
	Recommendation	Restrict Access and Remove	
Comments	Material should be removed following asbestos procedures by an asbestos contractor holding appropriate licence in accordance with the regulations.

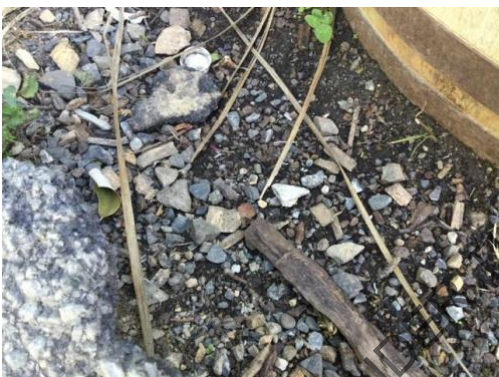
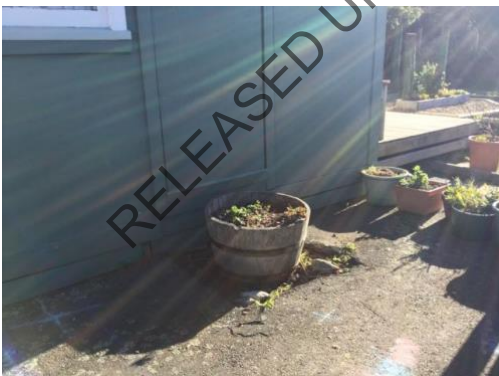
Building / Floor	Kowhai building / Ground Floor	
	Location	006	External

Sample Number	S041/15382	
	Item / Position	Debris - Boarding debris to around flowerpot at front of kowhai building (fenced area)	
	Material	Insulation board	
	Extent (approx.)	1 m ²	
	Product Type	AIB, textiles, gaskets, ropes, paper etc.	2
	Condition	High damage / visible debris	3
	Surface Treatment	Bare AIB or encapsulated lagging / spray / textile	2
	Asbestos Type	Chrysotile	1
	Material Assessment	Medium	8
	Recommendation	Restrict Access and Remove	
Comments	Material should be removed following asbestos procedures by an asbestos contractor holding appropriate licence in accordance with the regulations.

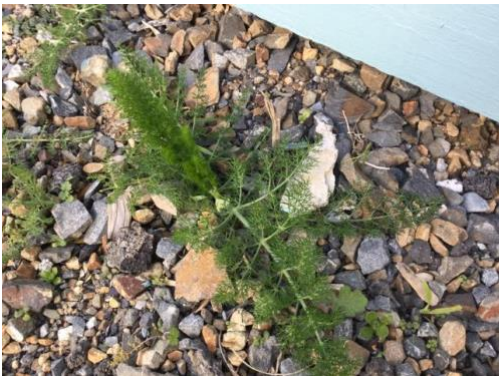
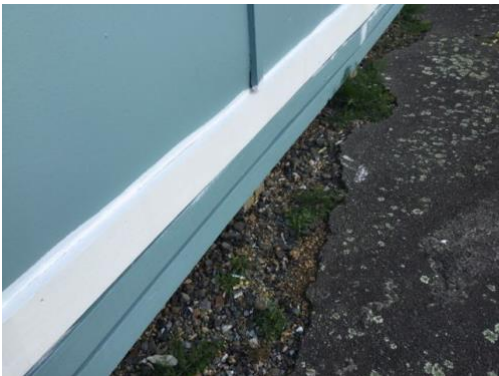
Building / Floor	Toy library / External	
	Location	011	External
	Sample Number	S017/15306	
	Item / Position	Debris - To floor around replacement sheet at toy library	
	Material	Cement Product	
	Extent (approx.)	3 m ²	
	Product Type	Composites (plastics, resins, mastics, roofing felts, vinyl floor tiles, paints, decorative finishes, cement etc.)	1
	Condition	High damage / visible debris	3
	Surface Treatment	Enclosed sprays / lagging / board or bare cement	1
	Asbestos Type	Amosite, Chrysotile, Crocidolite	3
Material Assessment	Medium	8	
Recommendation	Restrict Access and Remove		
Comments	Material should be removed following asbestos procedures by an asbestos contractor holding appropriate licence in accordance with the regulations.

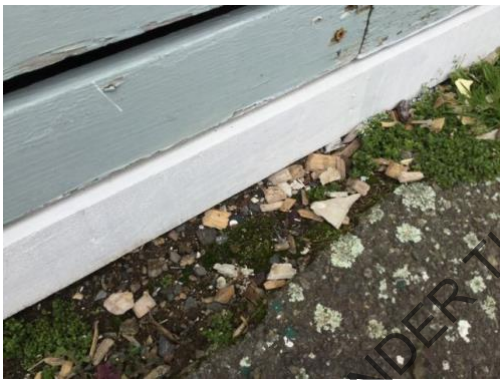
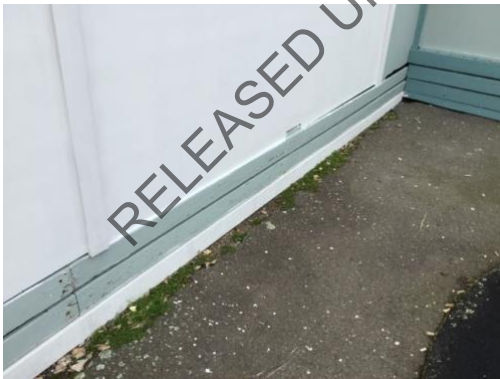
Building / Floor	Koru building / External	
	Location	016	External
	Sample Number	S015/15304	
	Item / Position	Debris - Cement debris around white replacement sheets	
	Material	Cement Product	
	Extent (approx.)	8 m ²	
	Product Type	Composites (plastics, resins, mastics, roofing felts, vinyl floor tiles, paints, decorative finishes, cement etc.)	1
	Condition	High damage / visible debris	3
	Surface Treatment	Enclosed sprays / lagging / board or bare cement	1
	Asbestos Type	Amosite, Chrysotile, Crocidolite	3
Material Assessment	Medium	8	
Recommendation	Restrict Access and Remove		
Comments	Material should be removed following asbestos procedures by an asbestos contractor holding appropriate licence in accordance with the regulations.

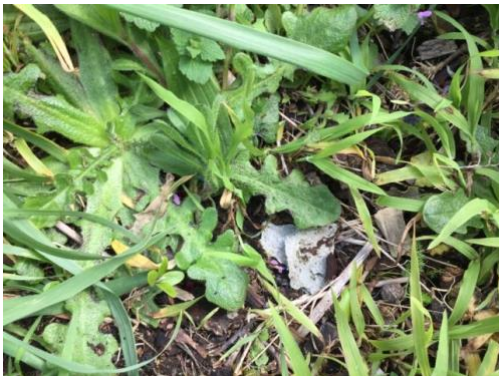
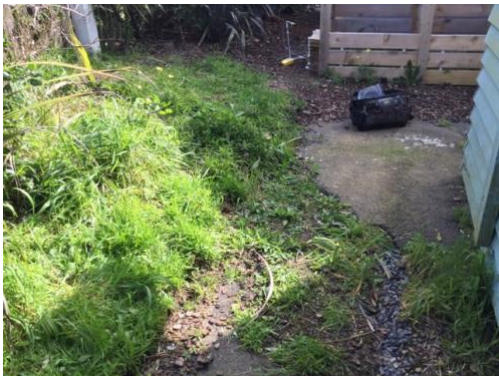
Building / Floor	Shed / External	
	Location	037	External
	Sample Number	S034/15375	
	Item / Position	Debris - Cement debris found on concrete floor and soil to rear of shed	
	Material	Cement Product	
	Extent (approx.)	10 m ²	
	Product Type	Composites (plastics, resins, mastics, roofing felts, vinyl floor tiles, paints, decorative finishes, cement etc.)	1
	Condition	High damage / visible debris	3
	Surface Treatment	Enclosed sprays / lagging / board or bare cement	1
	Asbestos Type	Amosite, Chrysotile, Crocidolite	3
	Material Assessment	Medium	8
	Recommendation	Restrict Access and Remove	
Comments	Material should be removed following asbestos procedures by an asbestos contractor holding appropriate licence in accordance with the regulations.

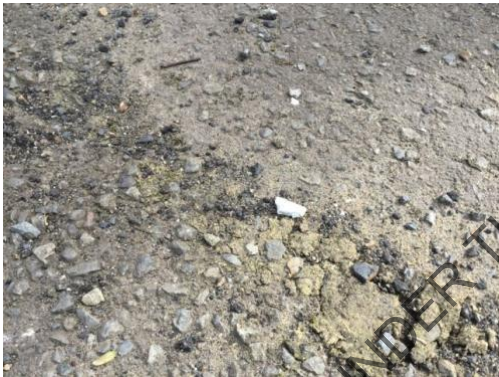
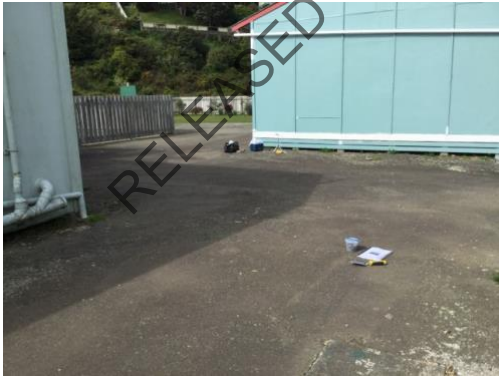
Building / Floor	Capital Montessori Preschool / External	
	Location	038	Walkway between toy library, shed and koru building
	Sample Number	S037/15378	
	Item / Position	Debris - Cement debris to concrete floor	
	Material	Cement Product	
	Extent (approx.)	Small amounts	
	Product Type	Composites (plastics, resins, mastics, roofing felts, vinyl floor tiles, paints, decorative finishes, cement etc.)	1
	Condition	High damage / visible debris	3
	Surface Treatment	Enclosed sprays / lagging / board or bare cement	1
	Asbestos Type	Amosite, Chrysotile, Crocidolite	3
	Material Assessment	Medium	8
	Recommendation	Restrict Access and Remove	
Comments	Material should be removed following asbestos procedures by an asbestos contractor holding appropriate licence in accordance with the regulations.

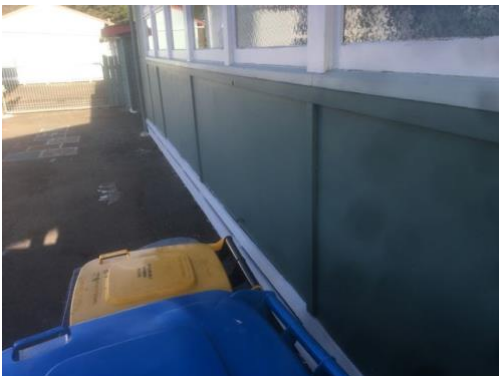
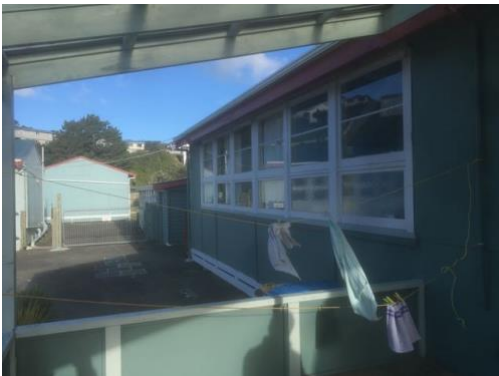
Building / Floor	Kowhai building / External	
Location	006	External
Sample Number	S002/14942	
Item / Position	Cladding - Cladding around building	
Material	Insulation board	
Extent (approx.)	170 m ²	
Product Type	AIB, textiles, gaskets, ropes, paper etc.	2
Condition	Few scratches / marks, broken edges etc.	1
Surface Treatment	Enclosed sprays / lagging / board or bare cement	1
Asbestos Type	Amosite, Chrysotile, Crocidolite	3
Material Assessment	Medium	7
Recommendation	Label & Manage	
Comments	Material should not be disturbed through actions such as sanding, cutting, drilling etc. without appropriate measures taken to suppress fibre release.

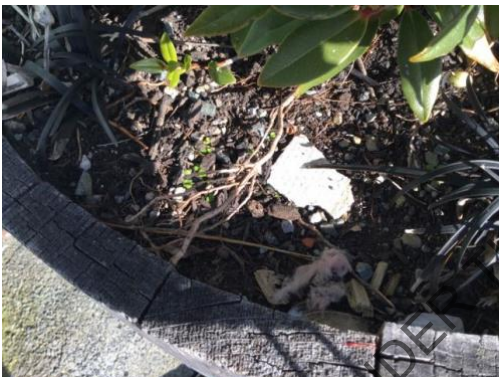
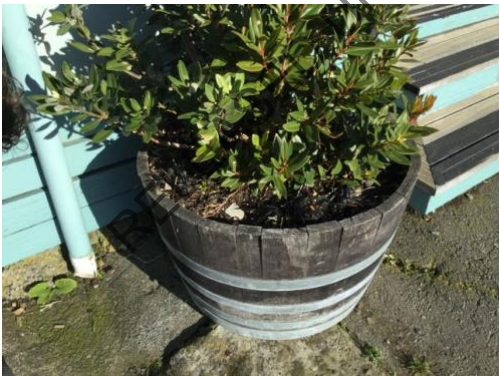
Building / Floor	Capital Montessori Preschool / External	
	Location	039	Central playground area
	Sample Number	S039/15380	
	Item / Position	Debris - Cement debris in plant pot outside koru building porch	
	Material	Cement Product	
	Extent (approx.)	0.25 m ²	
	Product Type	Composites (plastics, resins, mastics, roofing felts, vinyl floor tiles, paints, decorative finishes, cement etc.)	1
	Condition	High damage / visible debris	3
	Surface Treatment	Enclosed sprays / lagging / board or bare cement	1
	Asbestos Type	Chrysotile	1
	Material Assessment	Low	6
	Recommendation	Restrict Access and Remove	
Comments	Material should be removed following asbestos procedures by an asbestos contractor holding appropriate licence in accordance with the regulations.

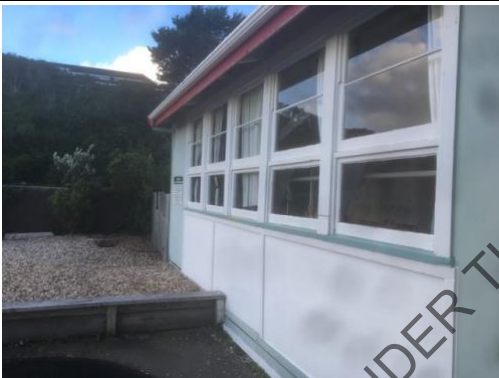
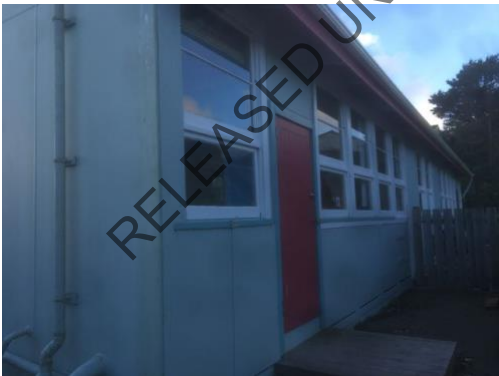
Building / Floor	Koru building / External	
	Location	016	External
	Sample Number	S008/14948	
	Item / Position	Cladding - Cladding around building	
	Material	Cement sheet	
	Extent (approx.)	110 m ²	
	Product Type	Composites (plastics, resins, mastics, roofing felts, vinyl floor tiles, paints, decorative finishes, cement etc.)	1
	Condition	Few scratches / marks, broken edges etc.	1
	Surface Treatment	Non-friable composite asbestos / encapsulated cement	0
	Asbestos Type	Amosite, Chrysotile, Crocidolite	3
Material Assessment	Low	5	
Recommendation	Label & Manage		
Comments	Material should not be disturbed through actions such as sanding, cutting, drilling etc. without appropriate measures taken to suppress fibre release.

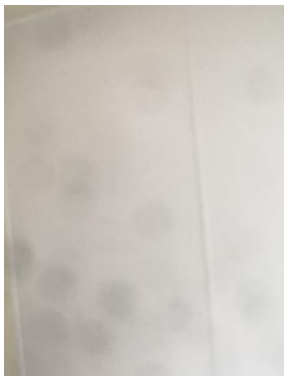
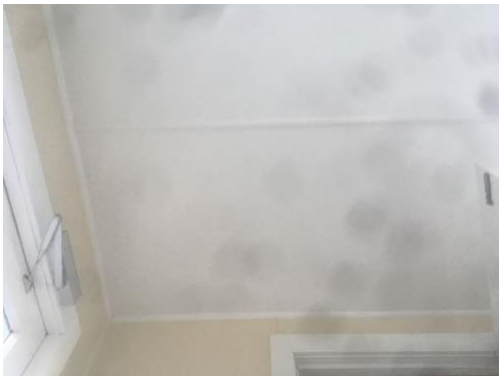
Building / Floor	Rata building / Ground Floor	
	Location	026	Porch
	Sample Number	S010/14950	
	Item / Position	Ceiling - Porch ceiling	
	Material	Insulation board	
	Extent (approx.)	2 m²	
	Product Type	AIB, textiles, gaskets, ropes, paper etc.	2
	Condition	Few scratches / marks, broken edges etc.	1
	Surface Treatment	Enclosed sprays / lagging / board or bare cement	1
	Asbestos Type	Chrysotile	1
	Material Assessment	Low	5
	Recommendation	Label & Manage	
Comments	Material should not be disturbed through actions such as sanding, cutting, drilling etc. without appropriate measures taken to suppress fibre release.

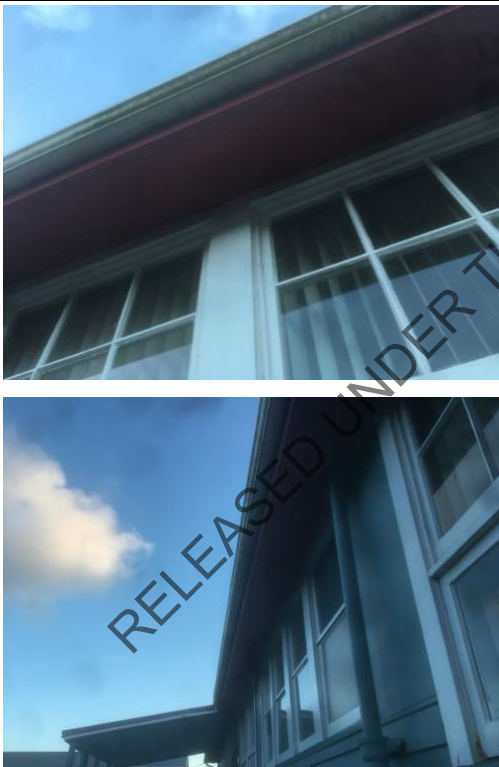
Building / Floor	Rata building / External	
	Location	027	External
	Sample Number	S014/14954	
	Item / Position	Soffit - Red painted soffit	
	Material	Cement sheet	
	Extent (approx.)	40 lin m	
	Product Type	Composites (plastics, resins, mastics, roofing felts, vinyl floor tiles, paints, decorative finishes, cement etc.)	1
	Condition	Few scratches / marks, broken edges etc.	1
	Surface Treatment	Non-friable composite asbestos / encapsulated cement	0
	Asbestos Type	Amosite, Chrysotile	2
	Material Assessment	Very Low	4
	Recommendation	Label & Manage	
Comments	Material should not be disturbed through actions such as sanding, cutting, drilling etc. without appropriate measures taken to suppress fibre release.

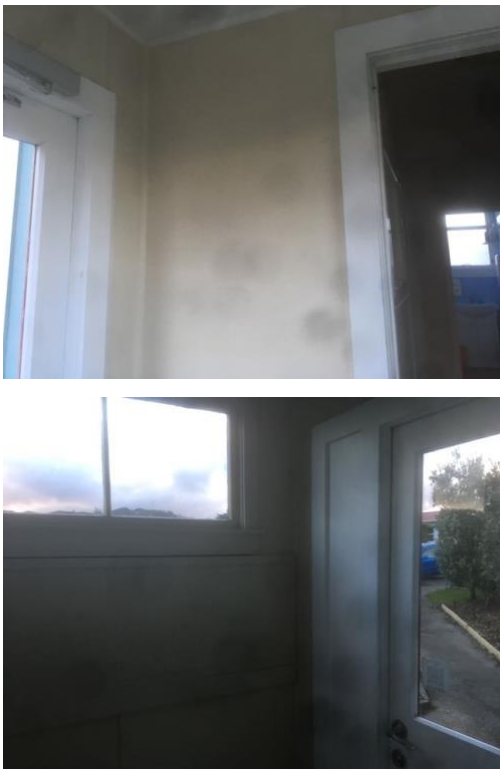
Building / Floor	Rata building / Ground Floor	
Location	026	Porch
Sample Number	S011/14951	
Item / Position	Walls - Walls	
Material	Cement sheet	
Extent (approx.)	12 m ²	
Product Type	Composites (plastics, resins, mastics, roofing felts, vinyl floor tiles, paints, decorative finishes, cement etc.)	1
Condition	Few scratches / marks, broken edges etc.	1
Surface Treatment	Non-friable composite asbestos / encapsulated cement	0
Asbestos Type	Chrysotile	1
Material Assessment	Very Low	3
Recommendation	Label & Manage

Comments	Material should not be disturbed through actions such as sanding, cutting, drilling etc. without appropriate measures taken to suppress fibre release.
----------	--

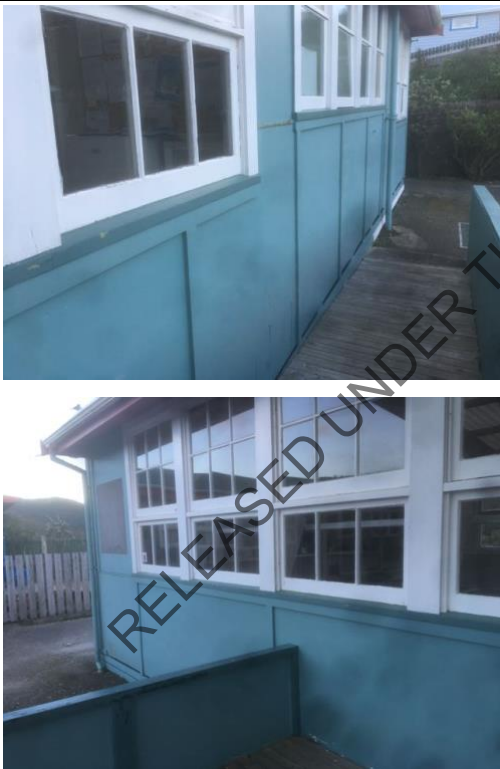
Building / Floor	Rata building / External	
	Location	027	External
	Sample Number	S012/14952	
	Item / Position	Cladding - Cladding around building	
	Material	Cement sheet	
	Extent (approx.)	110 m ²	
	Product Type	Composites (plastics, resins, mastics, roofing felts, vinyl floor tiles, paints, decorative finishes, cement etc.)	1
	Condition	Few scratches / marks, broken edges etc.	1
	Surface Treatment	Non-friable composite asbestos / encapsulated cement	0
	Asbestos Type	Chrysotile	1
	Material Assessment	Very Low	3
	Recommendation	Label & Manage	
Comments	Material should not be disturbed through actions such as sanding, cutting, drilling etc. without appropriate measures taken to suppress fibre release.
