"...the proposed construction of a fence around Stonefields School in Stonefields, Auckland.

SERIOUS RISK ASSESSMENT: Recording Form

Recommendations for Property Modification Provision

Stonefields School - Te Kura o Ngā Pāraepōhatu Special Needs Modifications Fencing and Gates Report

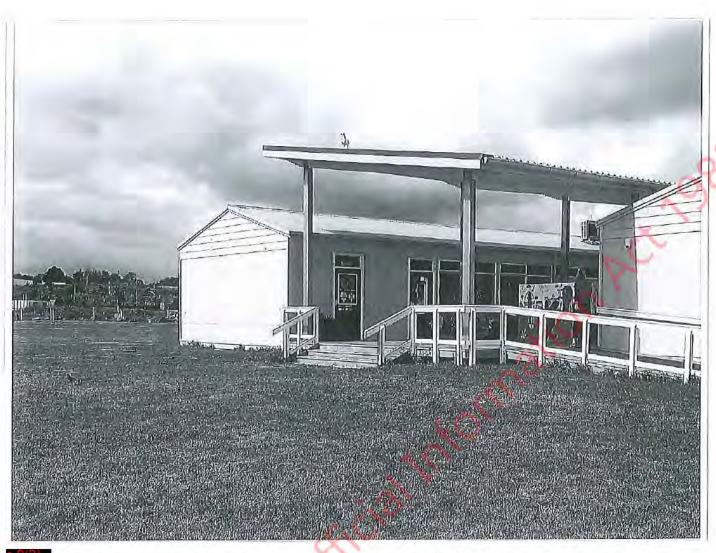
Learning Hub – access on to the field and at the back of the hub onto the road as well as the driveway for the satellite class.

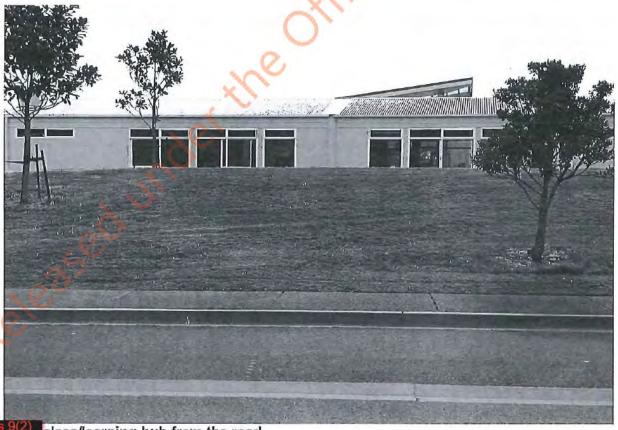
class/learning hub from the road

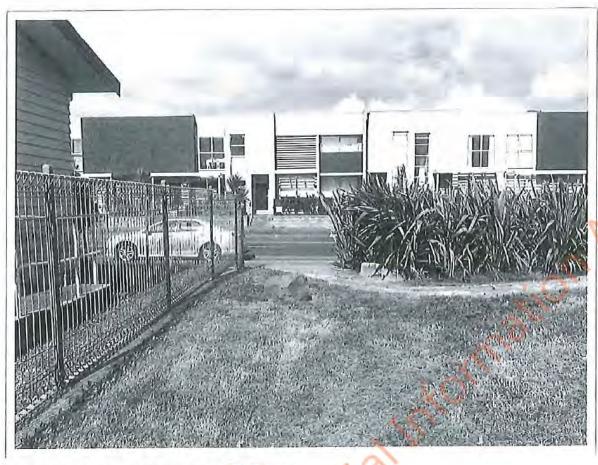
Road access from the field beside (3) c

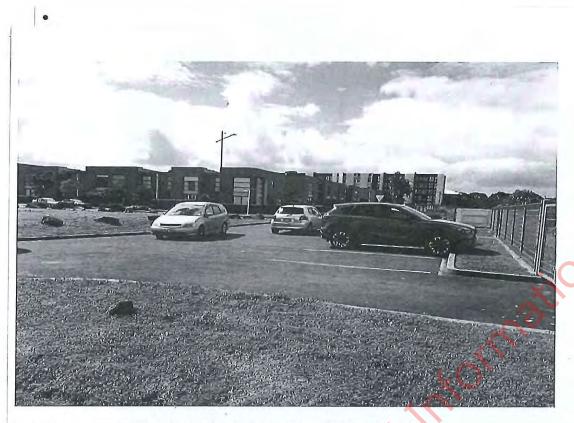
Public carpark on the perimeter of the school field - not fenced

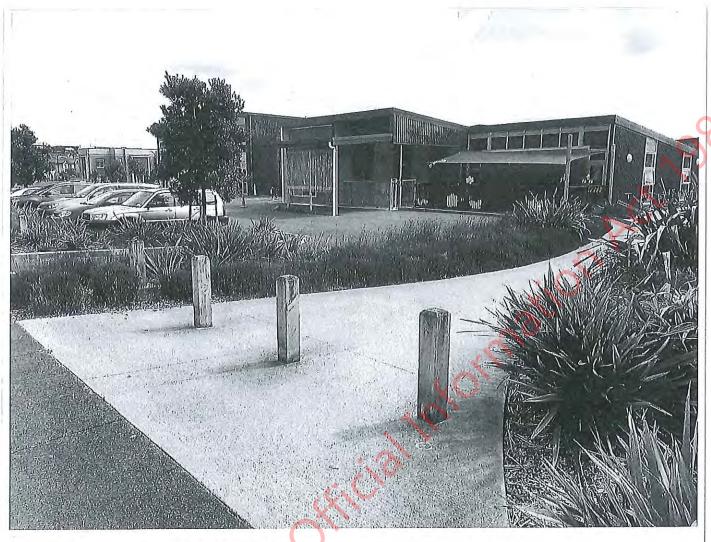
Satellite class access - not fenced - view 1

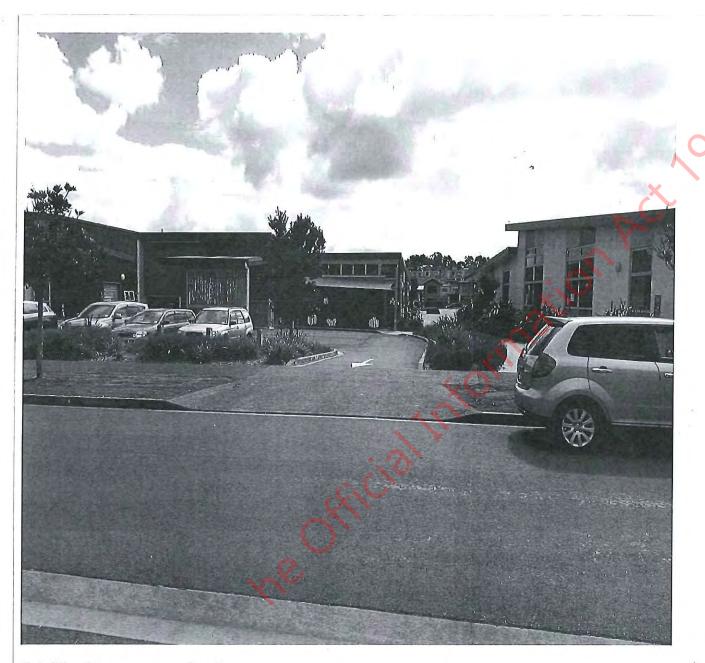
Satellite class access - view 2

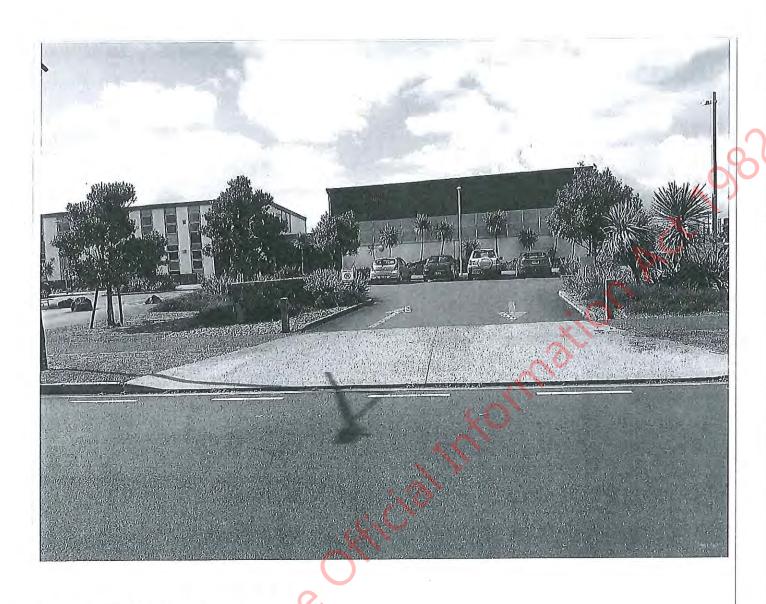
School carpark - view 1 - no fence or gate

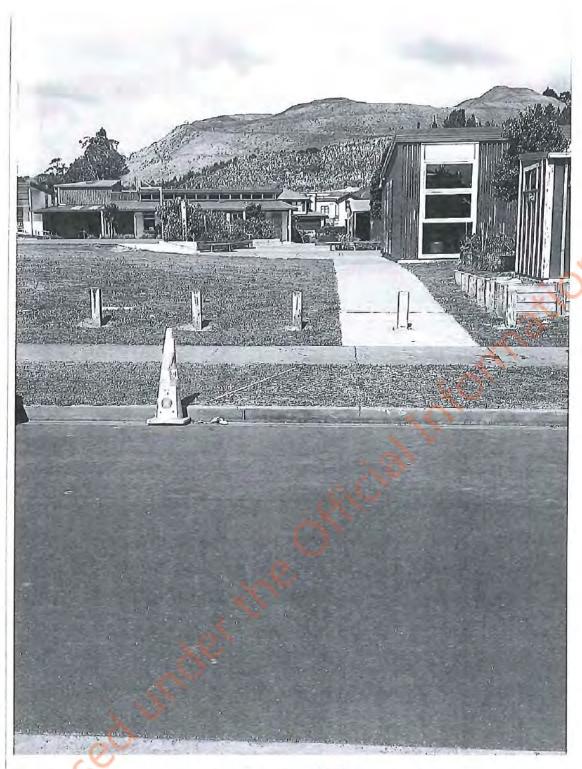
Road access from playground – this is where $\frac{1}{9(2)}$ ran out onto the road (a)

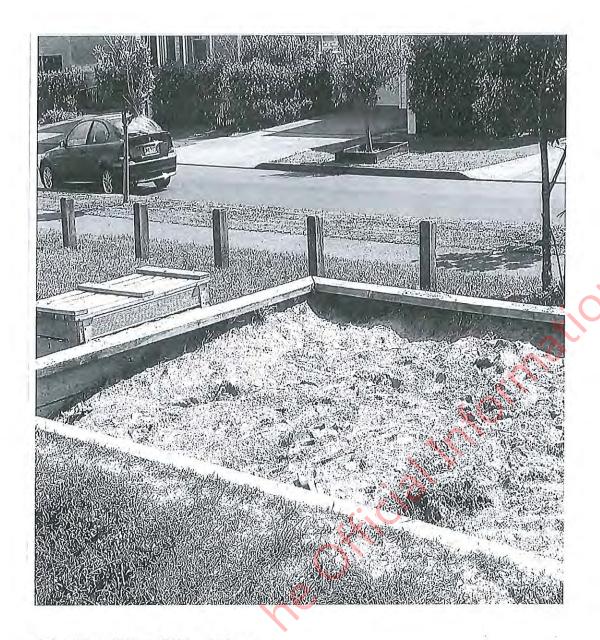
School sandpit on field – no fence

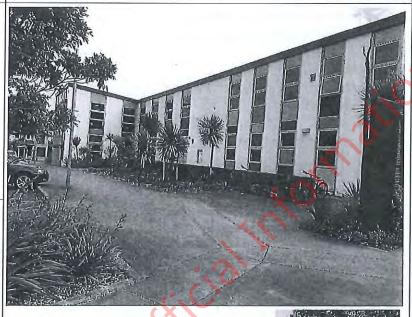
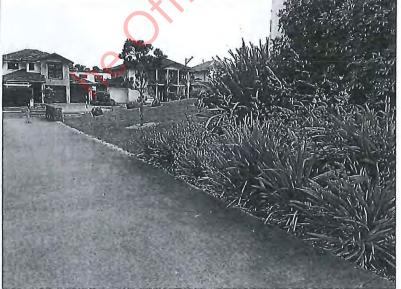
Provide fencing at either side of the school to enclose the school grounds and leave the car park open to the road so that cars can come in and out.

Note: the main paths will be open to the road.

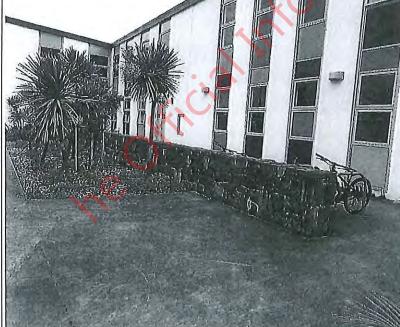
Issue 3 Boundary with Guyton St

This boundary is open to Guyton St.

Provide pedestrian gate at the pathway with self-closing mechanisms and signage to keep gate closed.

Provide vehicle gate for access to the field at suitable point along this boundary, or along the boundary on Stonemason Ave,

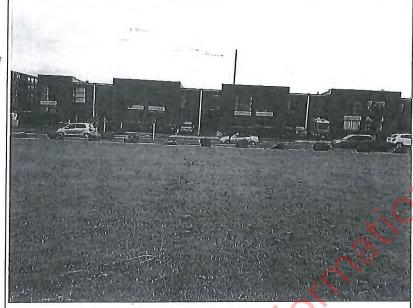
Provide fencing at this boundary according to the guidelines in this report.

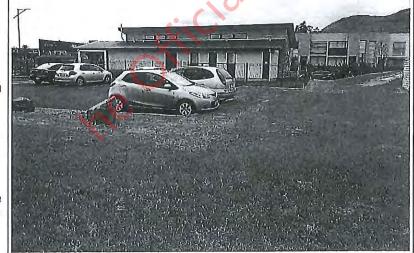
Issue 5. Community Dentist

Provide fencing according to the guidelines in this report to enclose the car park and Dentist from the school.

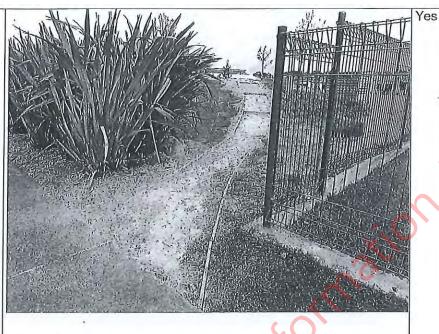
Provide fencing along this boundary as per the guidelines in this report.

Issue 7- Boundary with Vialou Lane. Fencing should be located at the apex of the slope to ensure students are visible from within the secure. Fencing to connect with courtyard fencing as noted in Issue 8.. Where required relocate feature rocks to prevent climbing (over fence)

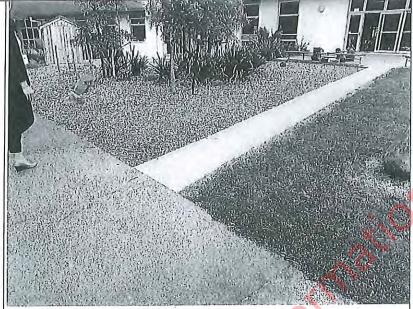
Issue 8

Paths to the classroom blocks along Vialou Lane.

Provide a pedestrian gate in the fencing line, (according to the guidelines in this report), at one of these pathways.

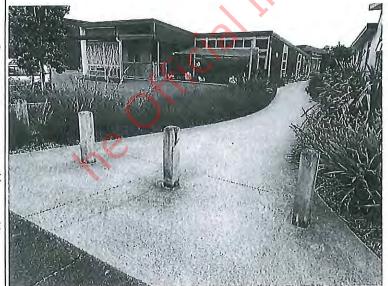
This shows the driveway into the car park outside the satellite classroom.

Enclose this car park off from the school. Provide pedestrian gate at suitable point along this pathway.

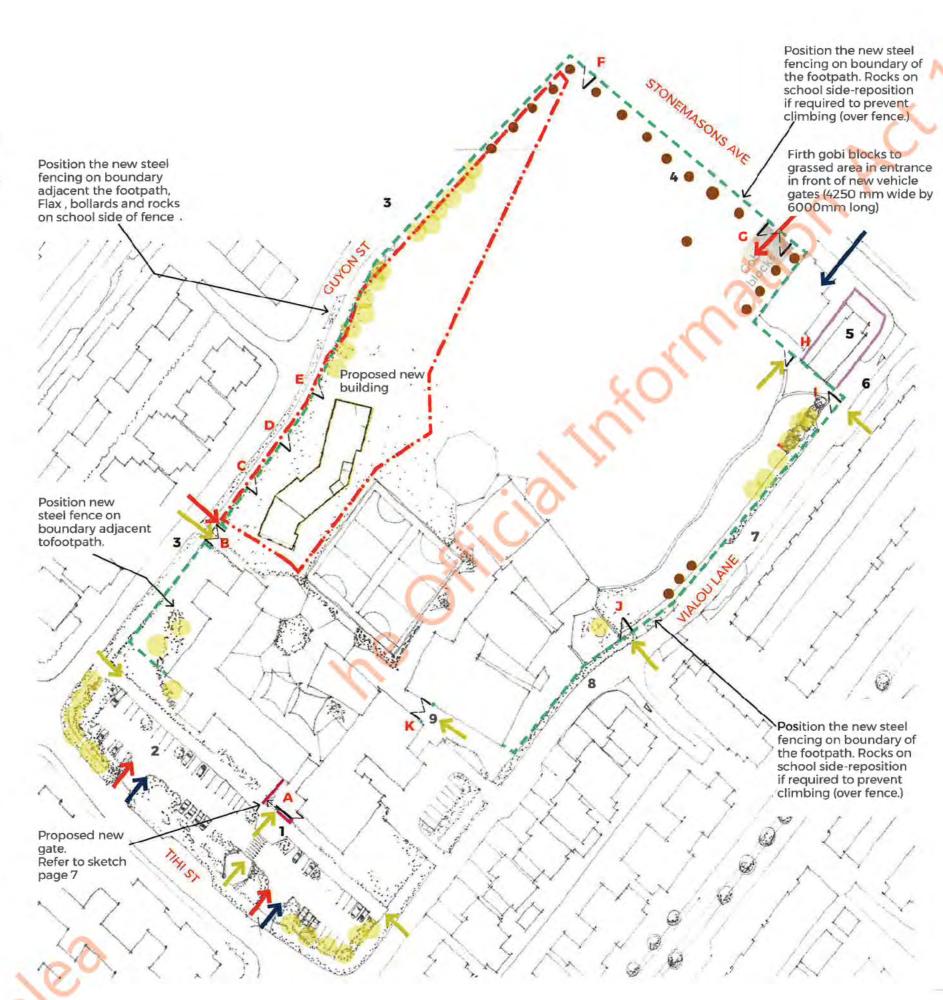
Fencing Plan

EXISTING STEEL PANEL FENCING RETAINED

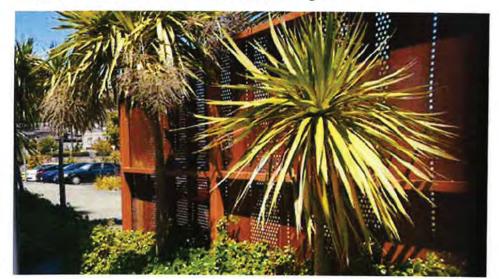
Issue 2 - Carpark on Tihi Street entrance . The carpark is not considered a safe area for students so is not enclosed within the secure fenced area. The buildings along Tihi street form a barrier and 'wing' gates will be installed to control access between the buildings. .

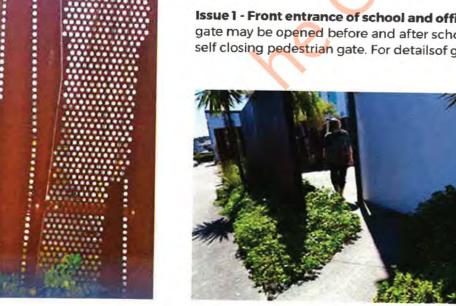
Issue 1 - Fence to prevent access to pathway between steel panels and wall. (Do not fix fencing directly to building)

Issue 1 - Fit section of fencing in gap between steel panels and wall. (Do not fix fencing directly to building)

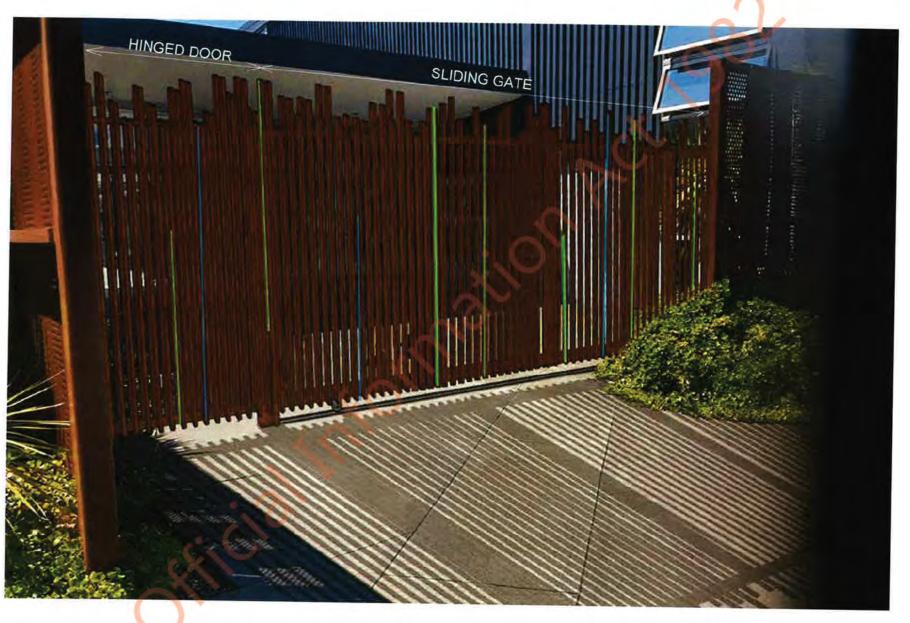
Issue 1 - Front entrance of school and office A new sliding gate at the front entry, with self closing pedestrian gate pedestrian to left hand side. The siding gate may be opened before and after school when controlled access sis not required. During school time when it is closed, access for adults will be via the self closing pedestrian gate. For detailsof gate options refer to page 8.

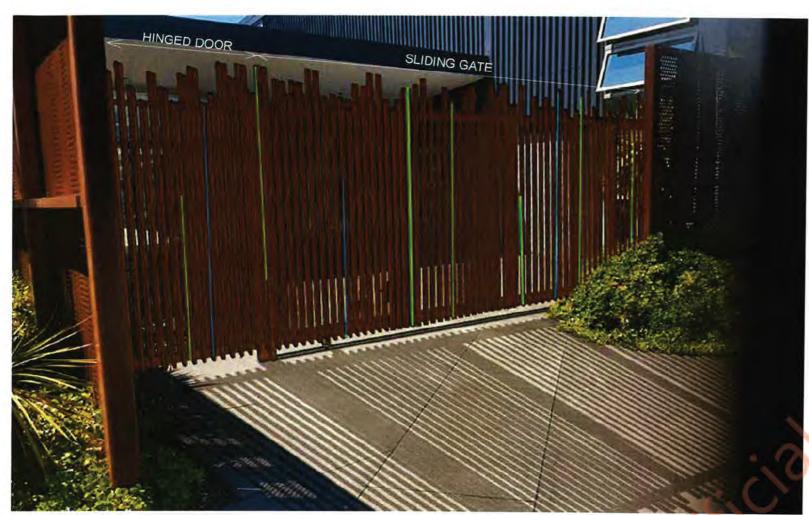
Option A- Galvanized Steel structure with Powdercoated Aluminium vertical fins * School contribution may be required, dependent on cost review.

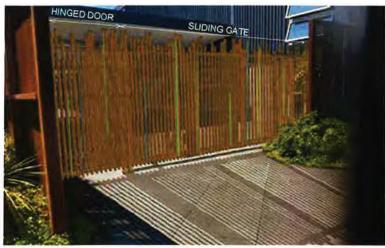
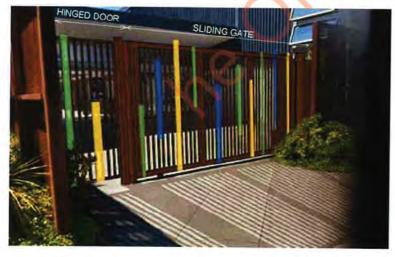
Option B- Vertical Timber Fins * School contribution may be Option C- Proprietary Fence * Fully funded by MoE

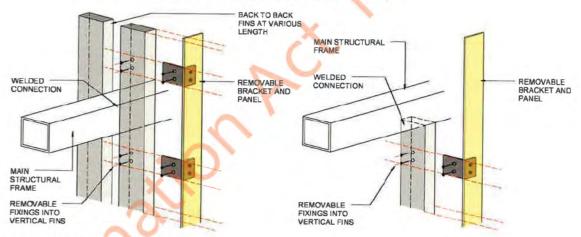
Option A & B- Design Schematic

- · simple construction methodology
- · prefabricated elements
- · welded or bolted bracket connection

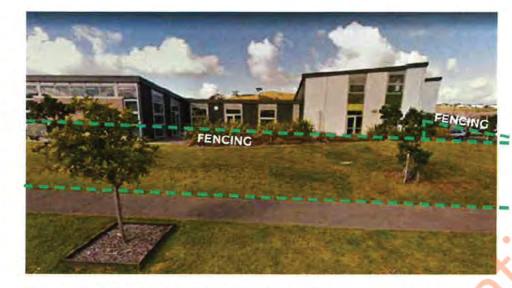
Issue 3 -Boundary with Guyton Street Enclose the courtyard and sandpit area with fencing so the courtyard is within the secure play area. Refer to page 6 for location.

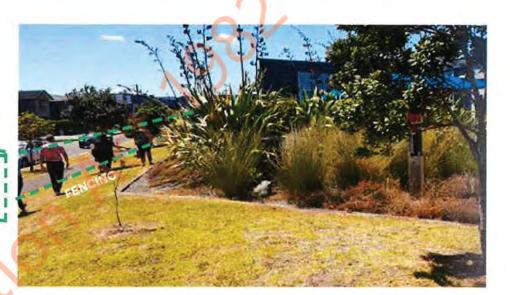
Issue 3- Boundary with Guyton Street.- The fencing should be located on the edge of the landscape area so the landscaping is within the secure play

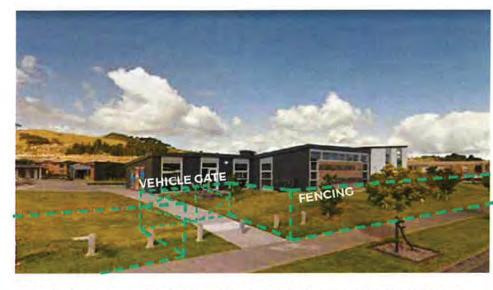
Issue 3 -Boundary with Guyton Street Enclosing the school gardens so they are within the secure area. Position the fence on top of the retaining wall. A pedestrian and uneven vehicle gate to be located on the path (outward opening to accommodate sloping path)

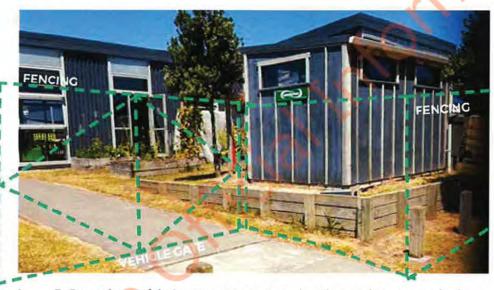
Issue 3 -Boundary with Guyton Street A pedestrian and uneven vehicle gate to be located on the path (outward opening to accommodate sloping path)

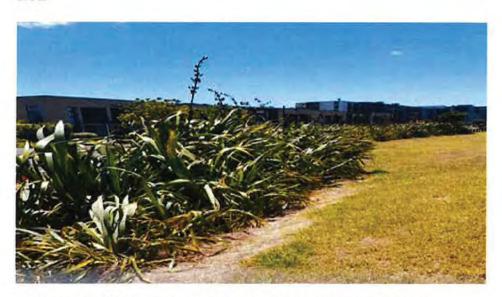
Issue 3 - Boundary with Guyton Street Fencing should be located between the public footpath and the harakeke bushes so the harakeke is within the secure area.

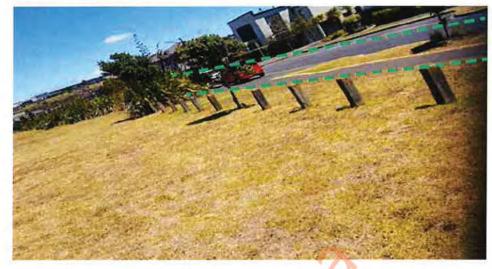
Issue 3 -Boundary with Guyton Street Fencing to be located along the school boundary adjacent adjacent the public footpath.

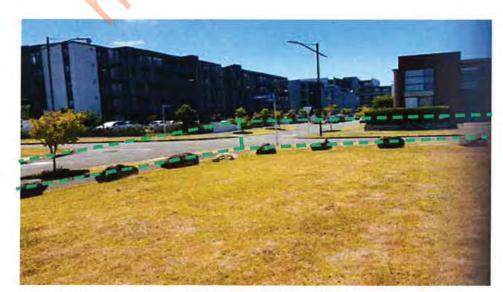
Issue 3 and 4 -Boundary with Guyton Street and Stonemason Ave Fencing to be located on the school boundary between the public footpath and the feature rocks. Relocate rocks min 1m from the fence as required to ensure they do not aid climbing (over fence). School to action make good of lawn, if required.

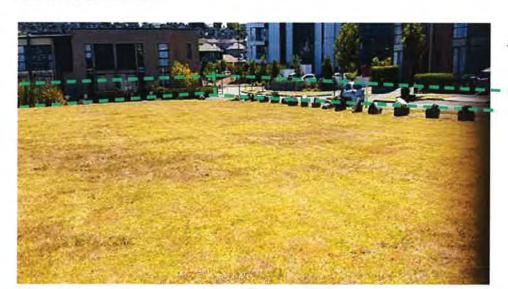
Issue 4 -Boundary with Stonemason Ave (As previous notes.

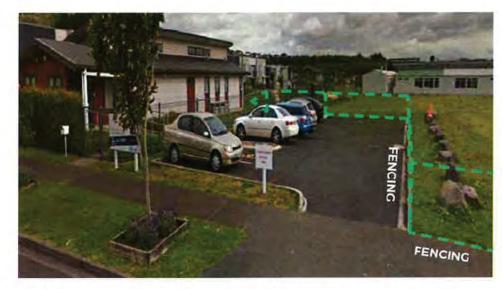
Issue 5- Community Dentist - New fencing to connect to fencing around Community Dental leaving the carpark open to public access. Provide a pedestrian gate to allow access from school to dentist

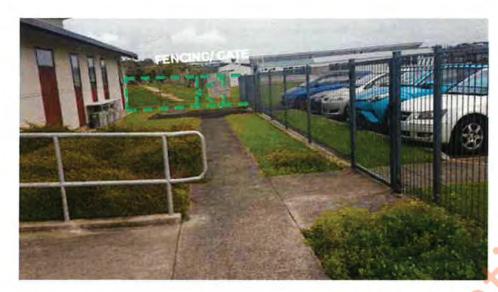
Issue 5 Community Dentist: Extend existing pedestrian path to new fence and gate

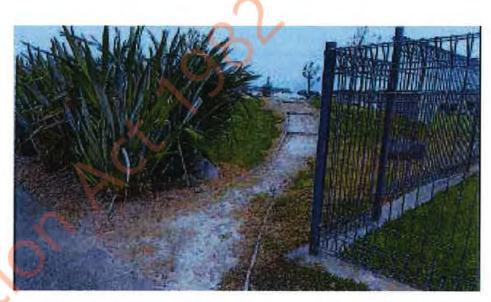
Issue 6 Path to field - Provide a pedestrian gate to the existing path.

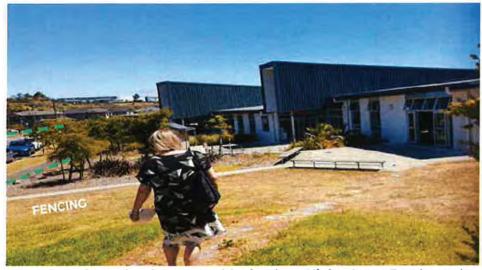
Issue 8- Paths to the classrooms blocks along Vialou Lane Fencing to be provided along the school boundary to create secure courtyards for student activities outside the classrooms.. (No pedestrian gates)

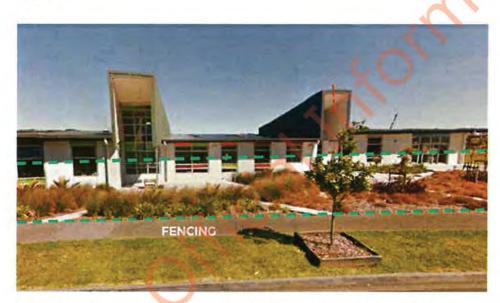
Issue 8- Paths to the classrooms blocks along Vialou Lane - As previous note

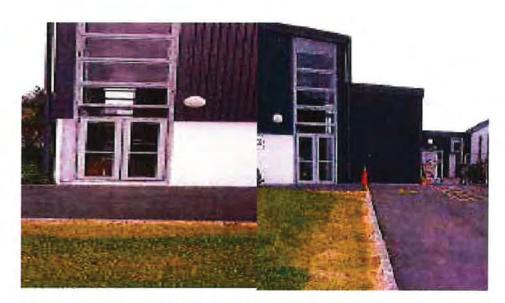
Issue 9 - Carpark outside satellite classroom The carpark is not considered a safe area for students so is not enclosed within the fenced area.

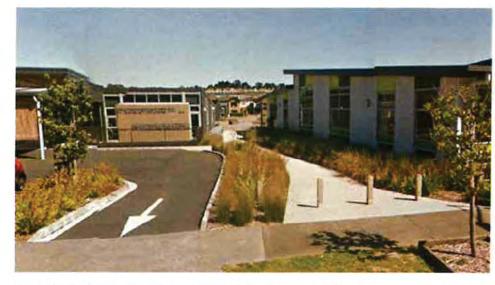
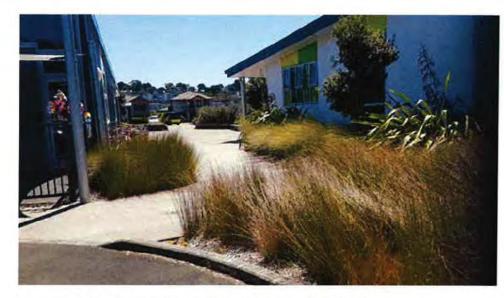
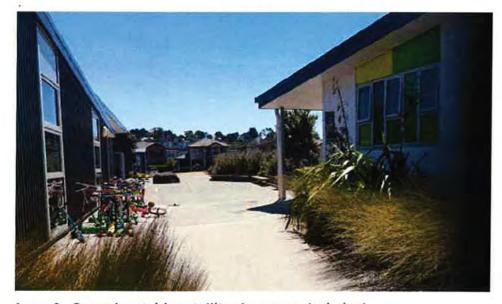
Issue 9 - Carpark outside satellite classroom (existing)

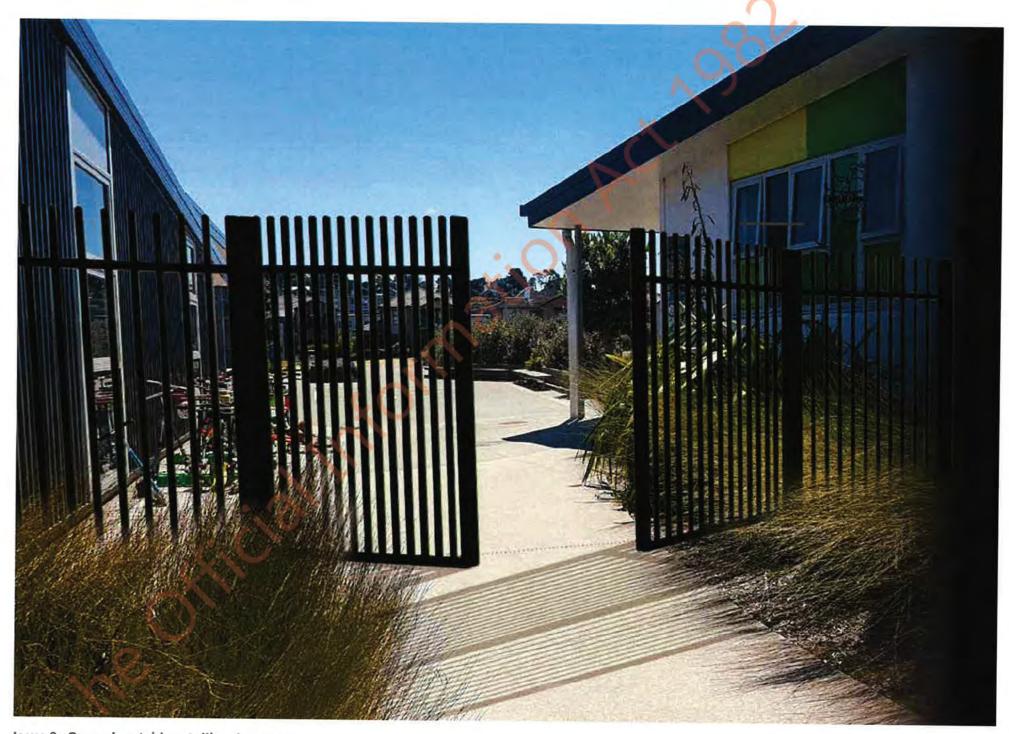
Issue 9 - Carpark outside satellite classroom

New fencing with double swing gates including a self closing pedestrian gate pedestrian to left hand side

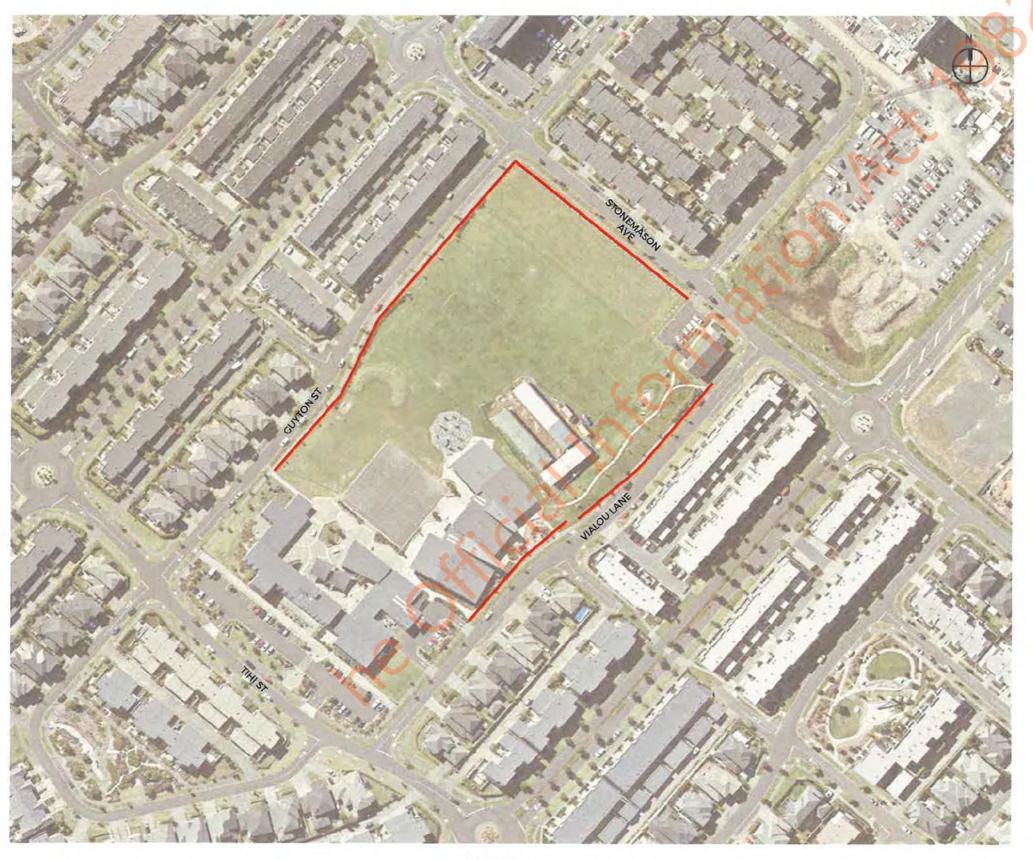
SCHOOL FENCING AND GATES REPORT | CLIENT APPROVAL DATE 14.06.2019 PROJECT NO 4-27494.21

LOCATION OF SCHOOL BOUNDARY
TO BE CONFIRMED. AN EASEMENT STRIP RUNS
ALONG GUYTON ST. CONFIRMATION OF EASEMENT
CONDITIONS REQUIRED.

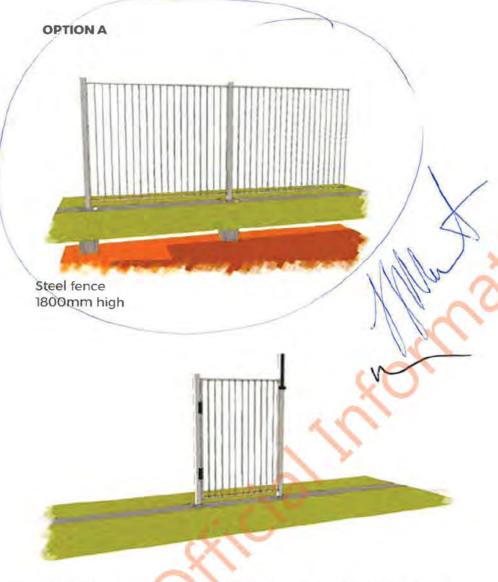
Pedestrian Gate - Self closing with latch and signage (A, B, C, E, F, G) 1800mm high

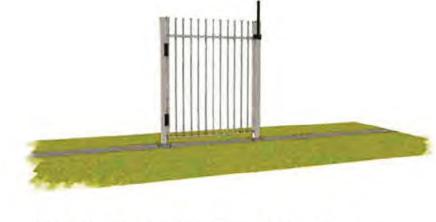
Pedestrian Gate - Self closing with latch and signage 1800mm high

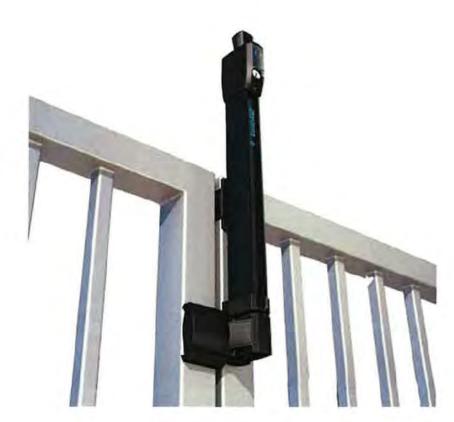
Pedestrian gate latch

PEDESTRIAN GATE MAGNA LATCH (Steel and Timber Gates) Magna latch to be mounted at 1600 mm high accessible from both sides of the gate with self closing hinges.
