POST OCCUPANCY EVALUATION

ENDEAVOUR SCHOOL FLAGSTAFF, HAMILTON

April 2016

Date: April 2016
Reference: 1-46083.00
Status: Final

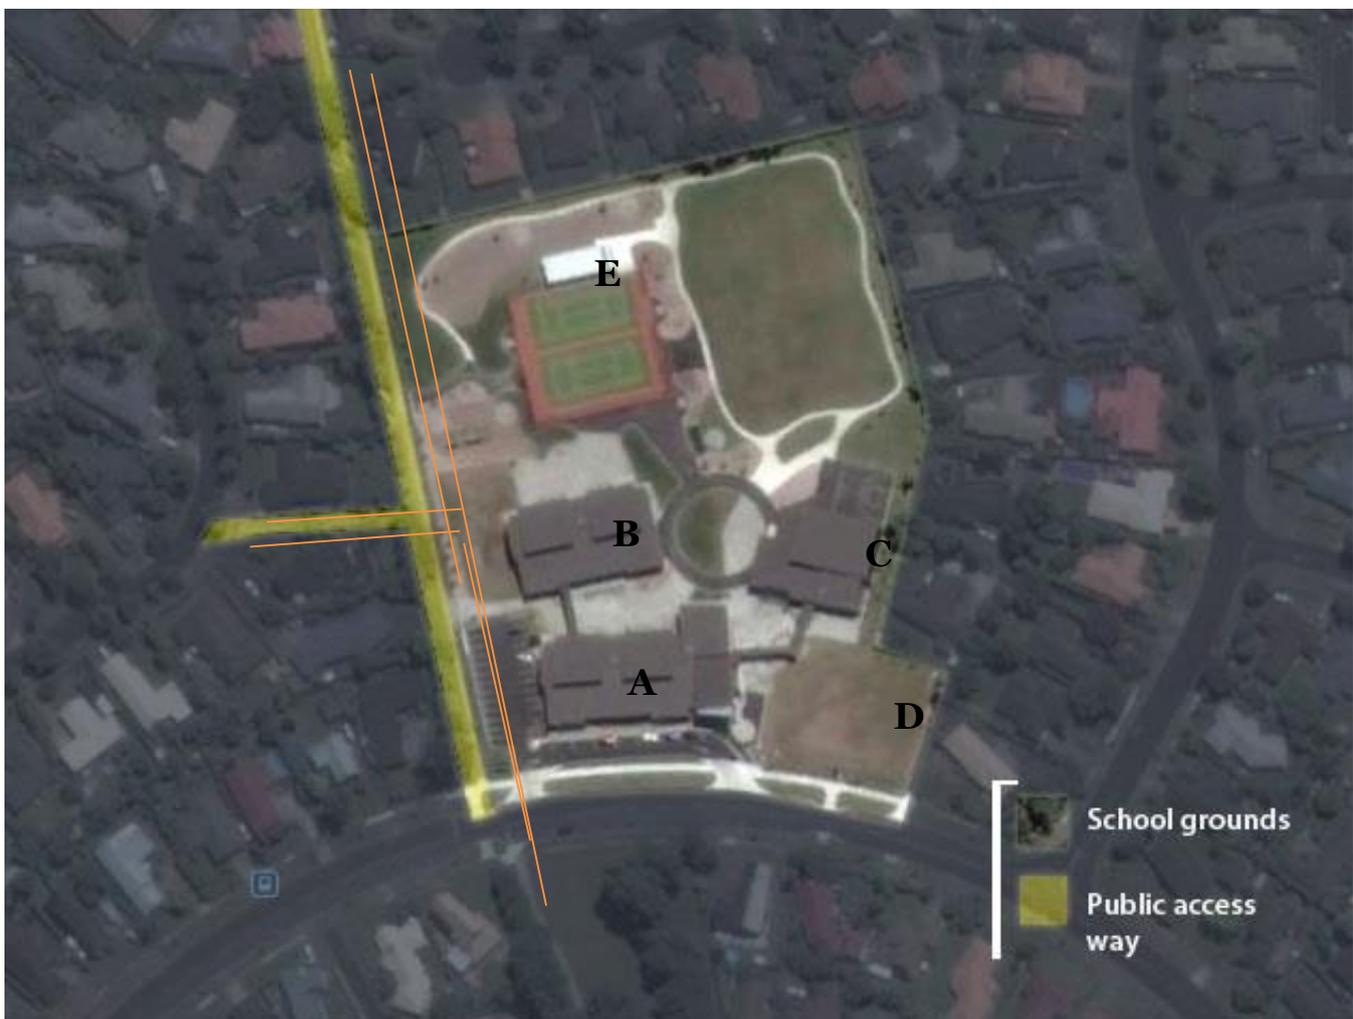
Figure 2 - Aerial – Endeavour School

The main school buildings are a small maintenance shed and covered bike storage (E), a building containing a multipurpose hall and library (C), and two separate single storey blocks for classrooms (A & B). These blocks are open plan classrooms that can have a multitude of classes running in one block. They also feature breakout rooms for individual student learning and wet areas. The administration block is attached to building A. Building D is planned for future expansion of the school

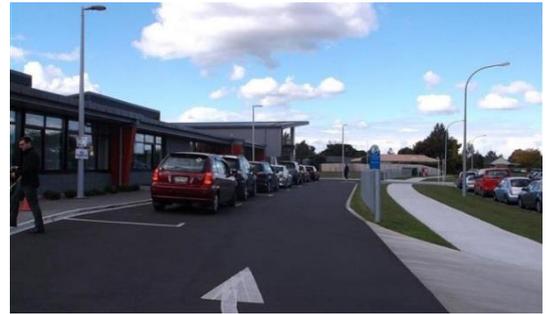
Figure 3

- The pickup and drop off zone is well positioned at the front of the school separate from the carpark area. This is in accordance with MoE guidelines. The Principal commented its simple uncomplicated design ensures ease of access by both parents and students. See Figure 3.

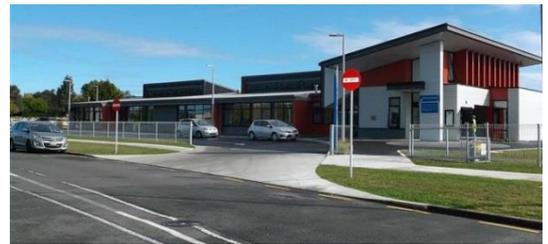
Figure 4

- Vehicular circulation through the site is good due to the design and clear marking in accordance with MoE criteria. The Principal commented that very few problems had been encountered even with the heavy vehicle numbers at peak school hours in the early morning and afternoon periods. See Figure 4.

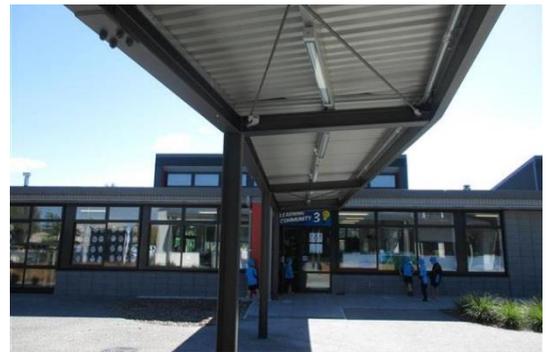
Figure 5

- The school has a clear internal pedestrian circulation route based around covered walkways which link the separate buildings. This is easy to follow due to the compact site design and the way the buildings sit in relation to those pathways. See Figure 5.

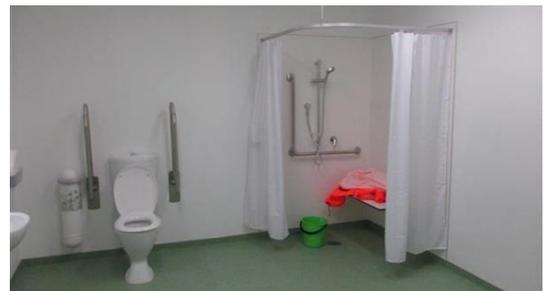
Figure 6

- All school blocks have accessible toilets located next to student toilets. The accessible facilities also include accessible showers. There is also space within these areas that allows accessible hoists to be installed in the future. As the school has no disabled students these facilities have not needed to be used. See Figure 6.

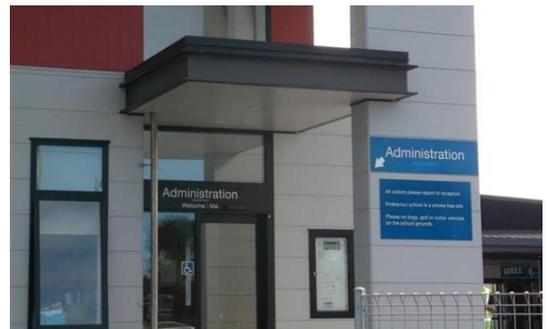
Figure 7

- The Principal commented that when the school initially opened reception and individual learning areas were not easily found by visitors to the site. The school has subsequently added more signage to improve wayfinding. Users in the school confirm this has been successful in solving the problem. See Figure 7.

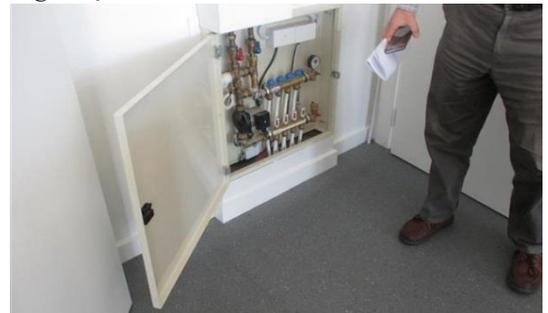
Figure 10

- Controls of the underfloor heating are via the Building Management System (BMS). The Principal commented he has had difficulty changing options with the BMS system. See Figure 10.

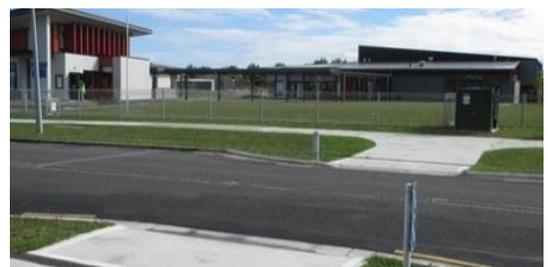
Figure 11

- Fencing is provided in line with MoE guidelines to the road and all neighbouring property boundaries. The use of retractable gates restricts after hours vehicle access to the school buildings. See Figure 11.
- The exterior of the school is well lit with perimeter bulkhead lights around the outside of the buildings and pole mounted exterior lighting to the drop-off zone and staff car park area. See Figure 12.
- Services are well secured, being located in a lockable central maintenance cupboard for each building. The service design has avoided any protrusions into circulation routes where possible. This provides protection for occupants and allows easy access for maintenance and repairs by service contractors. See Figure 13.
- Ceiling mounted electric radiant heaters are correctly installed in locations out of reach of students and staff. See Figure 14.

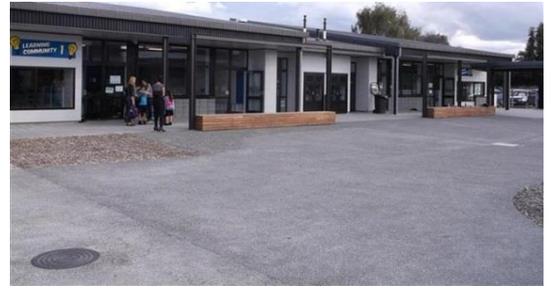
Figure 18

- The school has a lockdown function. The Principal commented that finding a safe place for children is difficult due to the large glass windows on the majority of teaching spaces, See Figure 18.

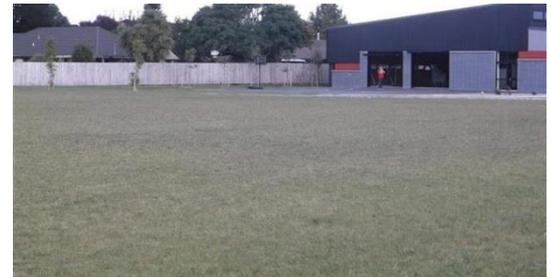
Figure 19

- The Principal commented that he believed the school playing fields will still be adequate once the school was at full capacity. He also advised that the playing surfaces had good grass cover at the opening of the school which allowed for immediate use of the field. See Figure 19.

- There is no established planting/tree shading in the areas surrounding the playing fields. Staff reported that outdoor learning was lessened by the lack of shaded areas. See Figure 19.

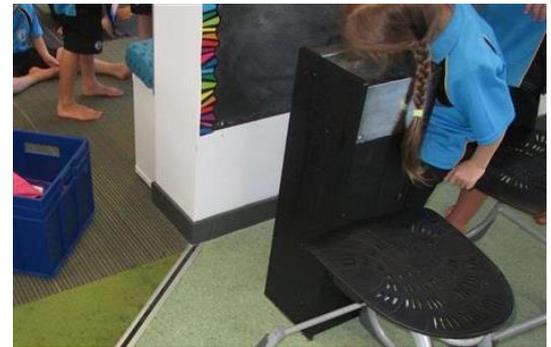
Figure 20

- Drinking fountains are well provided for within the school with each building having at least one tap. Fountains have both a drinking outlet and a bottle-filling outlet. Taps are also provided to the playing field and court area. See the fountain being used in Figure 20.

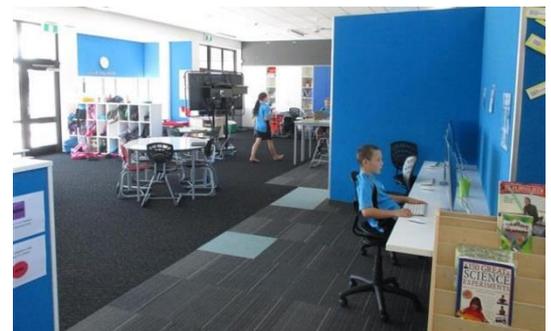
Figure 21

- The open design in the general learning areas are considered by users to work well, allowing learning in small groups. This is achieved by each space being broken up by a central “Y” shaped wall feature which allows a group to have discreet work space. See Figure 21.

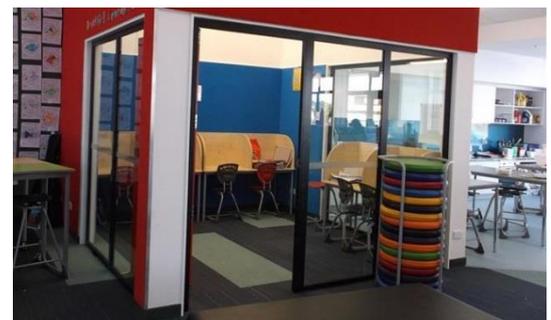
Figure 22

- Every learning area is equipped with a breakout room which allows the space to be used by individual students or small groups. Staff commented these worked well for older students who could be trusted to work alone. The use of glass walls within these spaces meant that staff could still monitor the areas and the activities of the students. See Figure 22.

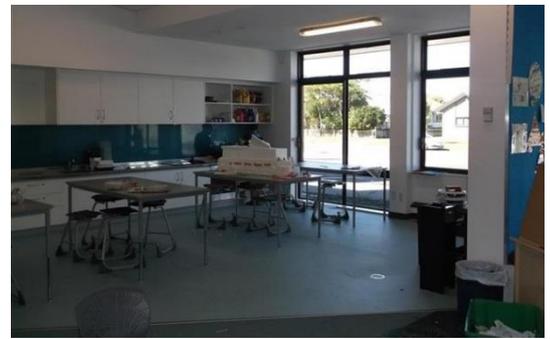
Figure 23

- Wet areas give students a different type of place to learn. The Principal commented these areas are used for all different types of activities, not just specific projects, and he liked the flexibility of the space. See Figure 23.

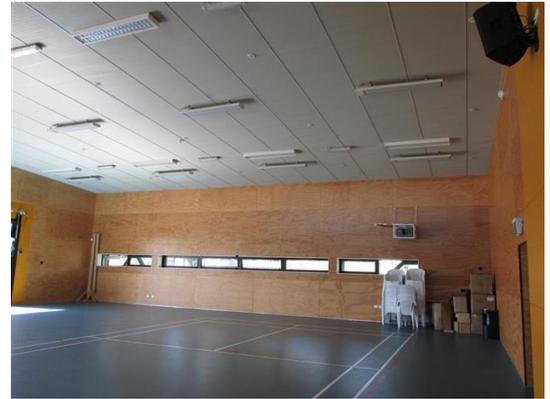
Figure 24

- The Principal commented the multipurpose hall has been very successful. He confirmed that the hall and it is well used by outside groups, for up to five nights per week. The flooring is easy to clean; the outer roller doors allow openness, ventilation and access. See Figure 24.

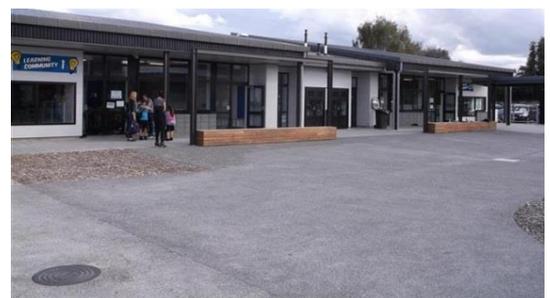
Figure 26

- Building eaves only provide limited cover (outdoor shading) for students. There is no shading to outdoor seating. See Figure 26.
- Users confirmed that storage for students' bags is insufficient. Many of the shelves provided are not big enough to take students books and belongings and there are not enough units to enable each student occupying the teaching spaces to have an individual space. See Figure 27.

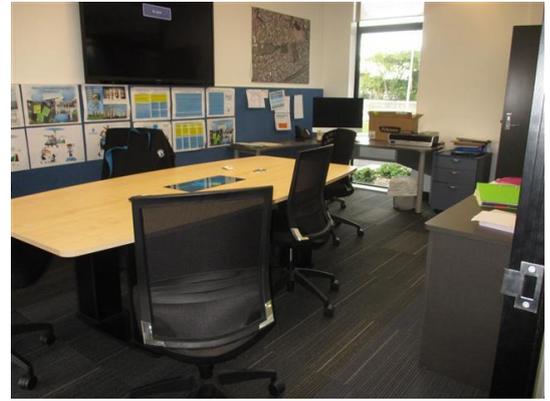
Figure 28

- Teachers have commented that they do not have adequate work areas. There is no shared staff work space. To cope with this the staff have adapted the board room for use as a work space. See Figure 28.

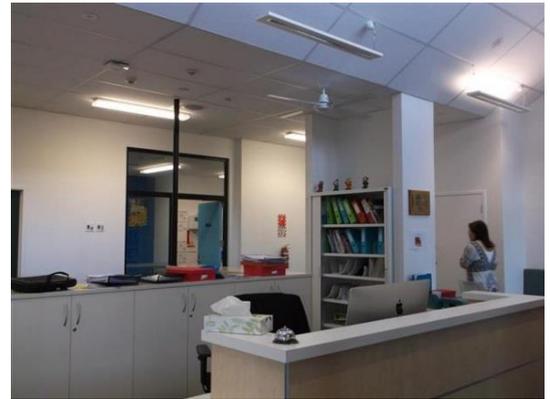
Figure 29

- The Principal commented that the admin work space behind reception is only sufficient for one or two people working, and is a noisy and often-disrupted space. Staff advised that they would have preferred some level of enclosure or separation between the reception area and admin work space. See Figure 29.

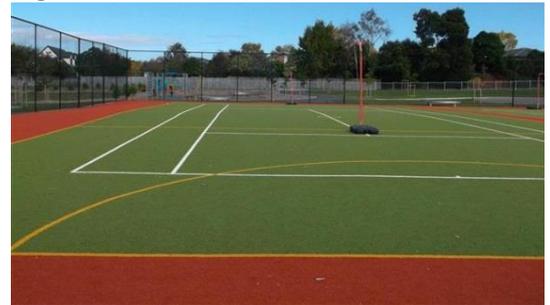
Figure 30

- The Principal advised that the original paved playing courts had an uneven surface and were poorly finished. The school tried to remedy this by re-covering the area in “tiger turf” but this was not sufficient to improve the uneven surface, which has large undulations and slope to it. See Figure 30.

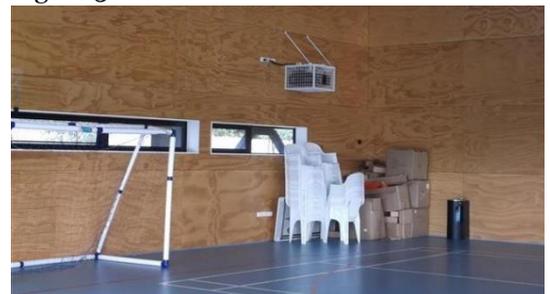
Figure 31

- There was little protection provided for fixtures and fittings within the school hall. The school had to install a cage on the projector to protect it. An electric wall panel was replaced due to damage resulting from the room being used for physical education classes. See Figure 31.

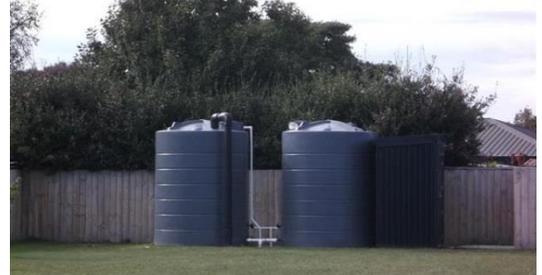
Figure 34

- The school has a rainwater harvesting/roof water catchment system with water storage tanks on the school grounds. This is used for hose taps and toilets reducing the schools public water cost. See the storage tanks in Figure 34.

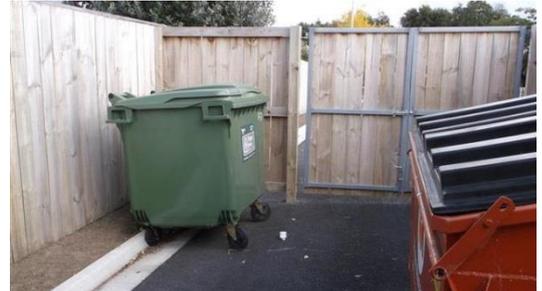
Figure 35

- There is an enclosure area for rubbish storage. The area where the bins are stored is fenced with a sealed asphalt ground to enable ease of access in wet weather. See Figure 35.

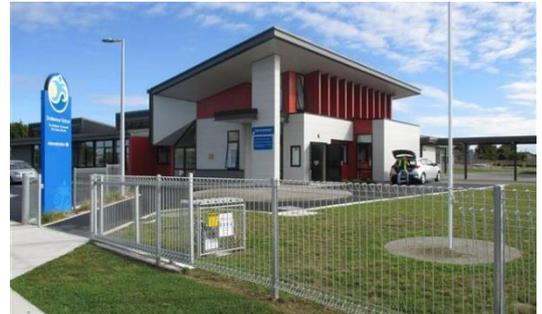
Figure 36

- The Principal has concerns over the quality of the entrance gates and fencing. Individual fence bars have fallen out and wheels have fallen off entrance gate. See Figure 36.

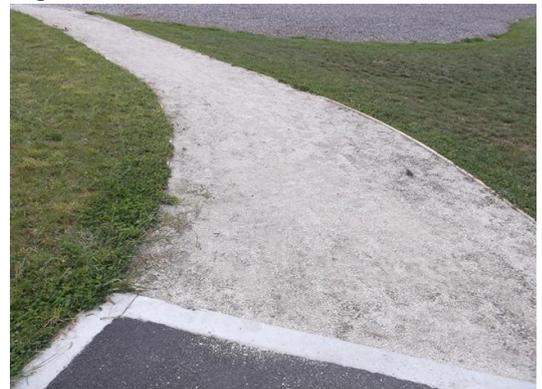
Figure 37

- White limestone chips and dust from the cycle/walking tracks stick to shoes and become deposited around the school. The Principal commented the limestone chip needs to be taken out as this is an ongoing problem and will increase cleaning and maintenance costs. See Figure 37.

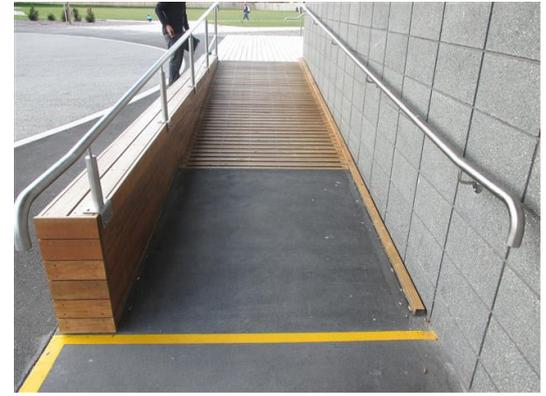
Figure 38

- The hand railing up to the hall multi-purpose space has not been sufficient to deal with school use. It is showing signs of significant wear and tear, the railing is loose and threatening to come off completely. See Figure 38.
