Model Project Specific Quality Assurance Plan

Weathertightness Remediation

Project title:	Weathertightness Remediation works to Block <xxxx> at <xxxxx> School
Prepared by (company name):	
Revision number / date:	
Property Address:	
Building consent number (if applicable):

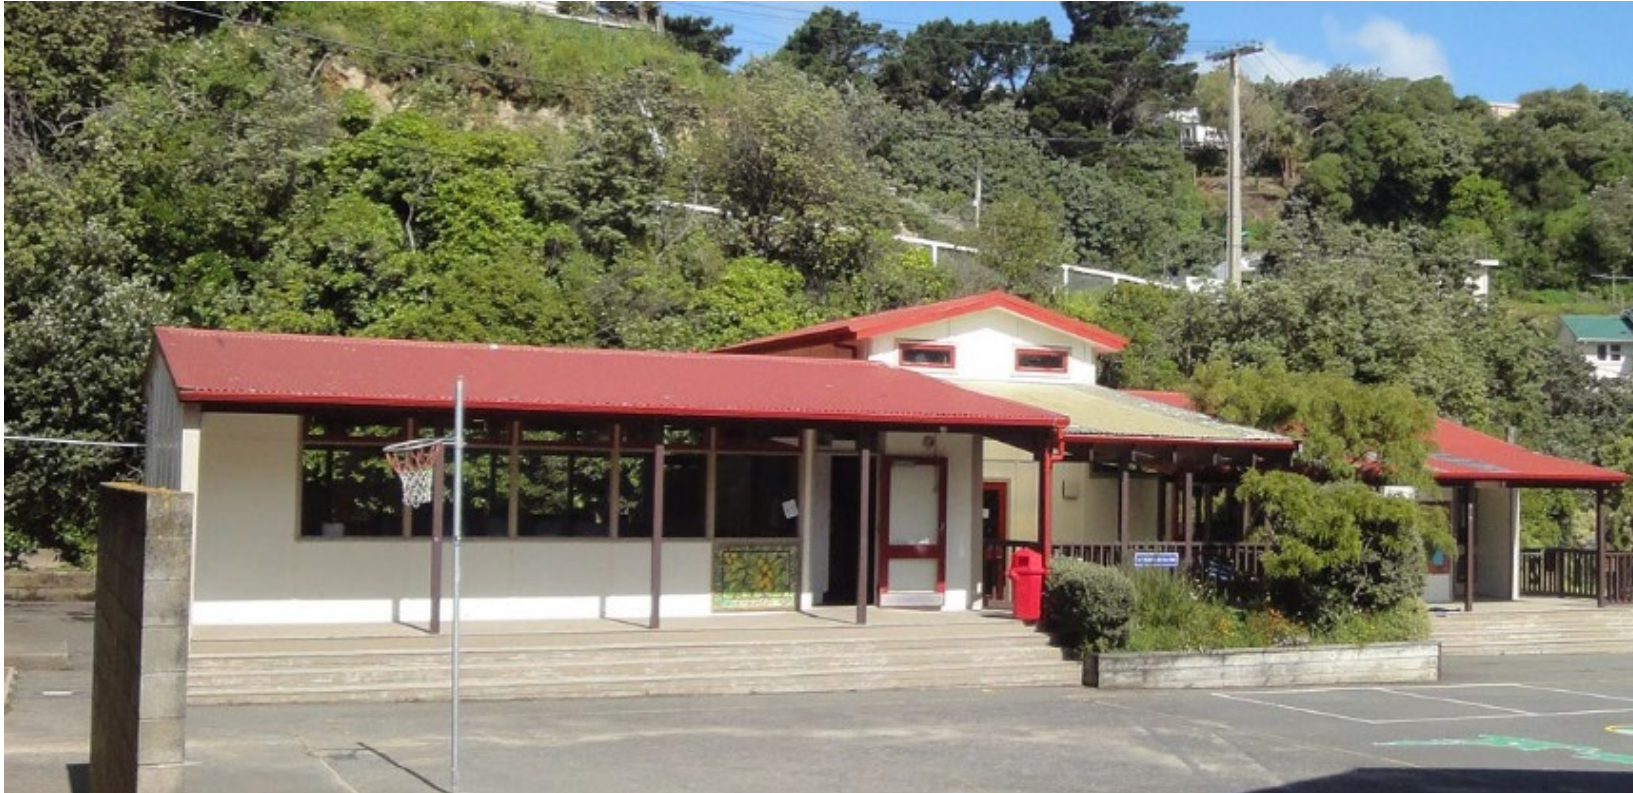
Fig. 1 Image of Block X (West Elevation)

Brief Building Description	
Existing Building:	Two classroom block; 1 storey classrooms with two storey toilet/lobby/store block in centre. 1986 – northern relocatable classroom on to site, with upgrades (unknown scope) in 1990. 1999 – southern relocatable classroom on to site, with centre block for toilet, lobby, and store, and decks and verandas built
Foundation/flooring system:	Timber piles with timber floor joists and particle board flooring
Wall/Cladding/System:	Asbestos sheet and ply sheet
Roof System:	Long run Colorsteel
Roof slope:	> 10 degrees
Wind zone:	EH & SED, based on Council on-line map data
Exposure zone:	D
