**Mātauranga House**

**33 Bowen Street**

Targeted Detailed Seismic  
Assessment Report

**Ministry of Education**

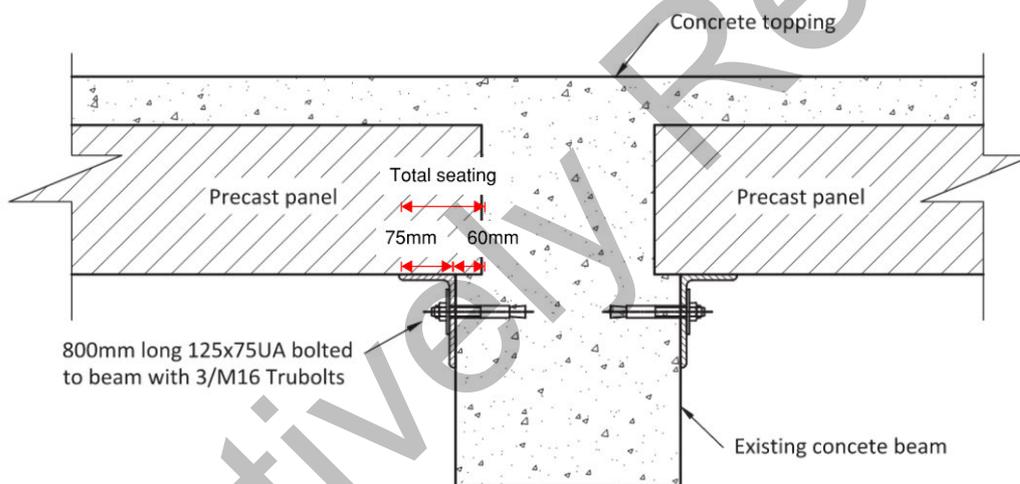
Figure 1.5 – Typical precast hollowcore unit seating detail

The flooring system consists of precast-prestressed 200 hollowcore units, with 65mm topping with 665 “non-ductile” mesh. The structural drawings indicate that the precast hollowcore units have 60mm of seating on the top of the precast shell of the RC beams. In 2014, steel catch brackets (75x125EAs) were installed at the end of each hollowcore precast slab unit to increase the seating. This results in a total seating length of 135mm. See Figure 1.5 below.

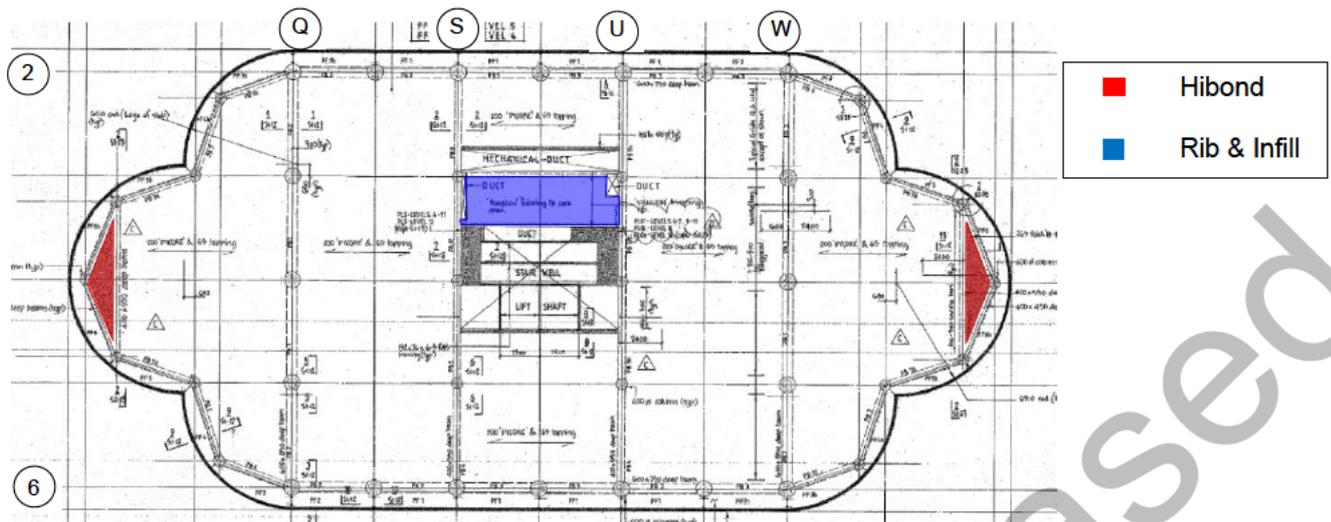
Figure 1.6 – Location of Rib and Infill flooring and Hibond

The hollowcore units with retrofitted seating are typical for all suspended levels except for the floor to the toilet areas which are Stahlton ribs with timber infill. Two very small areas at the northern and southern apexes of the building consist of insitu concrete on Hibond flooring. The floor panels typically span approximately 9.1m onto RC precast shell beams. These beams are supported on RC columns.

- Retrofit the Stahlton units considering the following:
  - Undertake onsite investigations to confirm the Stahlton unit seating length
  - If the onsite investigations show that the seating length is still insufficient then we suggest increasing the seating length by bolting steel members to the underside of the Stahlton ribs. This is to occur on all levels.

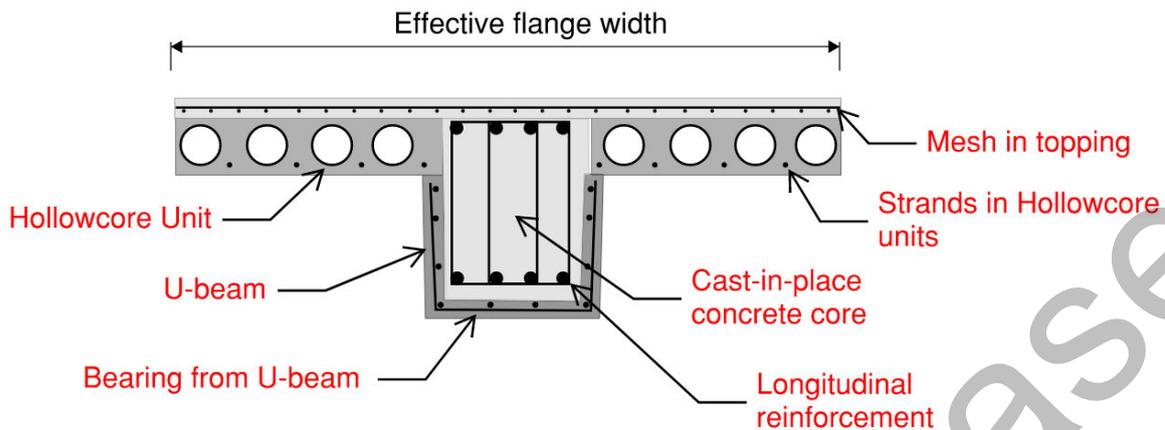
Figure 4.1 – Typical RC beam section showing elements that contribute to the flexural overstrength demands

In the longitudinal direction, some of the MRF beams are shear governed and not the desired flexurally governed. Therefore, the MRFs cannot form a reliable ductile mechanism without brittle failure occurring first under a design level earthquake. They cannot dissipate energy and resist repeated cycles of earthquake shaking without excessive strength degradation.
