Appendix A

Asbestos Management Survey

14 Camrose Grove

On 27/08/2018, 10 & 11/09/2018

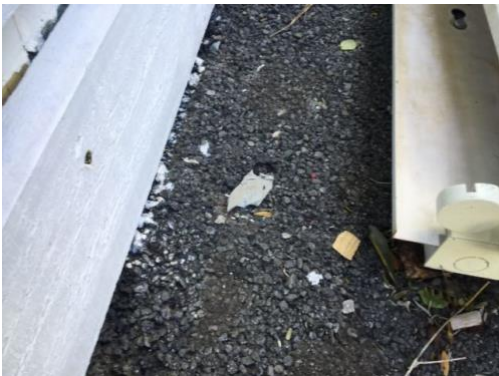
<p>No Photo Available</p>	Building / Floor	Capital Montessori Preschool / External	
	Location	039	Central playground area
	Sample Number	S040/15381	
	Item / Position	Debris - Boarding debris to playground area at kowhai building side	
	Material	Insulation board	
	Extent (approx.)	8 lin m	
	Product Type	AIB, textiles, gaskets, ropes, paper etc.	2
	Condition	High damage / visible debris	3
	Surface Treatment	Bare AIB or encapsulated lagging / spray / textile	2
	Asbestos Type	Amosite, Chrysotile, Crocidolite	3
	Material Assessment	High	10
	Recommendation	Restrict Access and Remove	
Comments	Material should be removed following asbestos procedures by an asbestos contractor holding appropriate licence in accordance with the regulations.

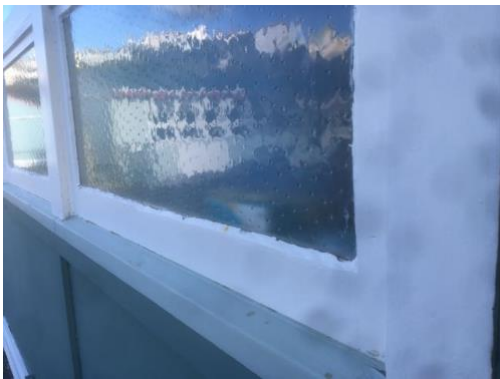
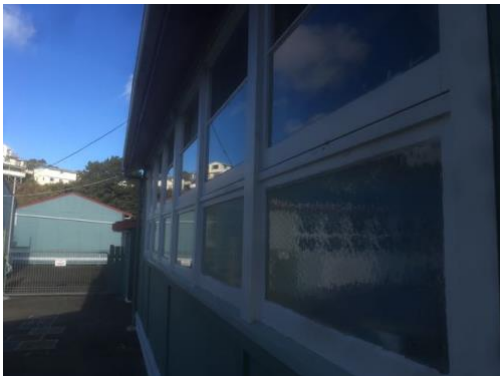
Building / Floor	Kowhai building / External	
	Location	006	External
	Sample Number	S003/14943	
	Item / Position	Windows - Around windows	
	Material	Window putty	
	Extent (approx.)	Various	
	Product Type	-	-
	Condition	-	-
	Surface Treatment	-	-
	Asbestos Type	NAD	
Comments	Material Assessment	N/A	0
Recommendation			
No recommendation required

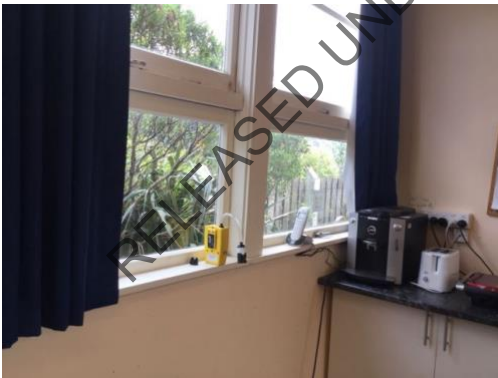
Building / Floor	Rata building / Ground Floor	
Location	030	Whole Rata building
Sample Number	S022/15363	
Item / Position	Dust wipe - To windows facing garden throughout building	
Material	Dust Wipe	
Extent (approx.)	7 lin m	
Product Type	-	-
Condition	-	-
Surface Treatment	-	-
Asbestos Type	NAD	-
Material Assessment	N/A	0
Recommendation	No recommendation required	
Comments

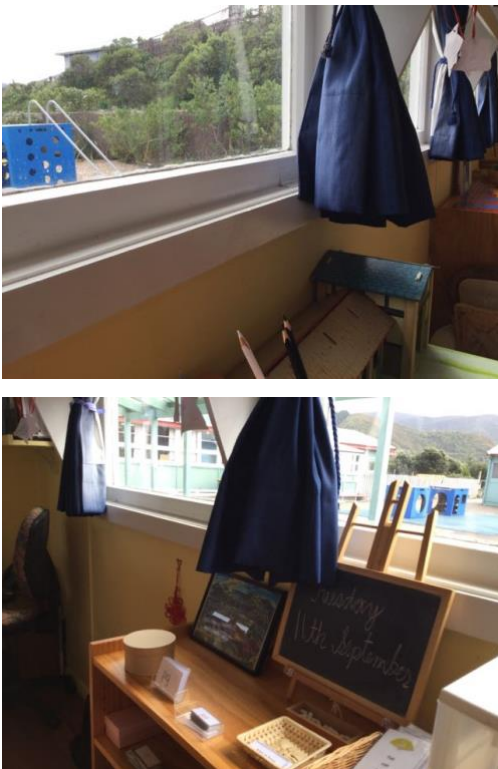
Building / Floor	Kowhai building / Ground Floor	
Location	031	Kowhai whole building
Sample Number	S026/15367	
Item / Position	Dust wipe - To windows facing garden	
Material	Dust Wipe	
Extent (approx.)	14 m ²	
Product Type	-	-
Condition	-	-
Surface Treatment	-	-
Asbestos Type	NAD	-
Material Assessment	N/A	0
Recommendation	No recommendation required	
Comments

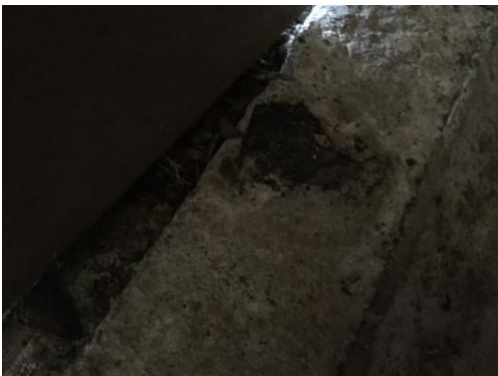
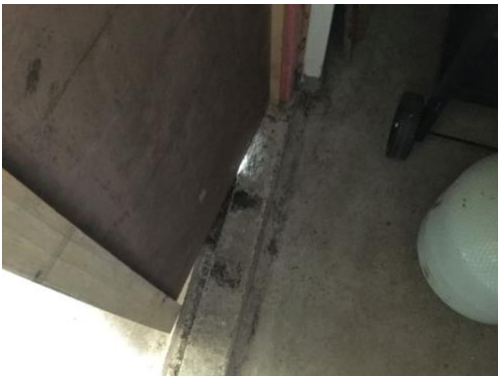
Building / Floor	Koru building / Ground Floor	
	Location	032	Koru whole building
	Sample Number	S028/15369	
	Item / Position	Dust wipe - To doorway at playground	
	Material	Dust Wipe	
	Extent (approx.)	1 m ²	
	Product Type	-	-
	Condition	-	-
	Surface Treatment	-	-
	Asbestos Type	NAD	-
	Material Assessment	N/A	0
	Recommendation	No recommendation required	
Comments

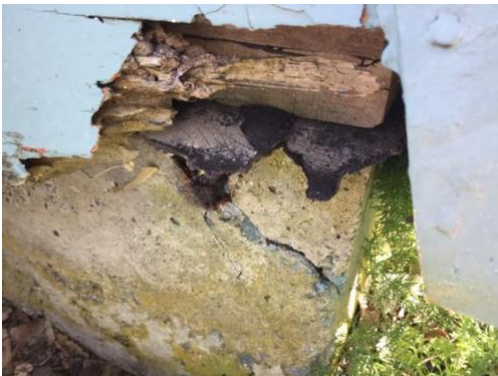
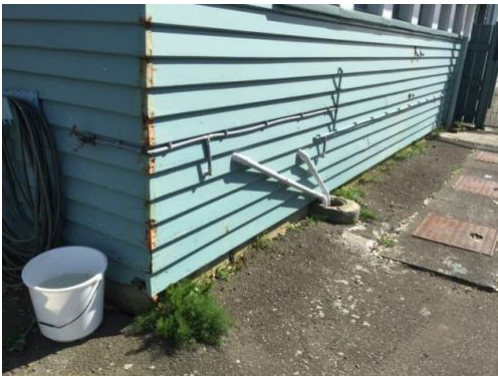
Building / Floor	Shed / External	
	Location	037	External
 	Sample Number	S035/15376	
	Item / Position	Debris - Cement debris found on concrete floor and soil at toilet entrance of shed	
	Material	Cement Product	
	Extent (approx.)	9 m ²	
	Product Type	-	-
	Condition	-	-
	Surface Treatment	-	-
	Asbestos Type	NAD	-
	Material Assessment	N/A	0
	Recommendation	No recommendation required	
Comments
