## ST1089

### GYMNASIUM WALL TESTING FOR MBIE AND MOE

# 1. INTRODUCTION

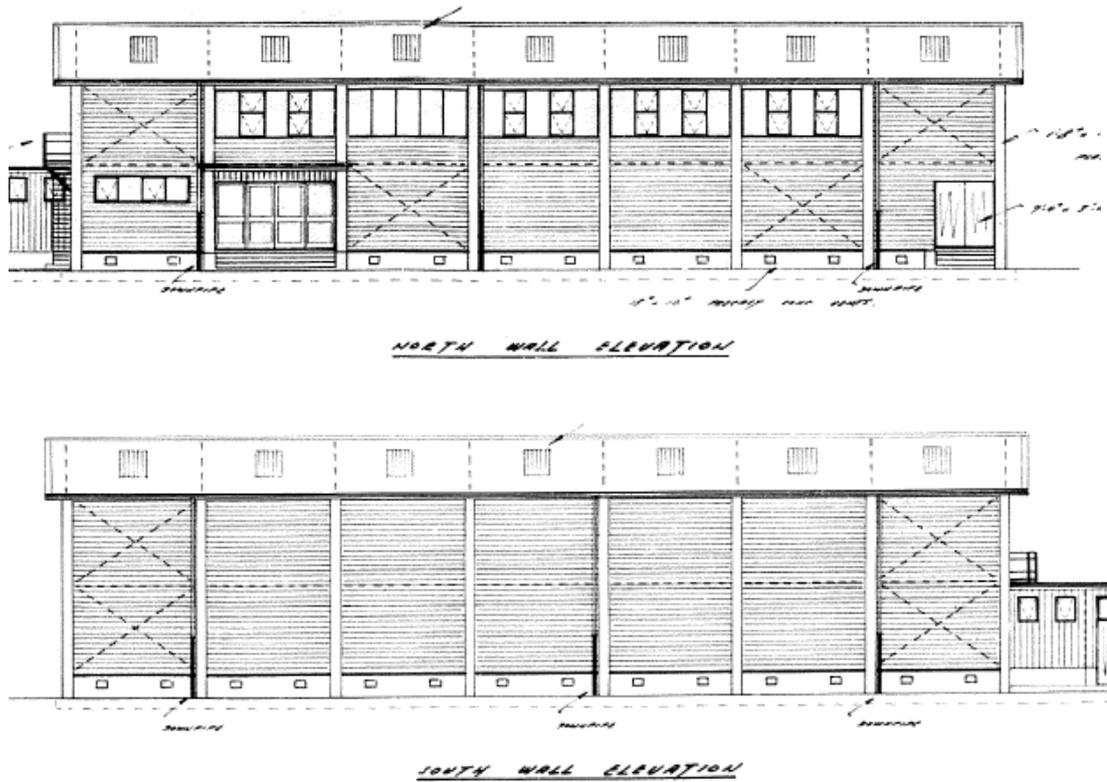
**Figure 1. Exterior Gymnasium Wall Elevations from Original Architect Drawings for Naenae College (Note: Steel Bracing shown as Dotted Lines between Portal Frames)**

The wall test specimen was based on details provided for a gymnasium building located at Naenae College in Lower Hutt, just north of Wellington. An original set of drawings was provided and the details on the drawings were verified through two visits by BRANZ staff to the building in Naenae. The building consists of a series of steel portal frames with timber frame infill walls between the frames. The portal frames are connected using steel channel sections bolted to lugs welded to the frames at two locations up the height of the portal frame legs. In some bays between the steel portal frames there are diagonal steel strap braces bolted to lugs welded to the frames. The building has a total of eight portal frames, resulting in seven bays, and on each side of the building there are four sets of diagonal braces, two upper and two lower, as shown in Figure 1.

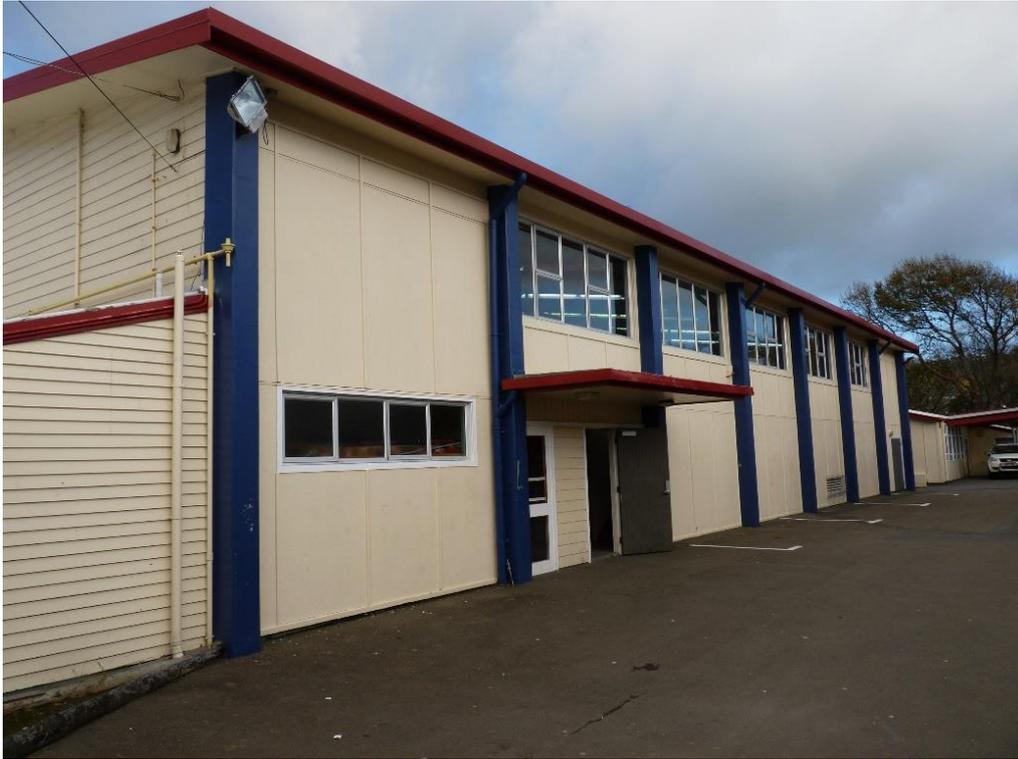
**Figure 2. North Side of Naenae College Gymnasium**

Most of the details from the original drawings were apparent in the building and were represented in the test specimen. One notable exception is that plywood had been installed on top of the weatherboard on both sides of the longitudinal walls, as shown in Figure 2 and Figure 3. On the north side of the gymnasium the plywood was installed up to the level of the windows, except in the first bay where it goes all the way to the top of the wall. On the south side of the gymnasium the plywood was installed to approximately 2.4 m up from where the weatherboard started at the bottom of the wall. It appeared that the plywood had been nailed directly to the weatherboard cladding with sparsely placed nails. As described in the next section, the plywood was not included in any of the test configurations as it was not considered original and it is possible that other gymnasiums around New Zealand do not include this extra cladding material.

In order to determine the contributions of the different materials making up the infill walls between the steel portal frames and possible contributions of these materials to the lateral load resisting behaviour of the walls, a specimen was constructed and tested in the Structures Laboratory at BRANZ. The specimen was tested in several different configurations having different combinations of the steel frames and bracing, interior linings, exterior cladding and openings (representing the large upper windows seen in Figure 2).

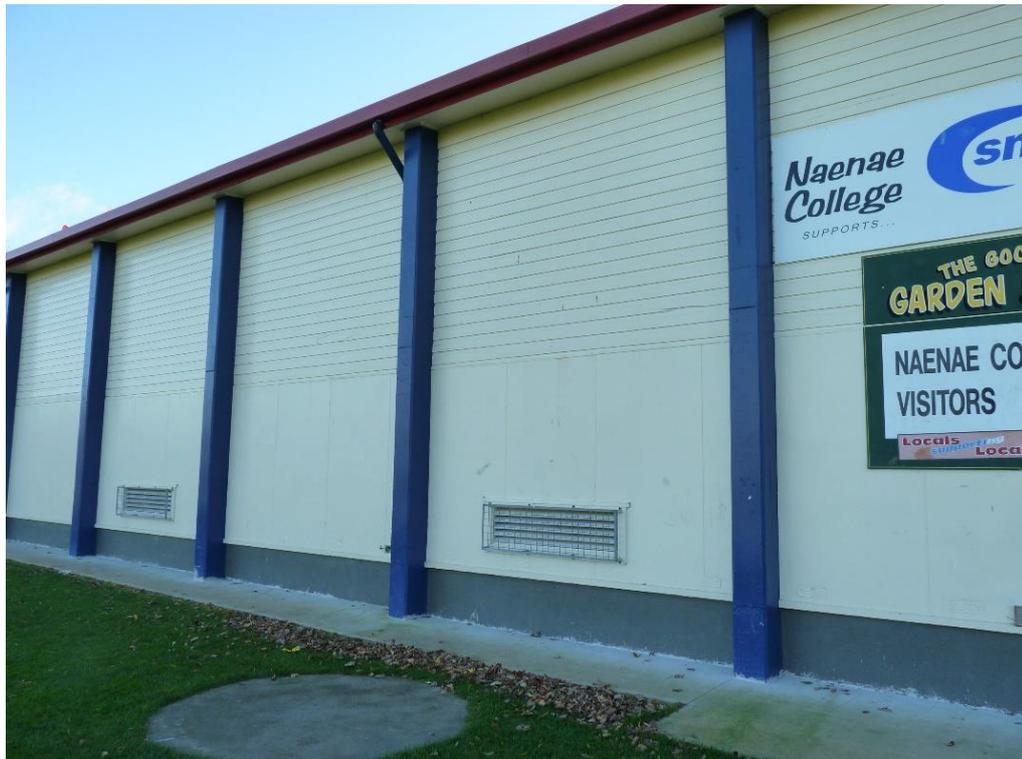
**Figure 3. South Side of Naenae College Gymnasium**

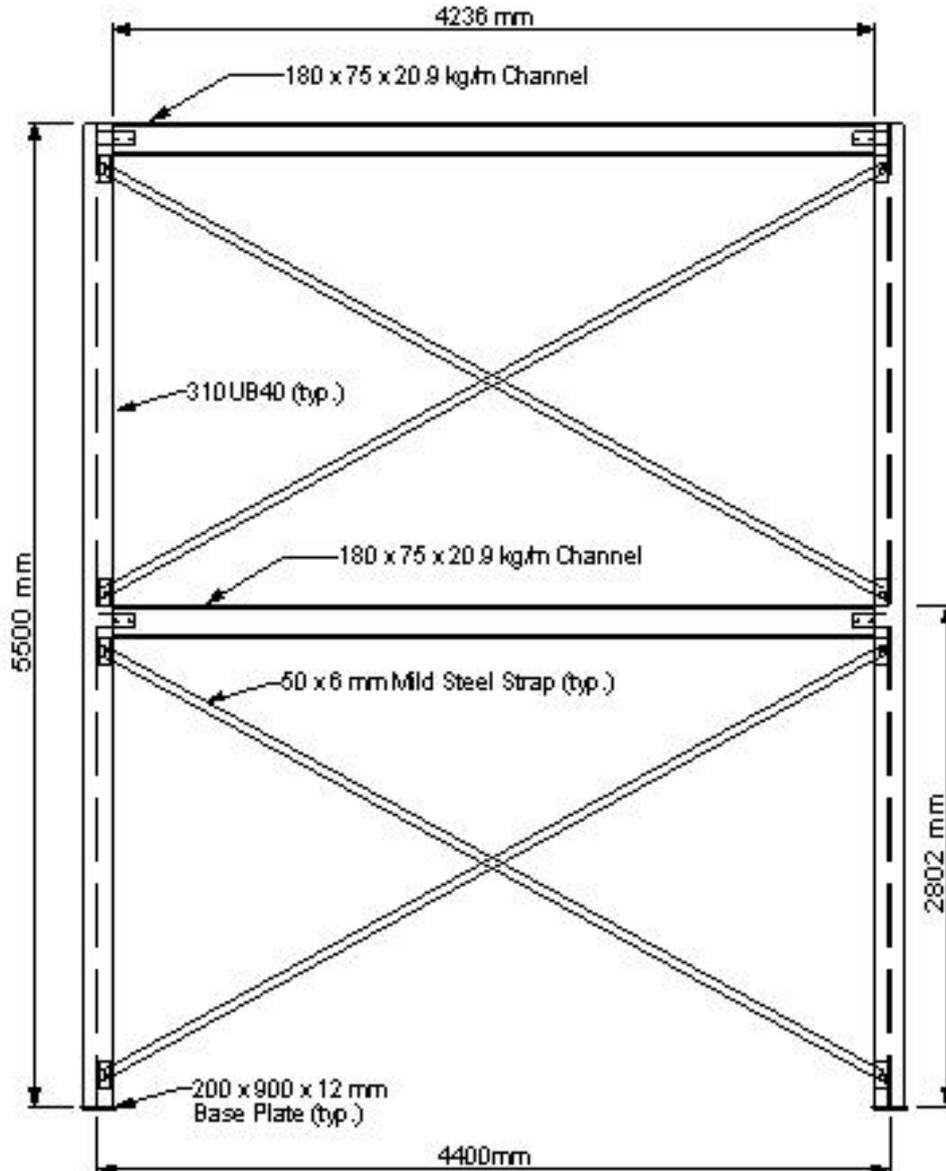
Figure 4. Steel Components of Wall Test Specimen and Overall Dimensions

The dimensions of the test specimen can be seen in Figure 4, which also shows the steel columns, beams and braces that were included in the first test configuration. The steel columns were intended to model the portions of the portal frame columns that are only encased in concrete but do not have a concrete wall supporting the columns. These short concrete walls can be seen at the bottom of the wall in Figure 3. The columns used in the test were slightly smaller than those in the as-built gymnasium but their weak axis stiffness was very similar to the as-built columns. It was assumed for the test specimen that the columns were essentially pinned at the bottom and were connected to the laboratory strong floor using a 12 mm thick mild steel plate welded to the column bottoms and then bolted to the strong floor using two 16 mm diameter bolts that were in line with the column webs.

A total of nine configurations were tested using the steel columns and beams shown in Figure 4. These configurations are described in Table 1.

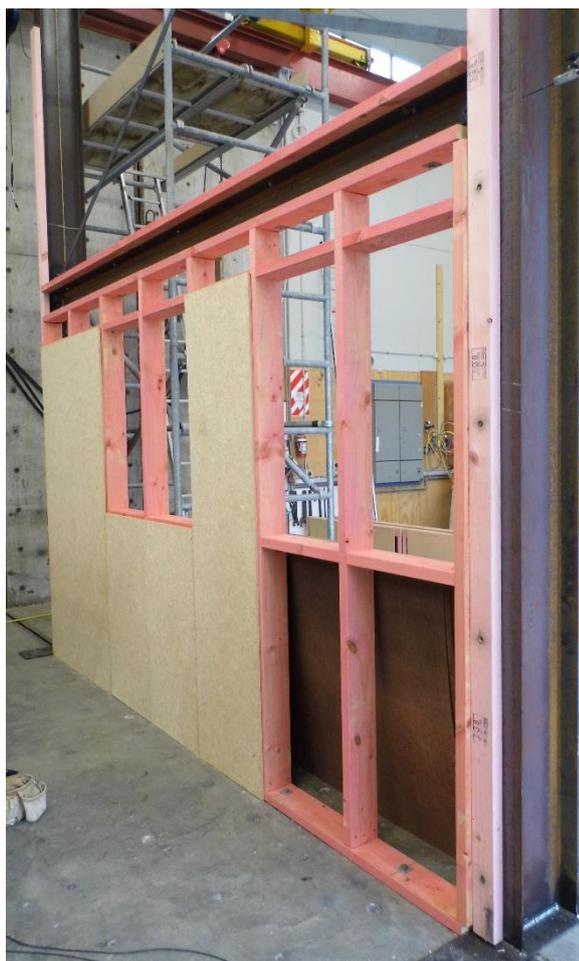
**Figure 5. Test configuration B under construction**

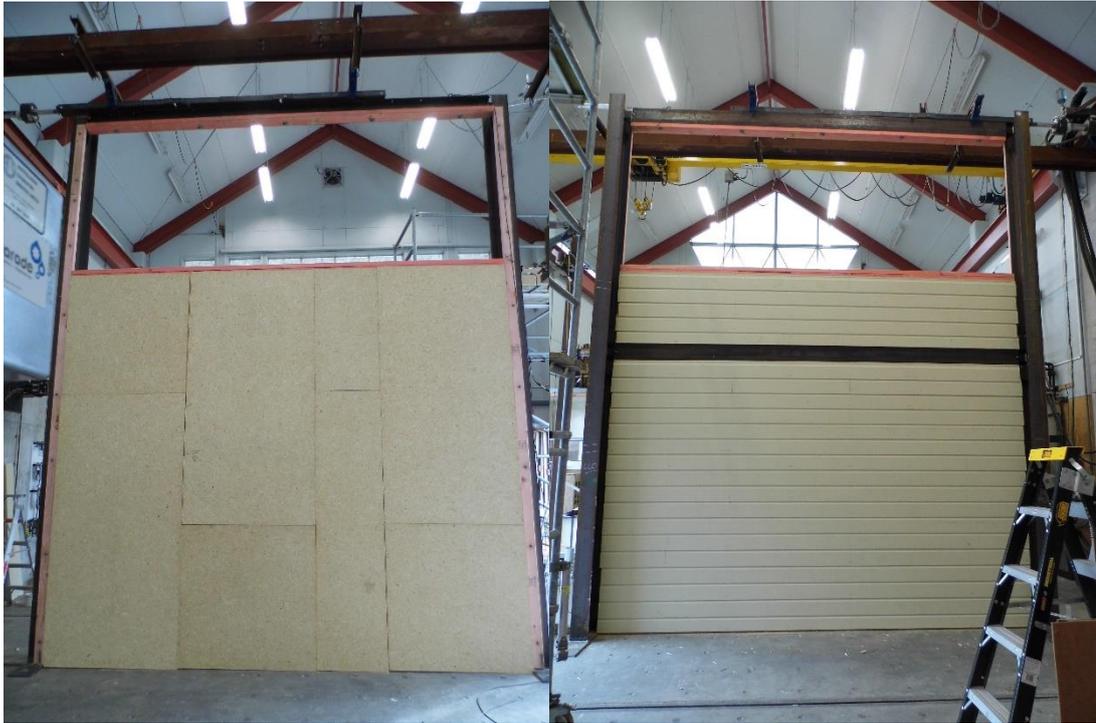
**Figure 6. Test Configurations E and F with Particleboard on the Interior (Left) and Rusticated Weatherboard on the Exterior (Right)**

For Tests E and F, the studs in the upper section of the frame were trimmed down to the level of the sill for the window in the as-built gymnasium, which was taken to be 3.6 m from the bottom of the specimen. A continuous 140 mm x 45 mm SG8 sill trimmer member was placed over the length of the specimen across the top of the trimmed studs and fixed to the top of the studs with two 90 x 3.15 gun driven nails per stud. This was intended to replicate additional framing that would likely have been used around the window opening in the original building and also to avoid any out of plane movement of the framing during testing. Test E was conducted using the original nail size and spacing for the particleboard inner lining and included the exterior cladding material up the bottom of the window opening as shown in Figure 6. Test F was conducted using the same additional nailing for the particleboard as in Test C and included the exterior cladding material up the bottom of the window opening.

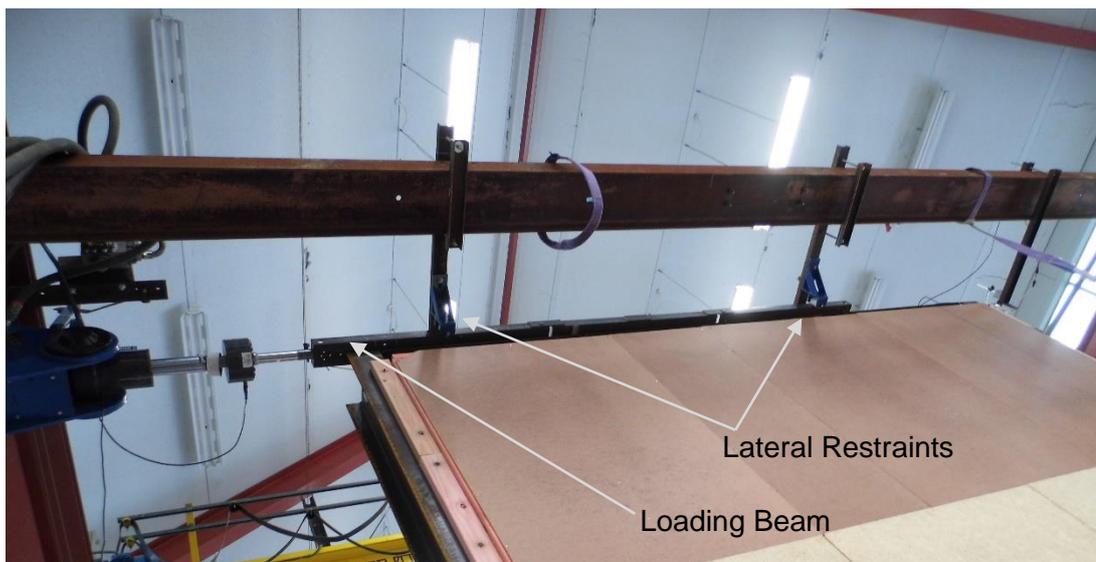
**Figure 7. Top of Wall Test Specimen Showing Loading Beam and Lateral Restraints**

movement of test configurations was prevented by roller restraints located at two points along the top edge of the specimens as seen in Figure 7. A rotary potentiometer was used to measure the global horizontal displacement of the top of the specimen. Additional potentiometers were used to measure the horizontal movement of the column furthest from the actuator at mid-height during testing. The test load and displacement measurements were recorded using a computer controlled data acquisition system. The load cell was calibrated to International Standard EN ISO 7500-1 (2004) Grade 1 accuracy and the linear potentiometers were calibrated to an accuracy of 0.2 mm. The rotary potentiometer had a much longer range and was calibrated to an accuracy of 1.0 mm.

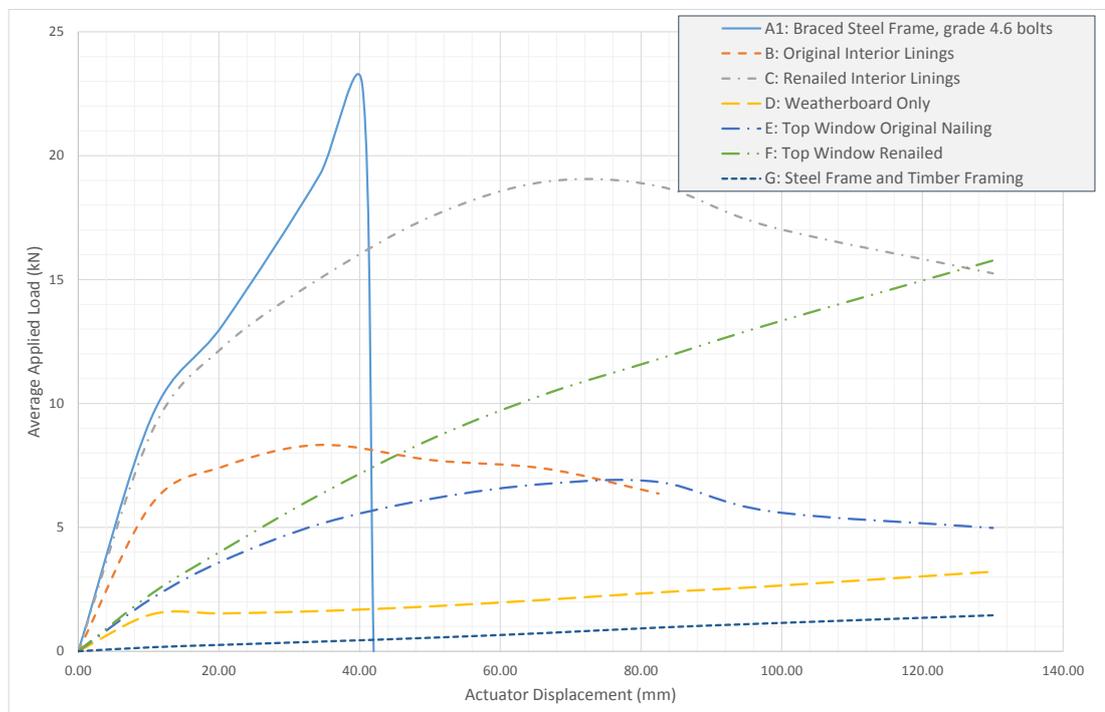
Figure 8. Average Backbone Curves for Tests A1, and Tests B to Test G

Load and LVDT displacement data obtained during testing provided ample data for the development of hysteresis loops and backbone curves for each test configuration. There was negligible difference between the LVDT displacement and the rotary potentiometer. Observations made during testing also provided qualitative information on the performance of these configurations during lateral loading. A composite series of 1<sup>st</sup> cycle backbone curves were created based on the averages of the positive and negative displacement cycles and these are shown in

Figure 8 for Tests A1 and Test B to Test G. Figure 9 presents the 1<sup>st</sup> cycle backbone curves for Tests A1 to A3.

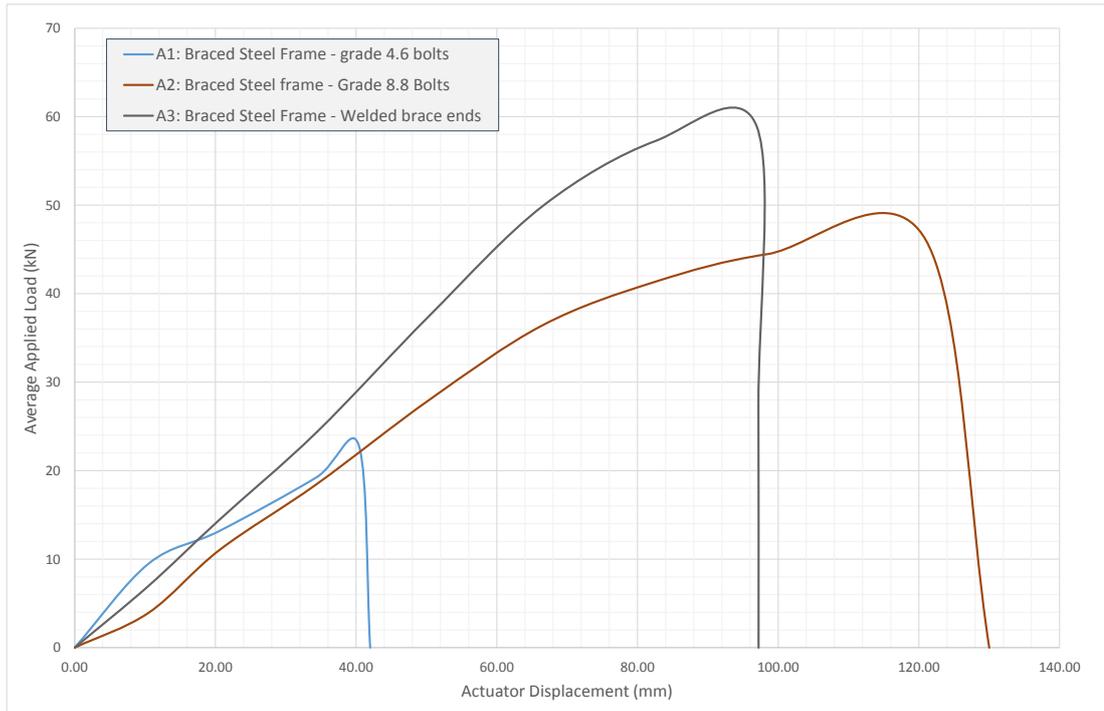
**Figure 9. Average Backbone Curves for Tests A1, A2 and A3**

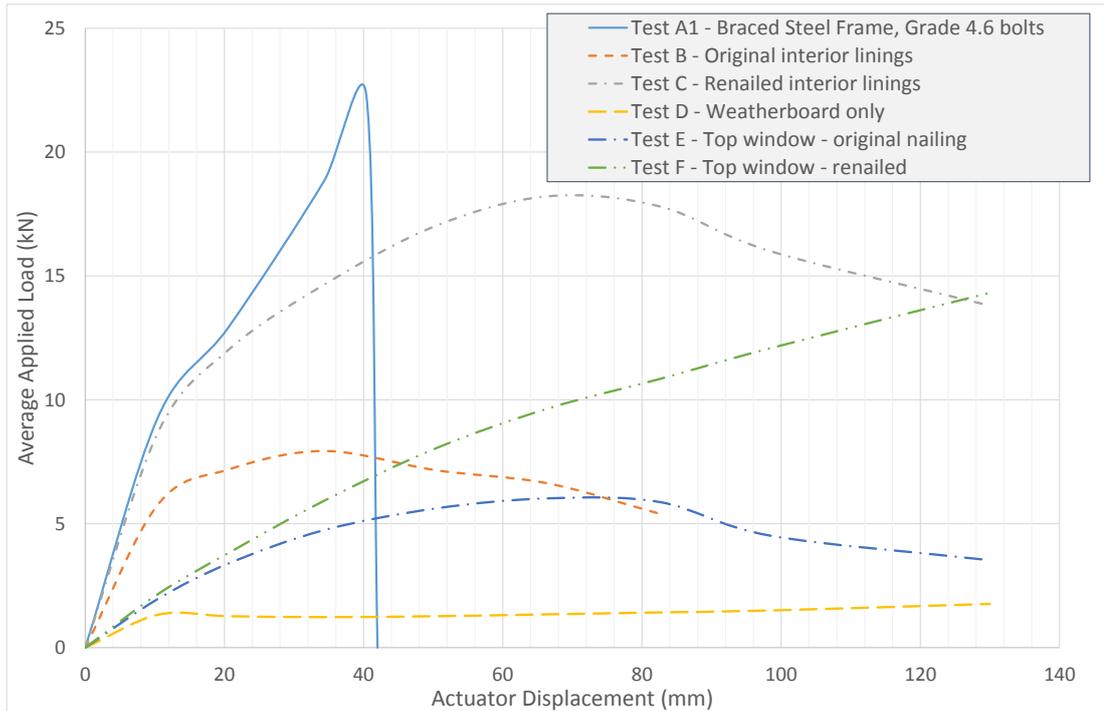
**Figure 10. Adjusted Average Backbone Curves with Steel Frame and Timber Frame Contributions Subtracted (Tests A1, B to F)**

An adjusted series of averaged 1<sup>st</sup> cycle backbone curves where the contributions of the bare steel frame and timber frame from Test G have been subtracted from the other curves are shown in Figure 10 for Test A1 and Test B to Test F. An adjusted series of averaged 1<sup>st</sup> cycle backbone curves where the contributions of the bare steel frame and timber frame from Test G have been subtracted from the other curves are shown in Figure 11 for tests A1, A2 and A3. An adjustment was also made to the plot for Test A3 to account for flexural uplift of the baseplates. Individual hysteresis plots are presented for all test configurations in the following sections.

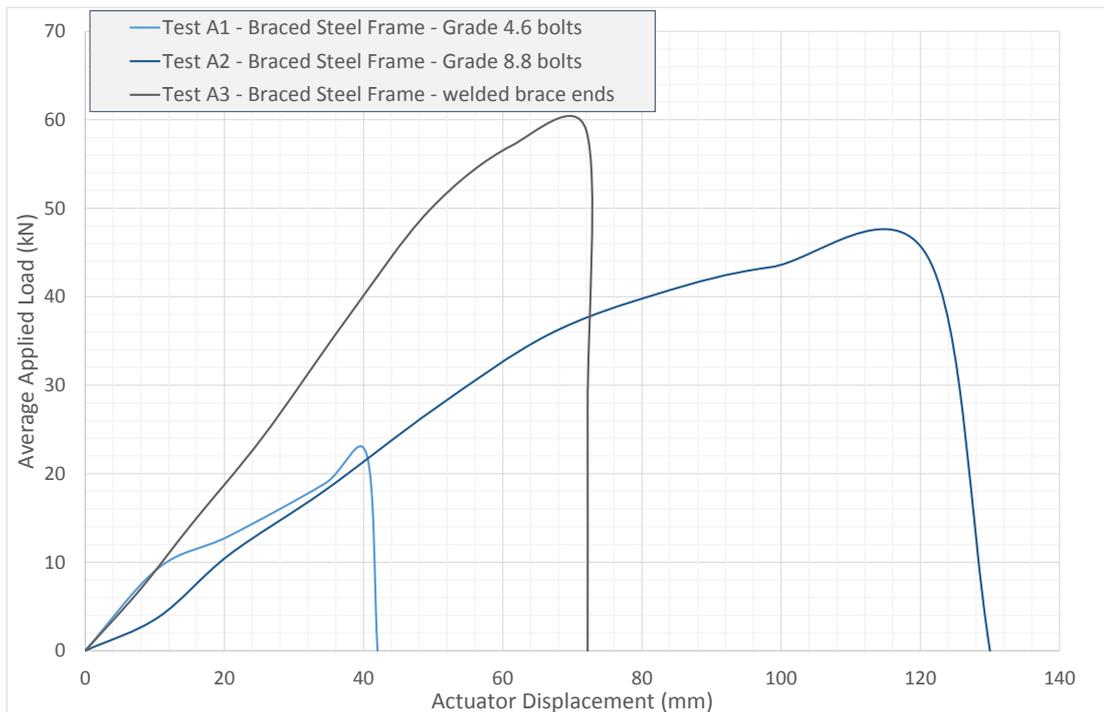
**Figure 11. Adjusted Average Backbone Curves with Steel Frame Contributions Subtracted (Tests A1, A2 and A3)**

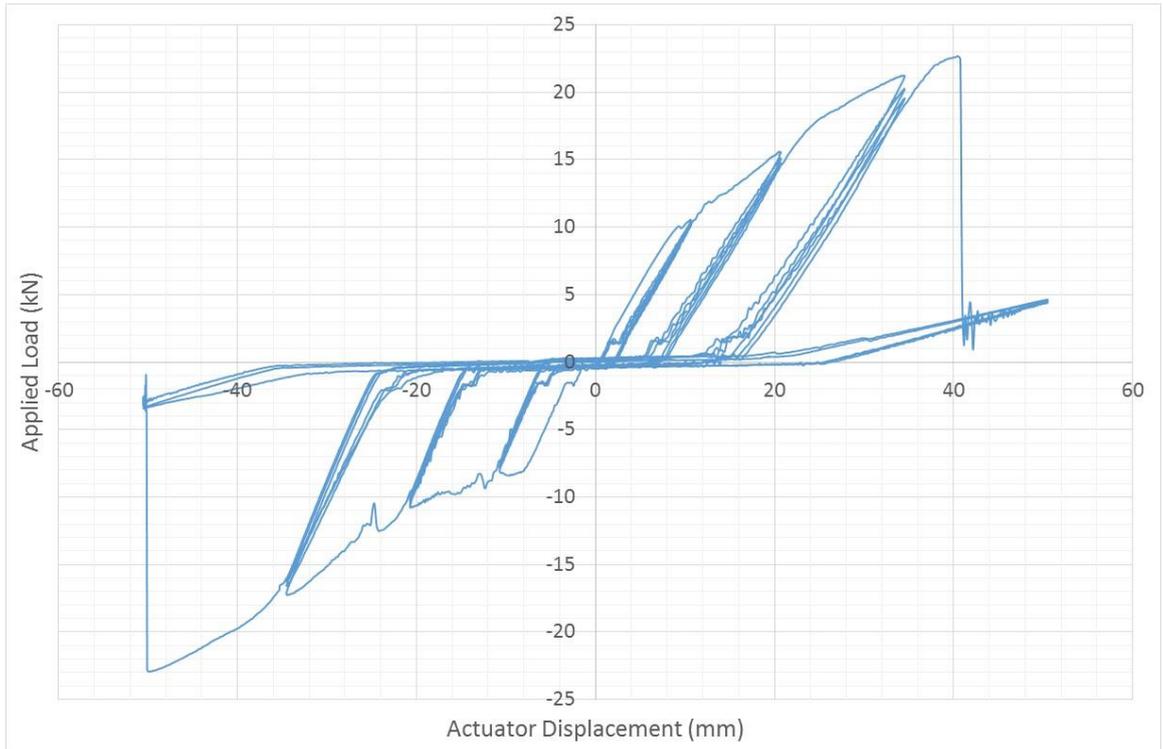
**Figure 12. Full Hysteresis for Test A1**

The full hysteresis for Test A1 is shown in Figure 12. The significant drop in load in each direction was due to shearing of the 12 mm bolts used to connect the braces to the lugs welded to the column webs in the upper bay of the specimen. Testing was stopped soon after the second bolt failure. In this test there was significant “slop” in the system because the diagonal steel straps could not be tensioned and there was a tolerance of 1 mm between the bolts and the hole at the bolted joints.

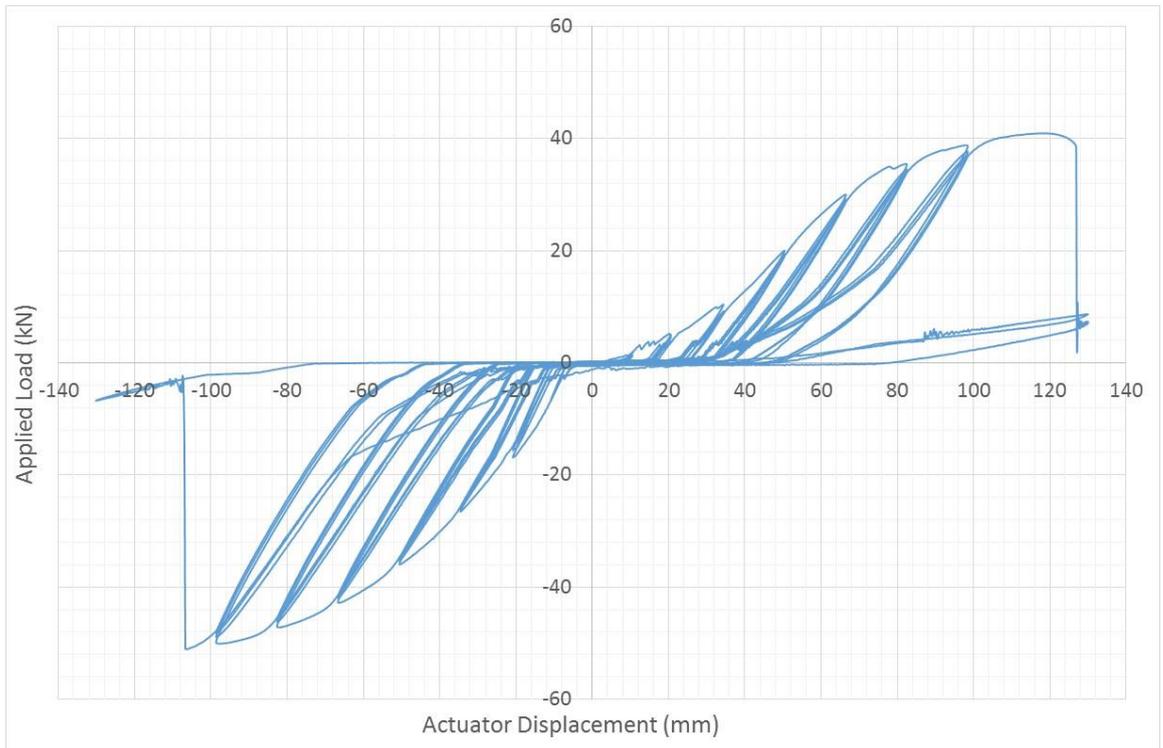
**Figure 13. Full hysteresis for Test A2**

The full hysteresis for Test A2 is shown in Figure 13. As with Test A1, the drop in load in each direction was due to shearing of the 12 mm bolts used to connect the braces to the lugs welded to the column webs in the upper bay of the specimen. Testing was stopped soon after the second bolt failure. In this test there was even more “slop” in the system because the diagonal steel straps could not be tensioned and there was a tolerance of 1 mm between the bolts and the hole at the bolted joints. It was also noted that Test A1 resulted in a small amount of bearing deformation around the holes in the steel straps, resulting in lower frame stiffness in the early stages of the test.

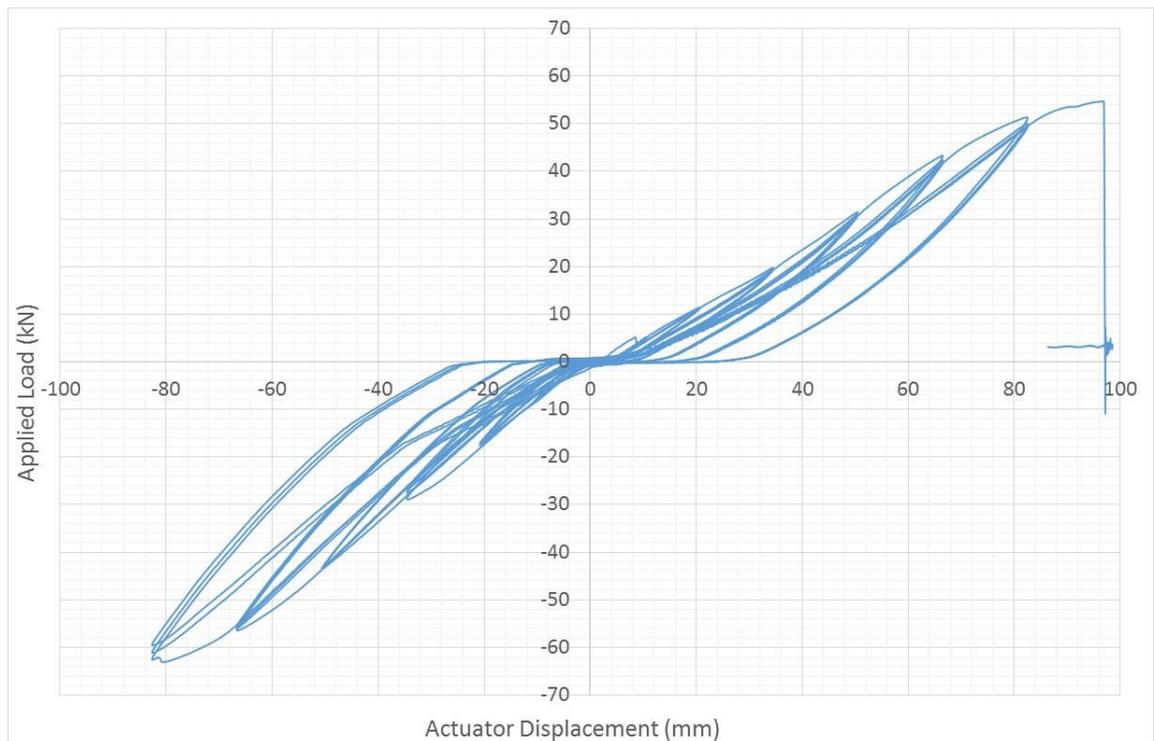
**Figure 14. Full hysteresis for Test A3**

The full hysteresis for Test A3 is shown in Figure 14. The drop in load was the result of a failure of one of the columns where it was attached to the baseplate. The test was stopped immediately after this failure as the test specimen had the potential of being unstable following this failure, which was considered a fabrication error in welding the column to the baseplate. Enough data had been recorded up to the point of failure that it was considered a valid test for determining the specimen response over the displacement range that was under consideration for this project.

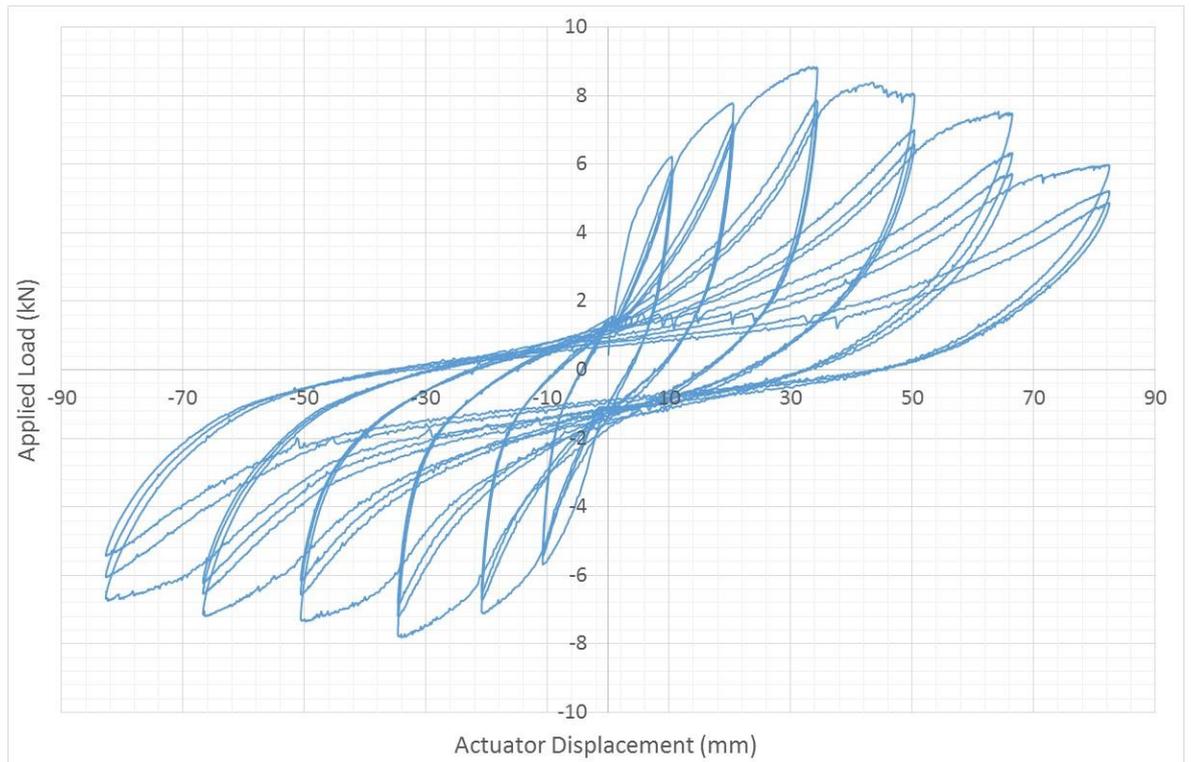
**Figure 15. Full Hysteresis for Test B**

The full hysteresis for Test B is shown in Figure 15. Testing was stopped for this configuration prior to the end of the full set of cycles because it became obvious that the peak load had been achieved and would not be regained. The drop in load resistance was due to the nails holding the particleboard and hardboard linings working out and allowing the panel materials to deform so that they no longer bore against each other along the edges. This was more obvious with the hardboard panels and towards the end of the test one of the hardboard panels became fully dislodged from the framing.

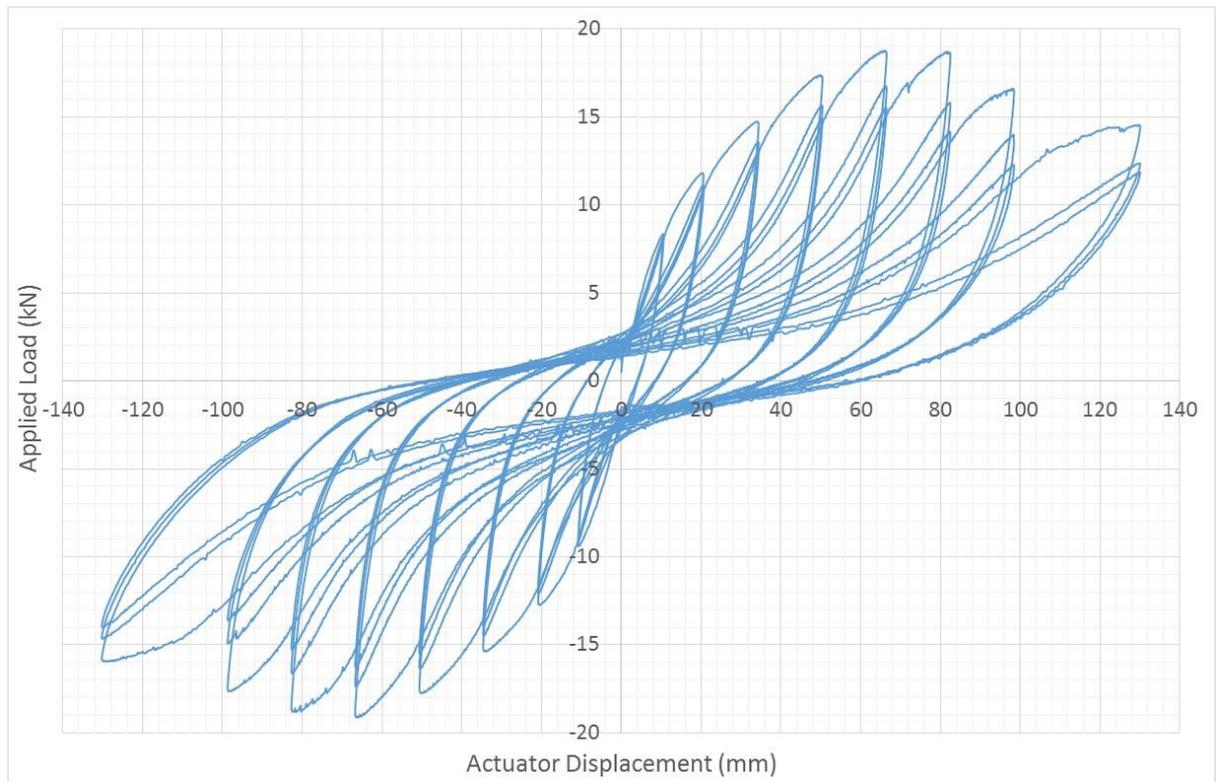
**Figure 16. Full Hysteresis for Test C**

The full hysteresis for Test C is shown in Figure 16. The re-nailed interior linings performed much better than the original fastenings and much higher loads were reached before the load resistance began to decline. The nails in the hardboard gouged out the hardboard around the fasteners which allowed for some deformation of the panels at greater displacements. The nails in the particleboard held much better than the original nailing and while some nails fractured at the interface between the particleboard and the timber framing, the remaining nails held the panels in place throughout testing.

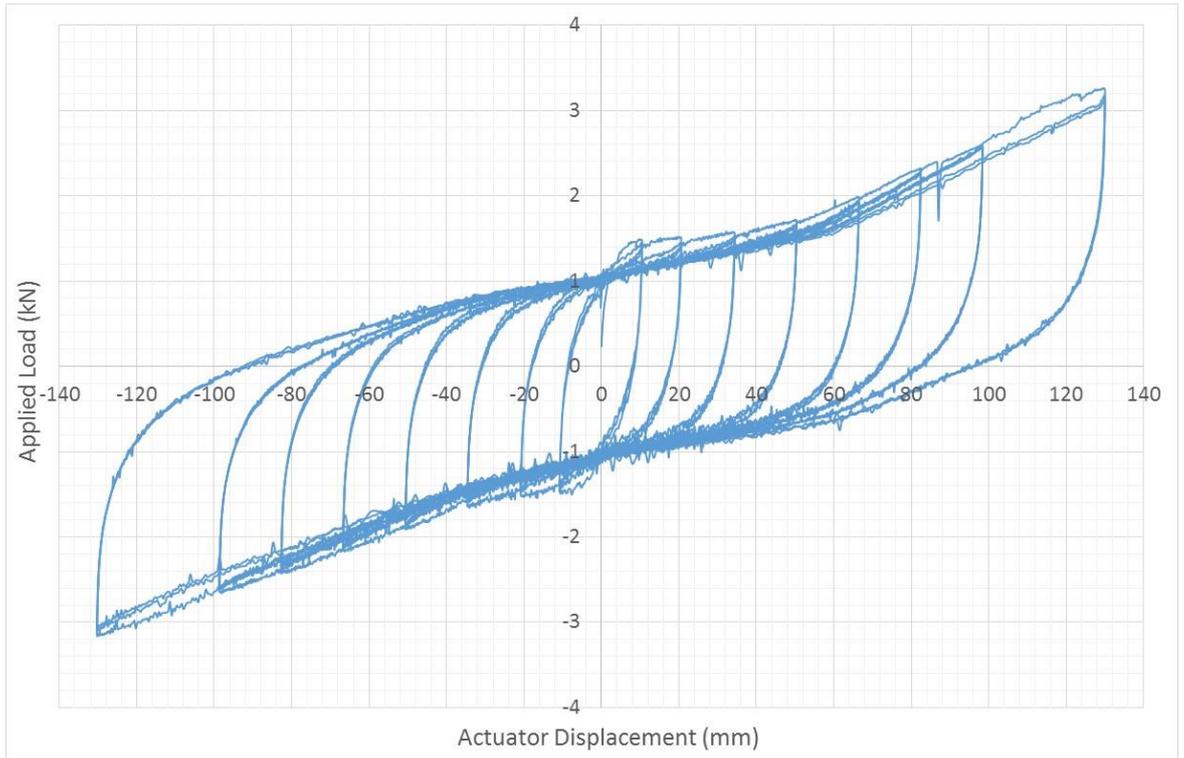
**Figure 17. Full Hysteresis for Test D**

The full hysteresis for Test D is shown in Figure 17. This configuration was dominated by friction of the weatherboards as they slid past each other during lateral loading. No damage was observed to the weatherboards or the connections of the weatherboards to the timber framing.

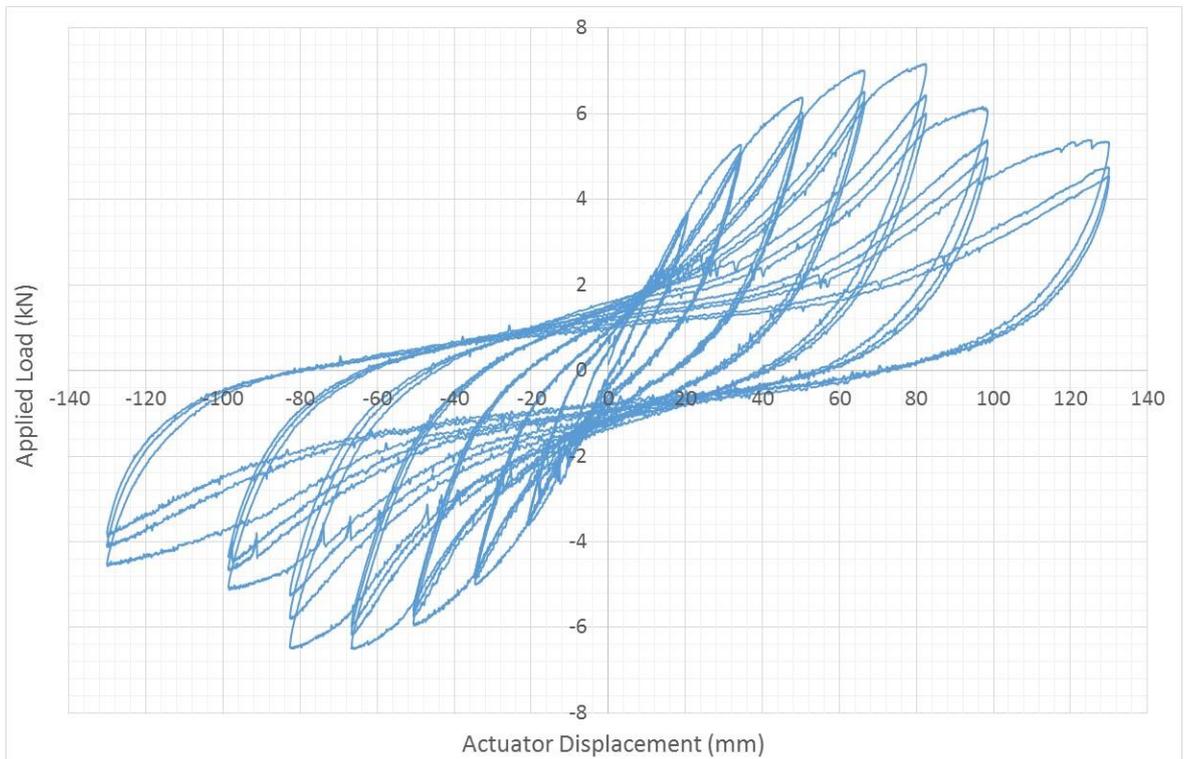
**Figure 18. Full Hysteresis for Test E**

The full hysteresis for Test E is shown in Figure 18. The behaviour of this configuration was similar to Test B except that the additional flexibility of the steel frame above the top of the particleboard lining resulted in lower loads being resisted.

The particleboard panels for Test E were observed to behave similarly to those in Test B in that the panels rotated individually and worked themselves off the timber framing either by pulling out the nails or the nails pulling through the particleboard.

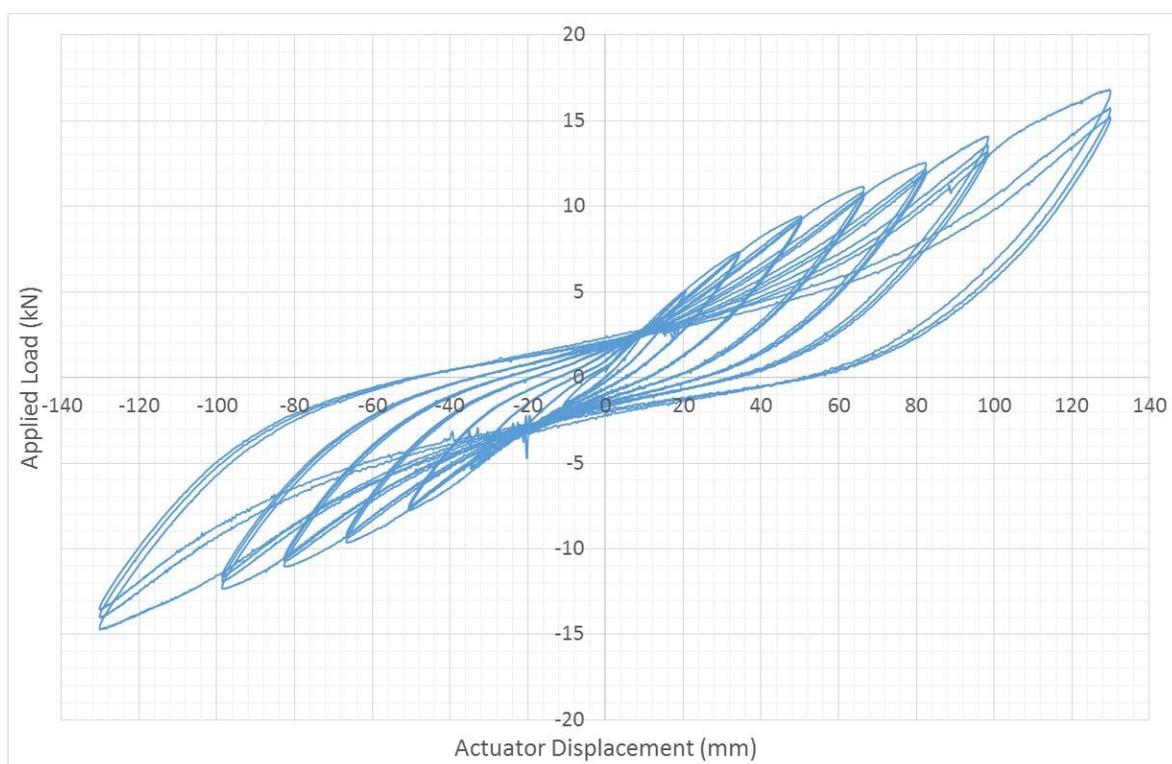
Figure 19. Full Hysteresis for Test F

The full hysteresis for Test F is shown in Figure 19, which shows that even at  $\pm 130$  mm of displacement the specimen is still resisting load and has not had any failure that caused a significant reduction in resistance. The new nails provided a significant increase in load carrying capacity over Test E and the damage to the particleboard was similar to Test C, although with fewer nails broken during the testing.

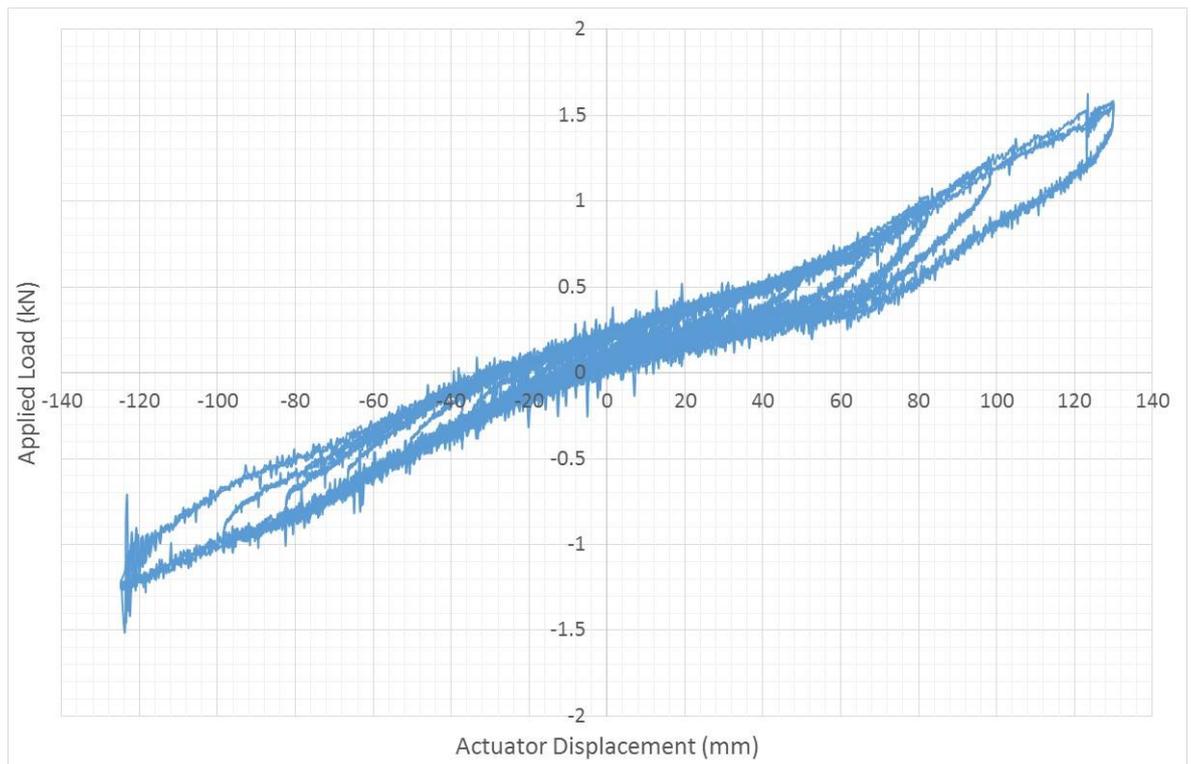
**Figure 20. Fully Hysteresis for Test G**

The full hysteresis for Test G is shown in Figure 20. No damage was observed during this test to either the steel frame or the timber frame, even at the largest displacement levels. This test confirmed that the contribution from the steel and timber frames by themselves was minimal compared to the contributions of other components of the tested configurations.

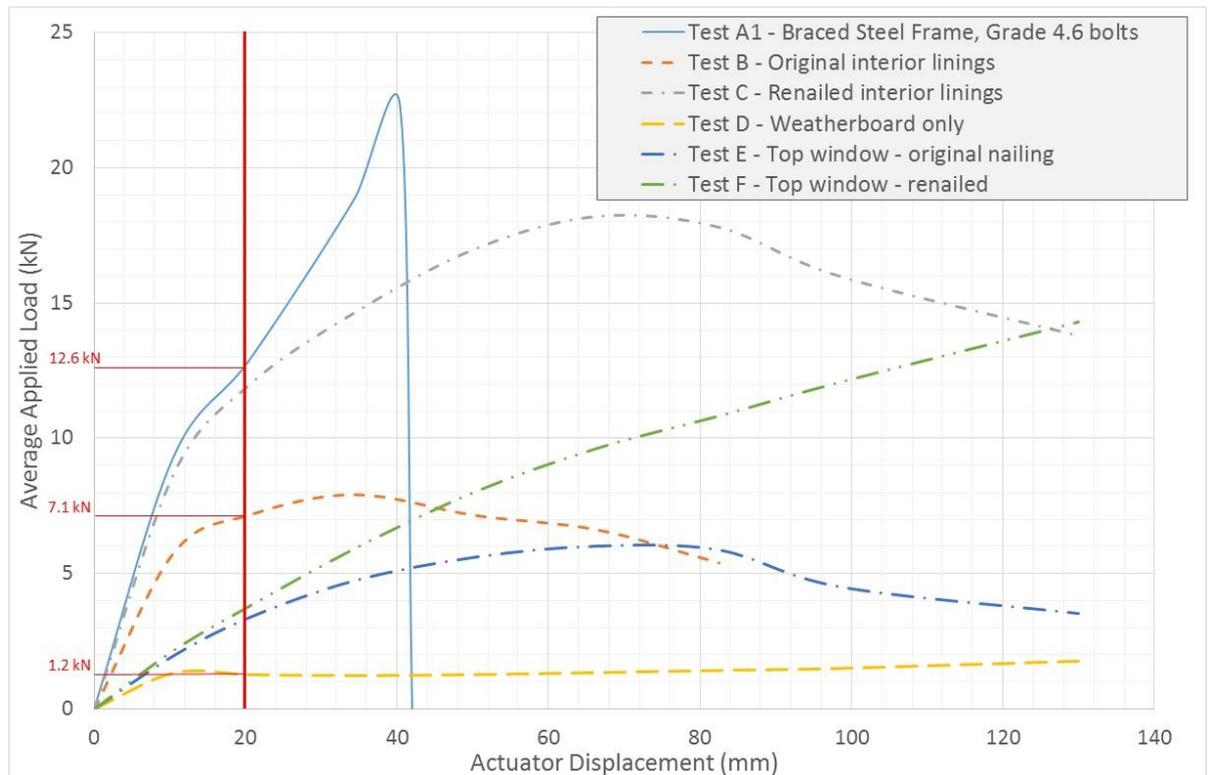
**Figure 21. Load Levels at 20 mm Displacement for Test A1, Test B and Test D**

seven times the resistance from the interior lining result (Test B) at 20 mm (7.1 kN per bay). The values taken from the backbone plots can be seen graphically in Figure 21. The south wall of the gymnasium can therefore be expected to resist approximately 83.3 kN at 20 mm of eave height displacement.
