Christchurch Schools Rebuild – Christchurch Girls High School

Appendix A:
Repair Sequence Drawings

Project
MOE - Christchurch Girls High School
Matai Street
Main Block Repair Phase Planning
Level 1 Soft Strip Out Plan - STAGE 1
Sheet No 101 Revision RB

This report focuses on the assessment of the Main Block structure (refer Figure 1.1) and is intended to provide an interim assessment of the seismic performance of the building relative to current new building standards (%NBS), recommendations for further assessment, options for remediation of earthquake induced damage, and recommendations for repair.

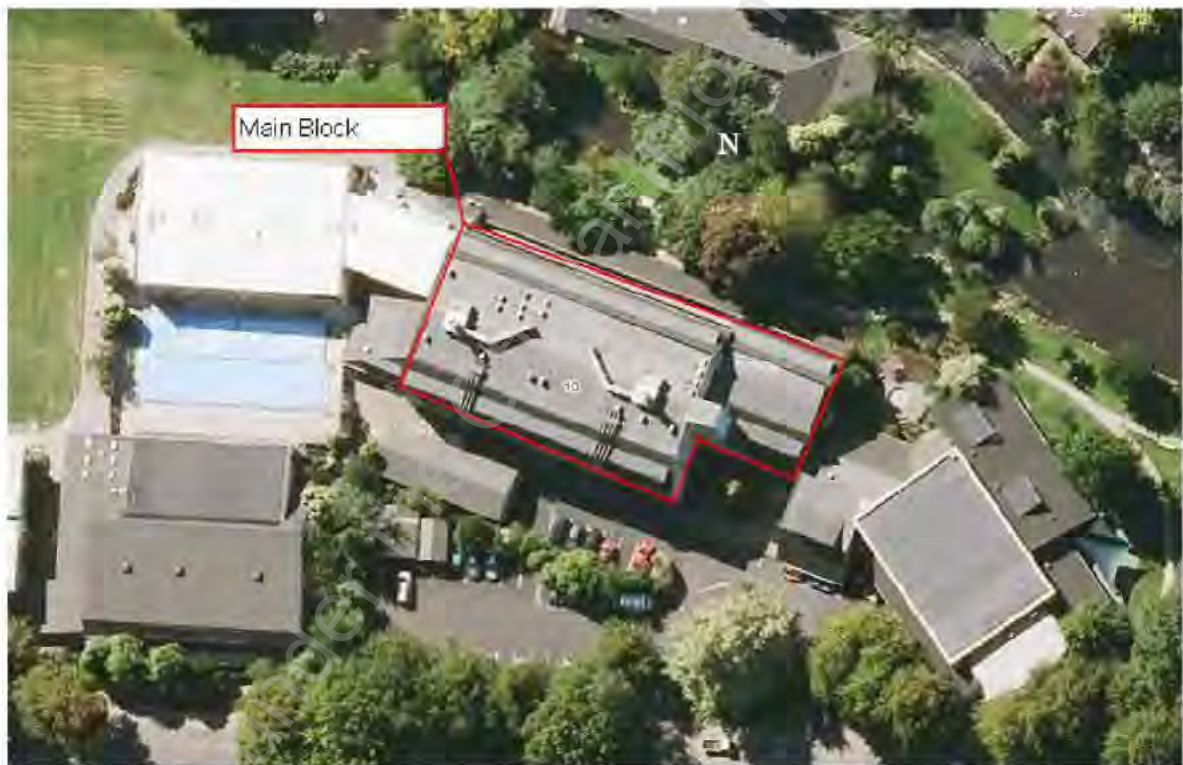
Figure 1.1: CGHS Main Block – Image courtesy Google Earth

For the purposes of this report the Main Block is considered to comprise the four storey block designed by the Ministry of Works in 1982. The Auditorium and Link Block, which are connected to the east and west of the Main block respectively, are addressed in separate reports.

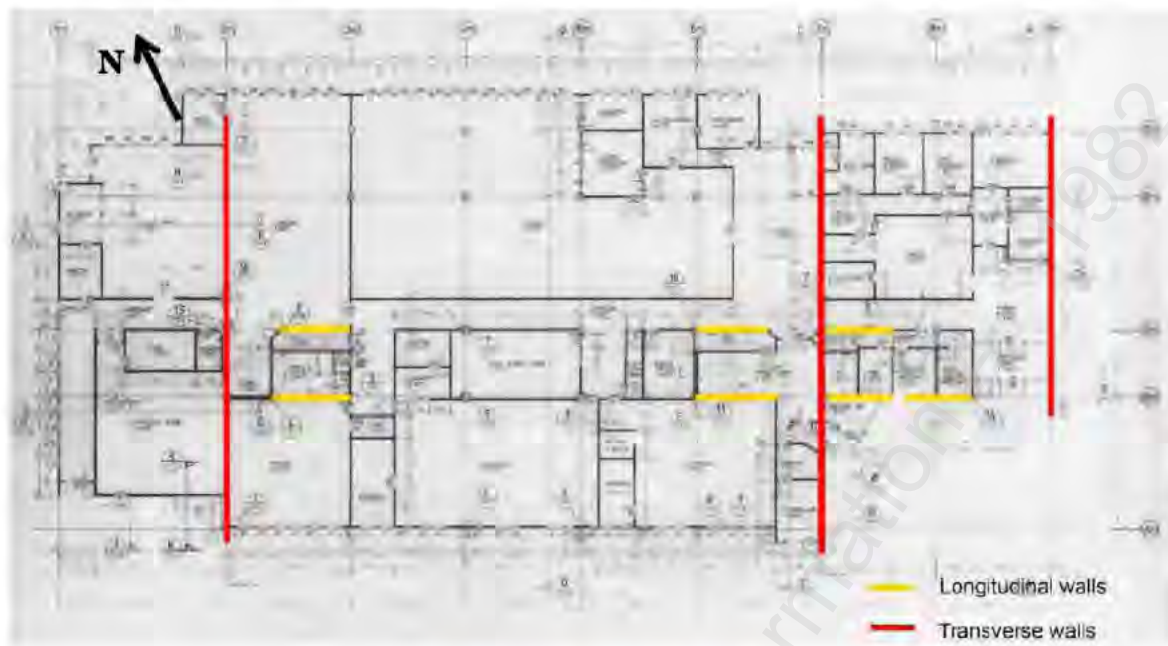
Figure 3.1: Ground Floor Plan

The lateral load resisting system in the transverse direction includes full height shear walls at the ends of the four storey sections and at the eastern end of the administration area. In the longitudinal direction the lateral load resisting system relies on the stair and elevator core walls along with a full height shear wall on the southern side at the eastern end. Refer Figure 3.1.

As these lateral load resisting elements are located more towards the southern side of the building, some moment frame action may be utilised on the northern side of the building.
