Detailed Seismic Assessment

**Taradale Primary School Swimming Pool Enclosure, Ngarimu
Crescent, Taradale, Napier**

Ref No: 1163.1

12th April 2016

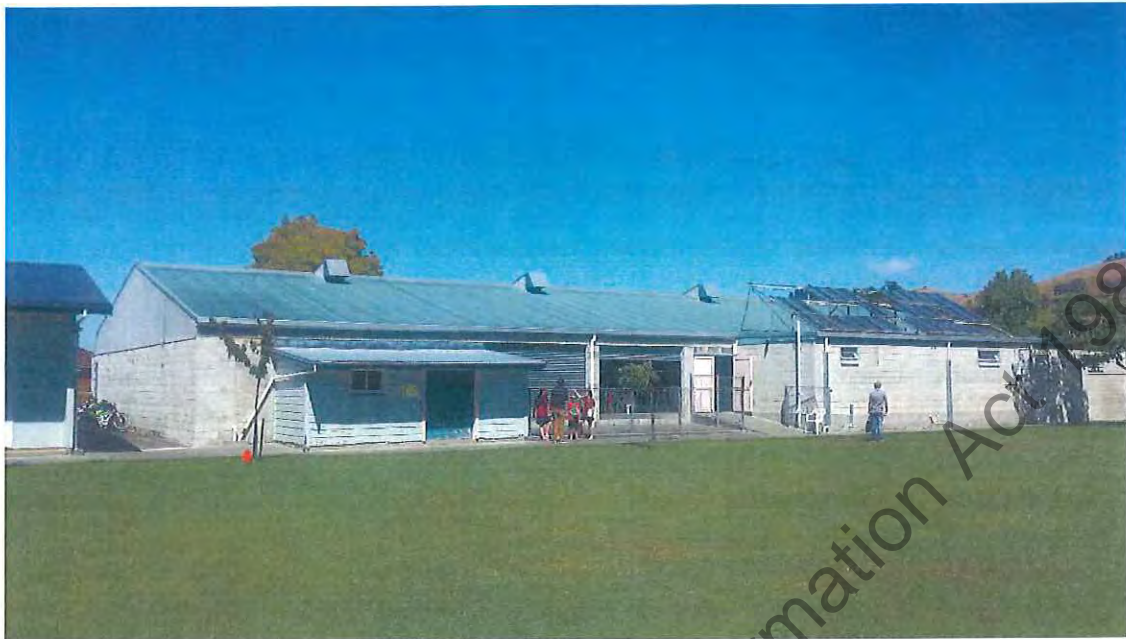
FIGURE 1: Exterior Views of Greendale Swimming Pool Enclosure

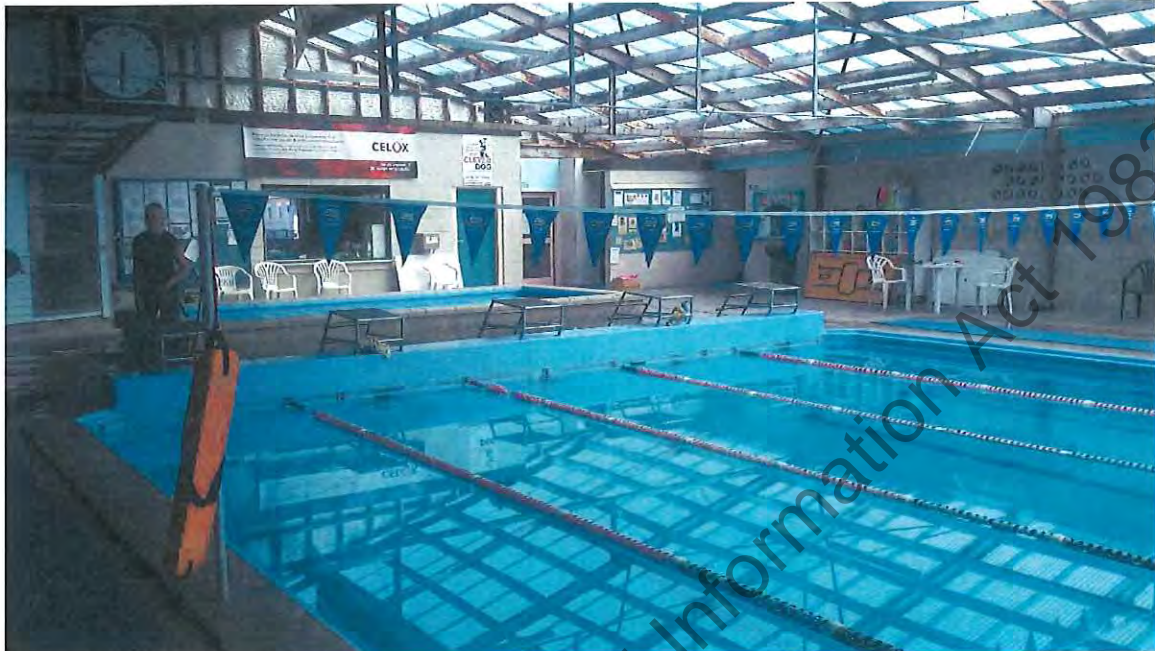
FIGURE 3: View to west of 1998 extension

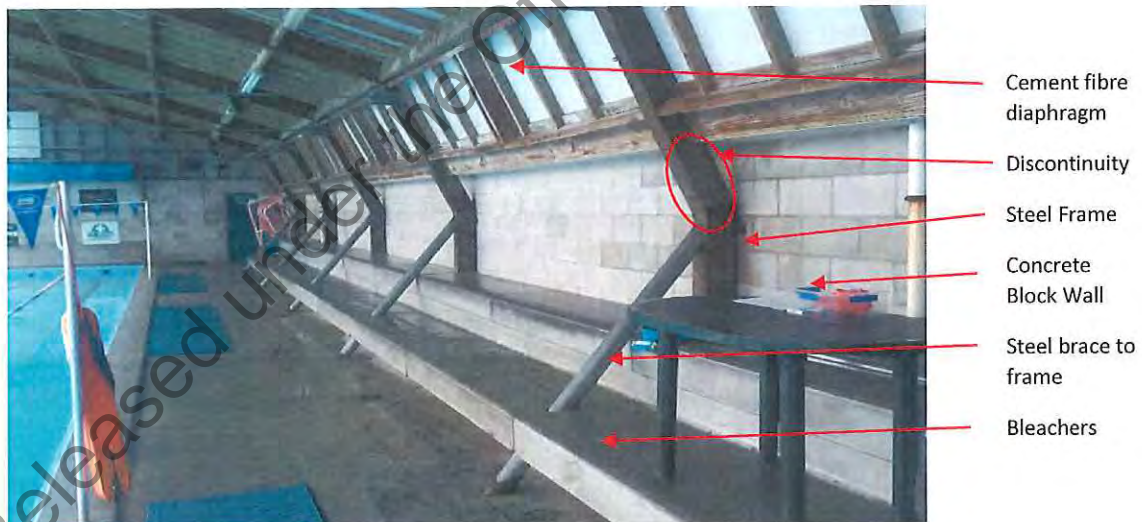
FIGURE 8: View of pool enclosure from south looking east

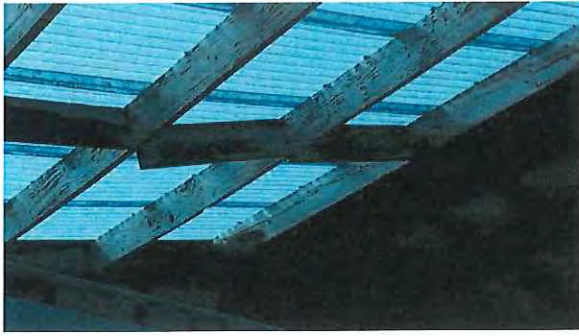
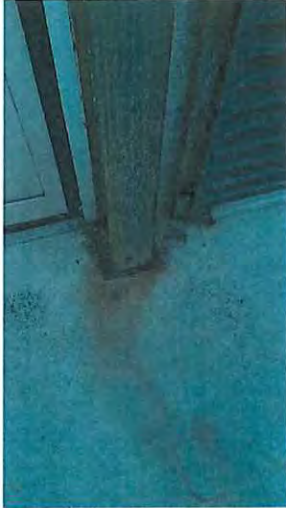
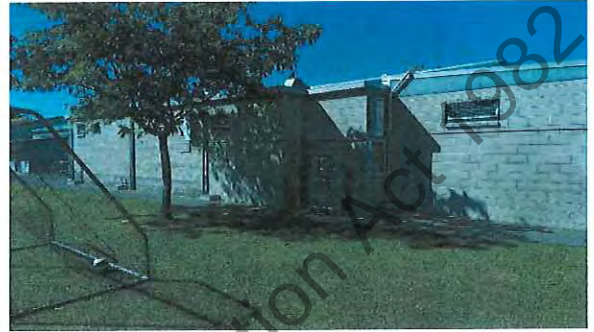
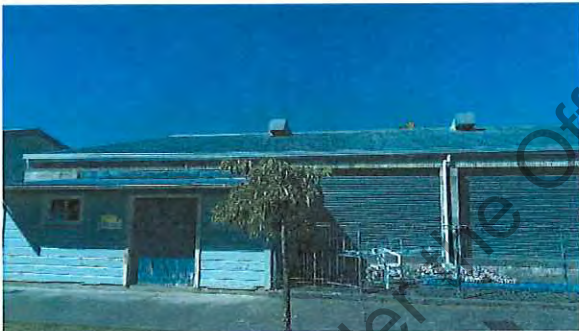
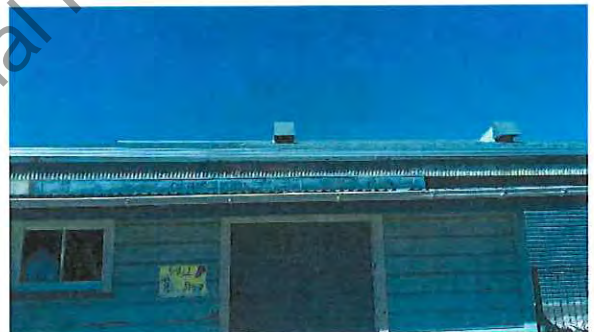
The remedial solution provided over page in figure 12 & 13 illustrate only a short term solution, to help safe guard risk and ensure the building has a 35% NBS rating. Given that the corrosion of the steelwork will continue to erode the available seismic capacity of the primary elements, the solution is provided on the clear understanding that a subsequent review is undertaken to remediate the building over the next few months. Hence the temporary strengthening solution provided can only be deemed to be valid for 6-8 months for the date of this report.

To improve the seismic performance of the building to achieve at least 33% NBS, the remediation of the portal frame connections to foundations and concrete block masonry elements would need to be undertaken. Refer Section 8 for Temporary Remedial Measures.

- Improve connections of purlins to frames.
- Improve foundation to southern portal frame columns.
- Improve connection of the strut connection to the southern portal frame column.
